WMSC Commissioner Brief: W-0185 - Improper Roadway Worker Protection - King Street Station - June 24, 2022

Washington Metropolitan Area Transit Authority Department of Safety (SAFE) Office of Safety Investigations FINAL REPORT OF INVESTIGATION A&I E22392

King Street Station - Improper RWP

June 24, 2022

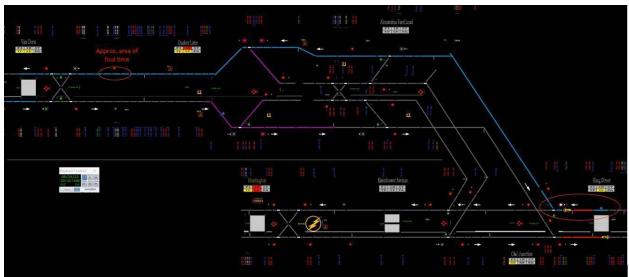
Further investigation into this incident revealed that personnel have displayed confusion at stations that service multiple train lines with turnouts, where the line changes after departure and a Mobile Work Crew is under foul time protection. As in this case at King Street Station, the yellow line train was continuing towards Huntington Station, not continuing in the direction of the Mobile Work Crew (near Van Dorn Street Station on the blue line) as shown in the figure.

Figure 1 - AIMS display of FT protection in place at 10:12 hours as Train ID 302 departs King Street Station, track 2.

ARS playback confirmed that RWICs are instructing AMFs to release a particular train line while they are under FT protection, this action has contributed to the confusion. Radio communication observation revealed that RWICs intermittently instruct AMFs to allow one train line to continue and another train line to hold while the Mobile Work Crew is under FT protection. This action leads to confusion on the part of the Train Operator when they encounter AMFs that have been instructed to hold all train movement during FT. According to the MSRPH Section 5 – RWP, 5.13.6

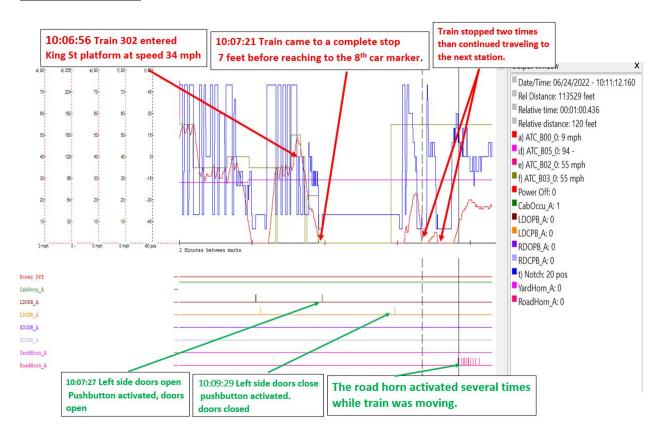
3260 VMS Graph:

IIT has completed analysis of the data retrieved from the consist (L3260/61X3244/45X3254/55). Based on the VMS data, the lead car 3260 entered King Street Station traveling at a speed of 34 MPH, the train came to a complete stop 5 feet before reaching the eight-car marker, speed limits changed from 40 mph to 0 mph.

At 10:07:27 the left side doors were opened to service the station. After closing the doors, the train received a speed limit of 55 mph, the master controller was placed in P5 power mode, and the train moved 577 feet then came to a complete stop with 55 mph speed limits. The train began to move and stopped again after traveling 63 feet. The train remained in a stop position for 26.6 seconds then proceeded towards Eisenhower Avenue Station with multiple road horn activations. Based on the available data, there was no failures of the train that may have contributed to this incident.

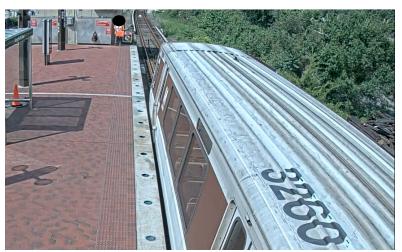
Image 1 – AMF positioned at the 8-car marker as Train ID 302 arrives at King Street, track 2.

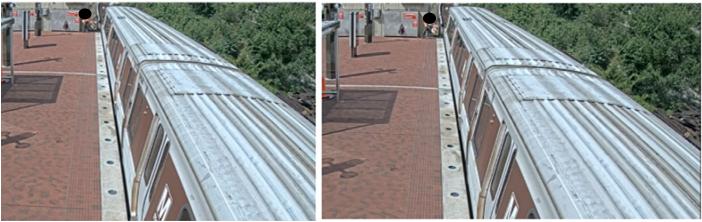
The CCTV confirmed that Train ID 302 entered the platform at King Street Station, track 2. The Train Operator looked out of the cab window and opened the doors on the platform side, words were exchanged with the AMF. A short time later the Train Operator looked out the cab window and closed the doors. As the train proceeds to depart the station the AMF waves their hand at the train, then speaks into the handheld radio. The train stops briefly, then continues toward Eisenhower Avenue Station.

Image 2 – AMF & Train Operator acknowledgement and AMF attempting to stop Train ID 302 from departing King Street Station.

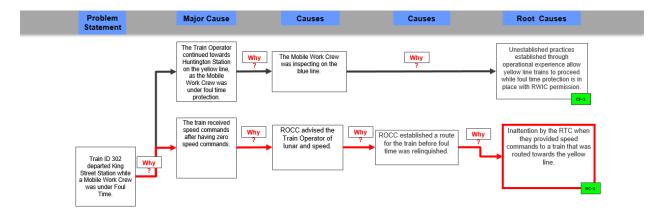
Appendix E - Root Cause Analysis

The probable cause of the Improper RWP event on June 24, 2022 was a conflicting instruction that resulted in confusion by the Train Operator when they were given a lunar signal and speed commands by the ROCC RTC after being held on the platform by the AMF due to a Mobile Work Crew under FT protection. A contributing factor to the event was practical drift from the procedure to hold all trains while a Mobile Work Crew is under FT and allowing the RWIC to authorize movement on adjacent lines. Additional contributing factors are a significant amount of radio traffic during the time of the event and numerous parties contacting ROCC.
