WMSC Commissioner Brief: W-0186 – Improper Vehicle Movement – McPherson Square Station – June 23, 2022

Washington Metropolitan Area Transit Authority
Department of Safety (SAFE)
Office of Safety Investigations
FINAL REPORT OF INVESTIGATION A&I E22386

McPherson Square Station – Improper Rail Vehicle Movement

June 23, 2022

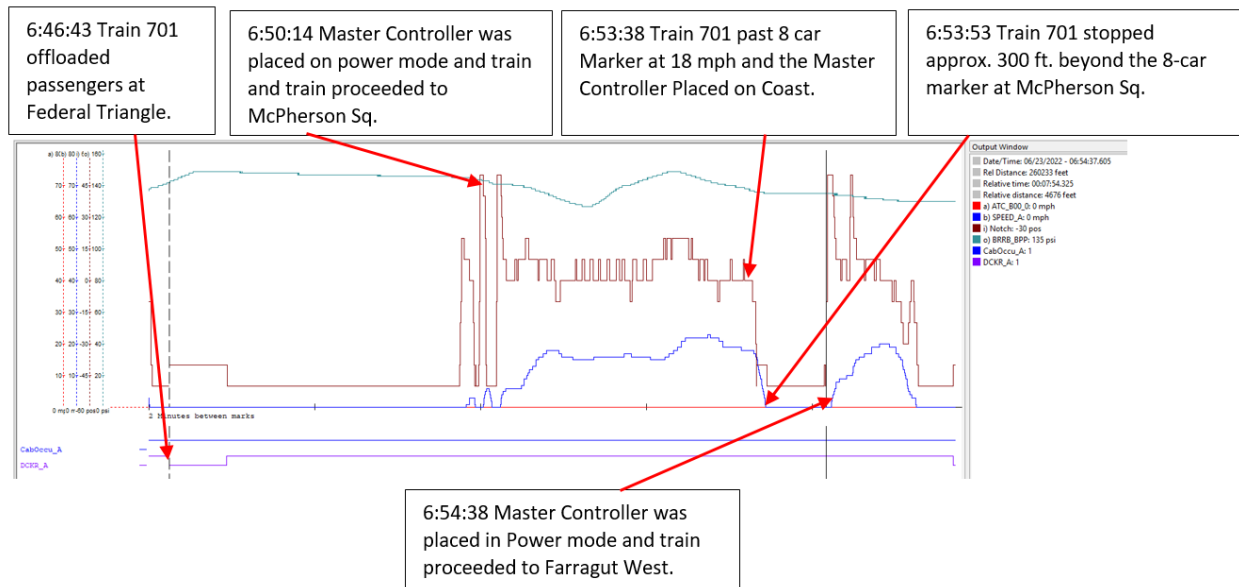
IIT CMOR analysis of the VMS data from Train ID 701 verified the Train Operator of Train ID 701 did not stop at Metro Center Station after departing Federal Triangle Station. Train ID 701 was offloaded at Federal Triangle Station and was then given a permissive block to Metro Center Station. Train ID 701 responded to the commands entered in the Master Controller at the time. Train ID 701 overran the permissive block and stopped approximately 308 feet beyond the 8-Car Marker at McPherson Square Station. Train ID 701 stopped for a few moments and then continued to Farragut West Station.

"Based on the VMS data, the IIT concluded there were no mechanical failures that contributed to the Train Operator bypassing the permissive block."

Diagram 1 – IIT CMOR VMS analysis showing Train Operator's movements from Federal Triangle to McPherson Square Station.

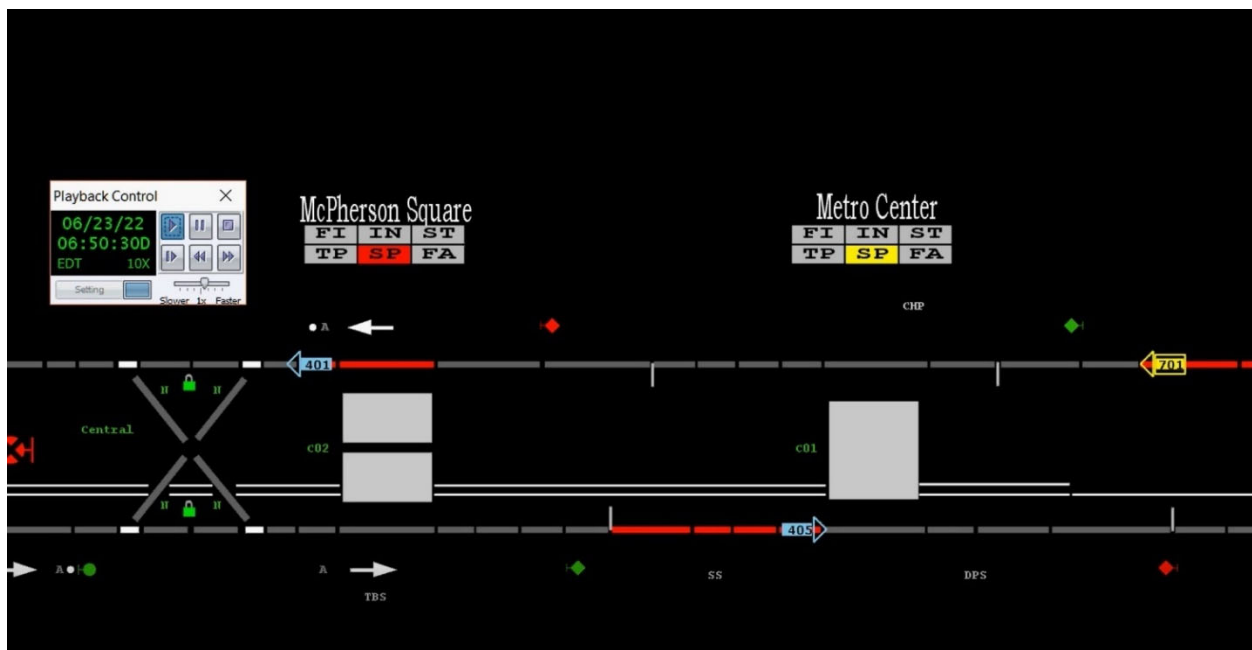
Figure 1 – Train ID 701 approaching Metro Center Station, Track 2 at approximately 06:50:30 hours.

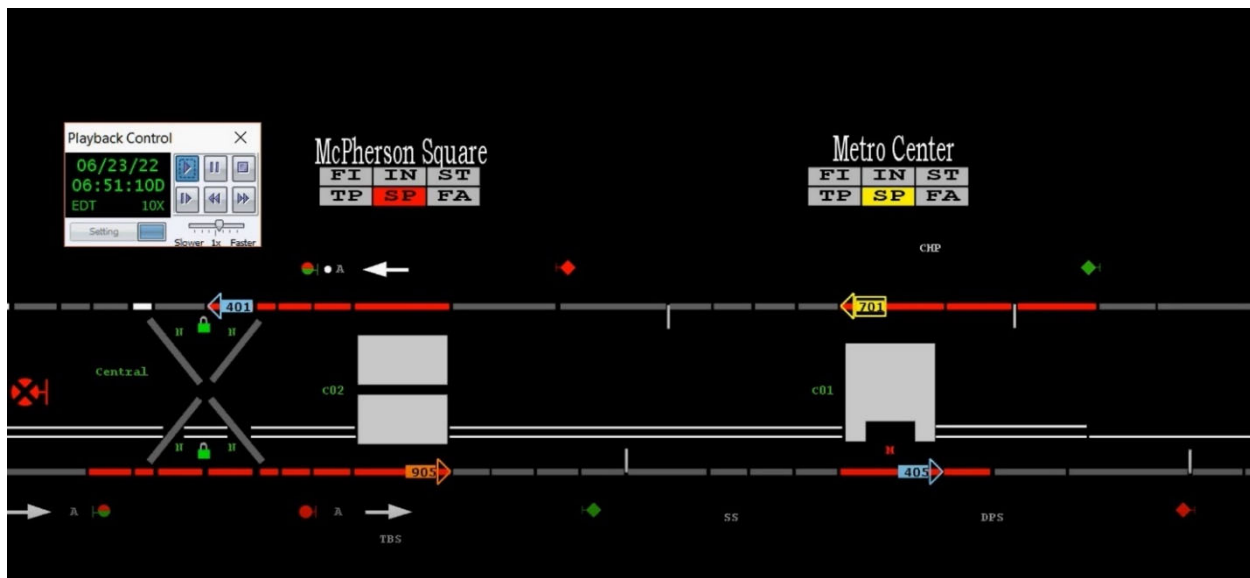
Figure 2 – Train ID 701 approaching the end of the permissive block at Metro Center Station, Track 2, 8-Car Marker at approximately 06:51:10 hours.

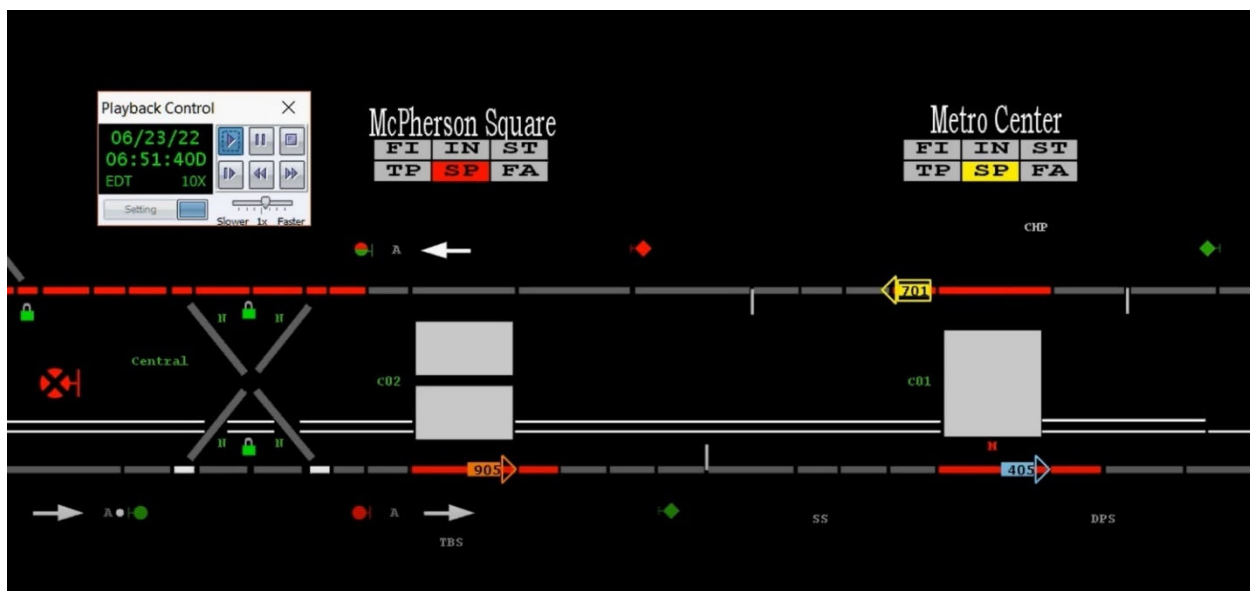
Figure 3 – Train ID 701 bypassed the permissive block at Metro Center Station and proceed towards McPherson Square Station at approximately 06:51:40 hours.

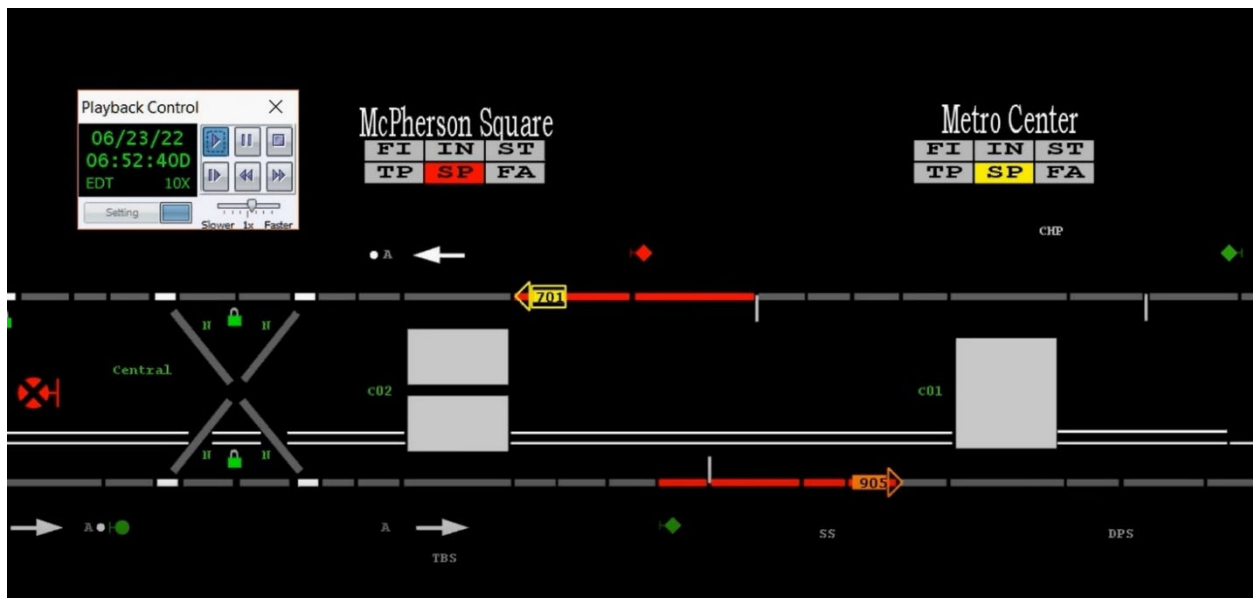
Figure 4 – Train ID 701 approaching McPherson Square Station, Track 2 at approximately 06:52:40 hours.

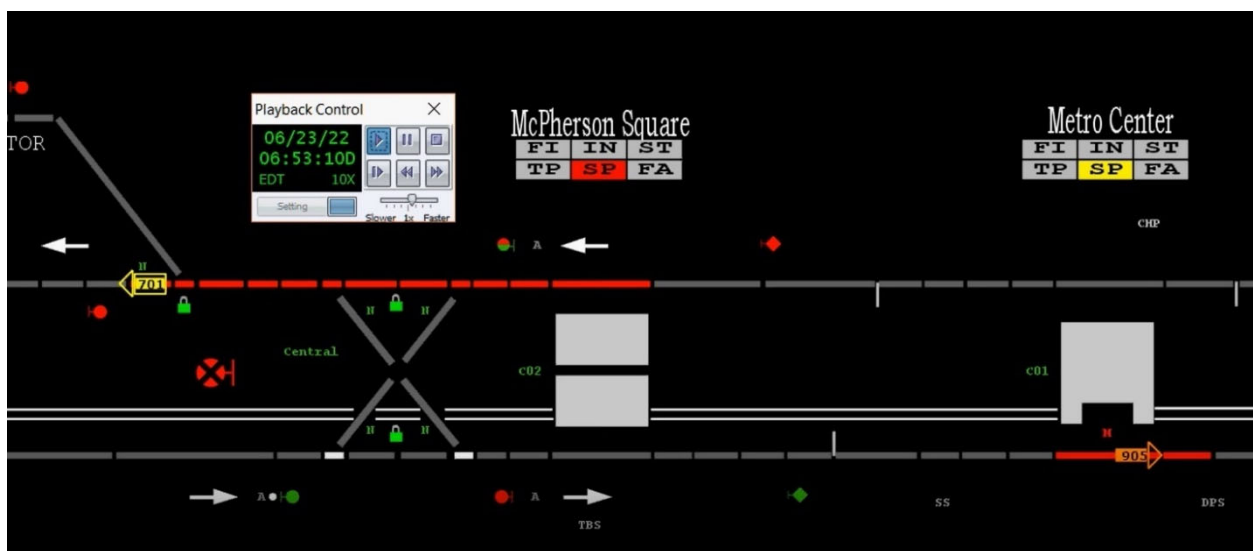
Figure 5 – Train ID 701 proceeded past the 8-Car Marker at McPherson Square Station, Track 2 at approximately 06:53:10 hours.

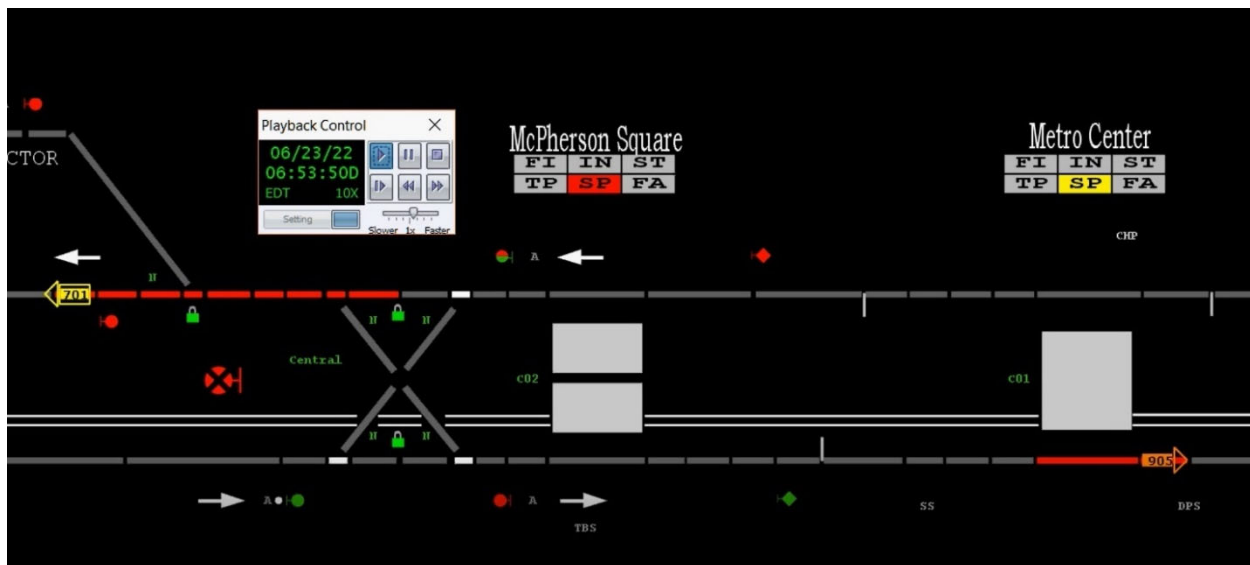
Figure 6 – Train ID 701 came to a complete stop approximately 308 feet beyond the 8-Car Marker at McPherson Square Station, Track 2 at approximately 06:53:50 hours.

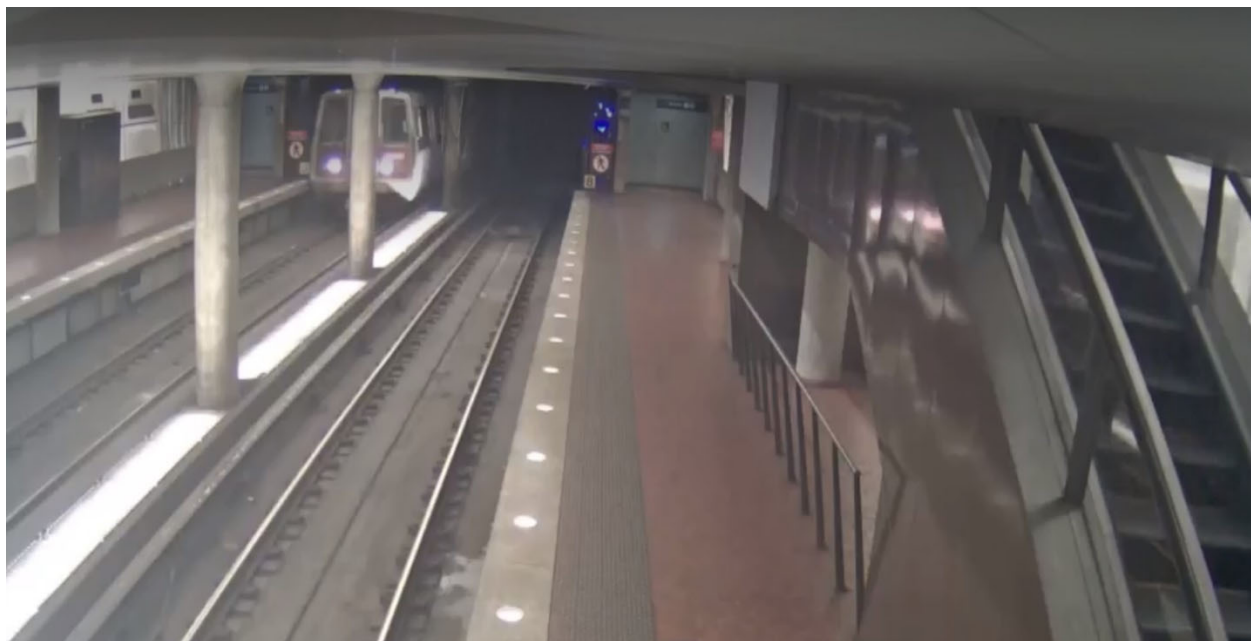
Figure 7 – Train ID 701 enters McPherson Square Station platform limits, Track 2 at approximately 06:52:35 hours.

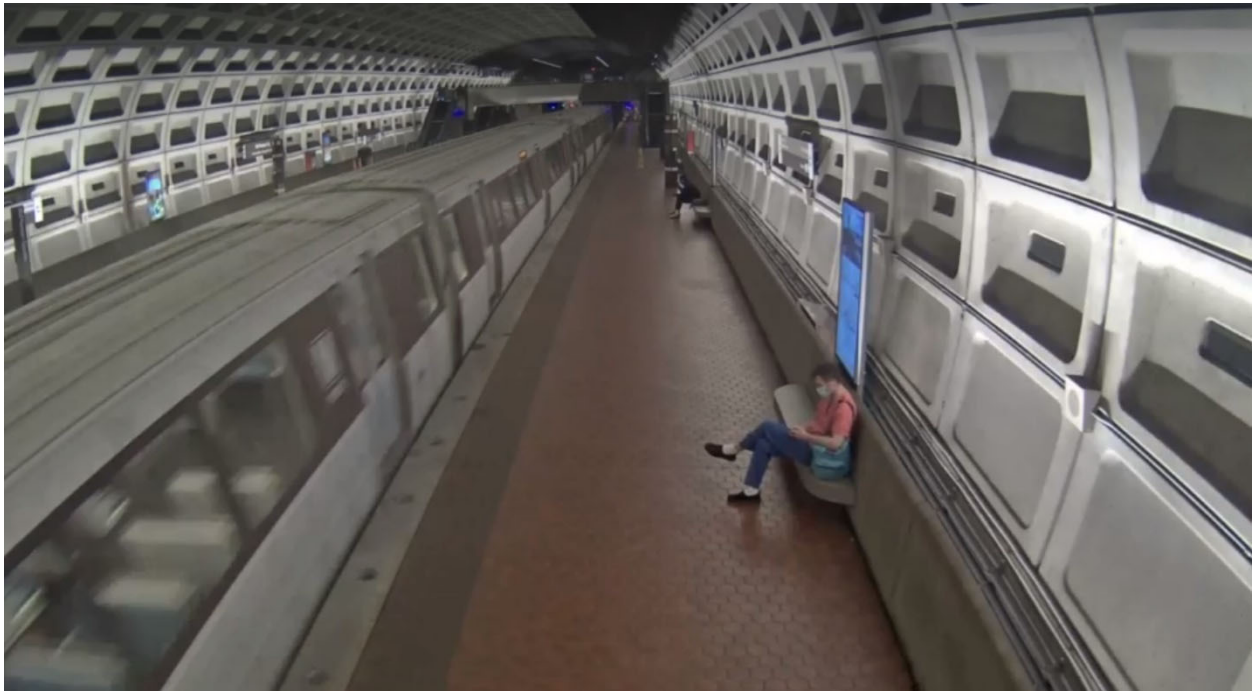
Figure 8 – Train ID 701 approaches the 8-Car Marker at McPherson Square Station, Track 2 at approximately 06:52:53 hours.

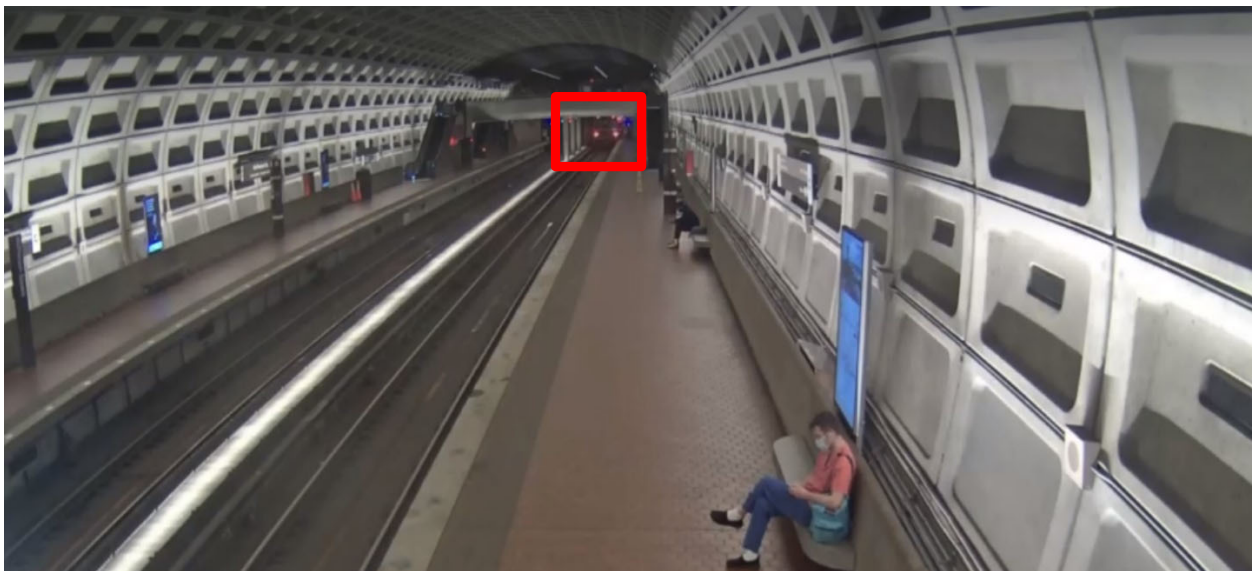
Figure 9 – Train ID 701 passes the 8-Car Marker at McPherson Square Station, Track 2 at approximately 06:53:11 hours.

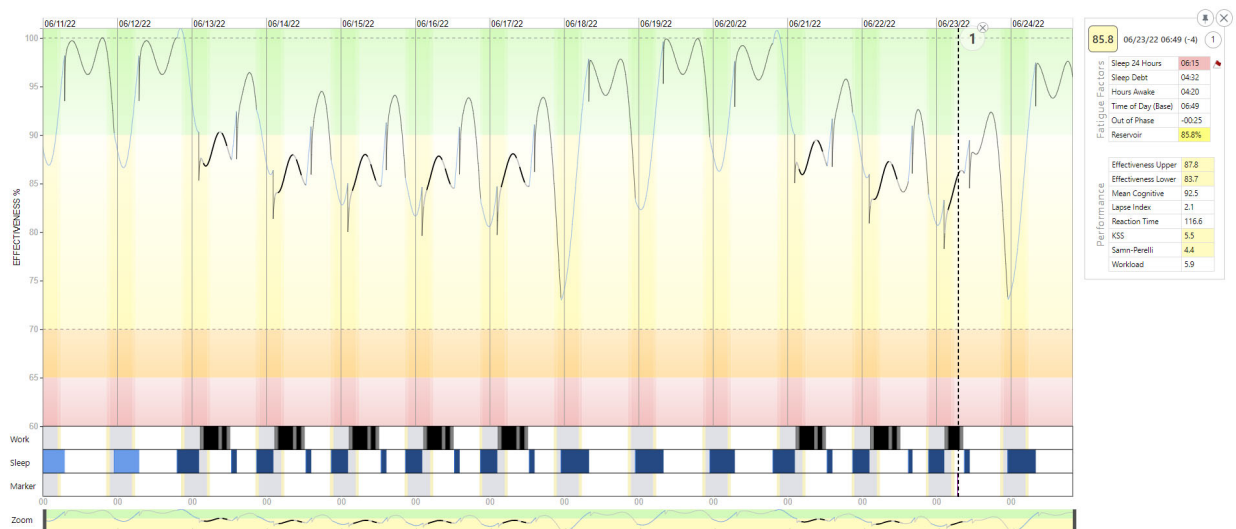
A biomathematical fatigue modelling application (SAFTE-FAST WebSFC) was used to further evaluate fatigue risk factors that may have been present in the Train Operator's schedule. The analysis was based on the Train Operator's work schedule, reported sleep from the day before the incident, and reported habitual sleep durations. Estimated performance effectiveness at the time of the incident was 85.8%. The analysis yielded no major risk factors for fatigue.

Modeling analysis output shows estimated performance effectiveness during the incident work shift and for the week leading up to the work shift, based on the employee work and reported sleep schedule. Estimates were based on the Train Operator's work schedule, reported sleep from the day preceding the incident, and reported habitual sleep durations (7 hours a day). Bold portions of the modeled curve show work (in black)

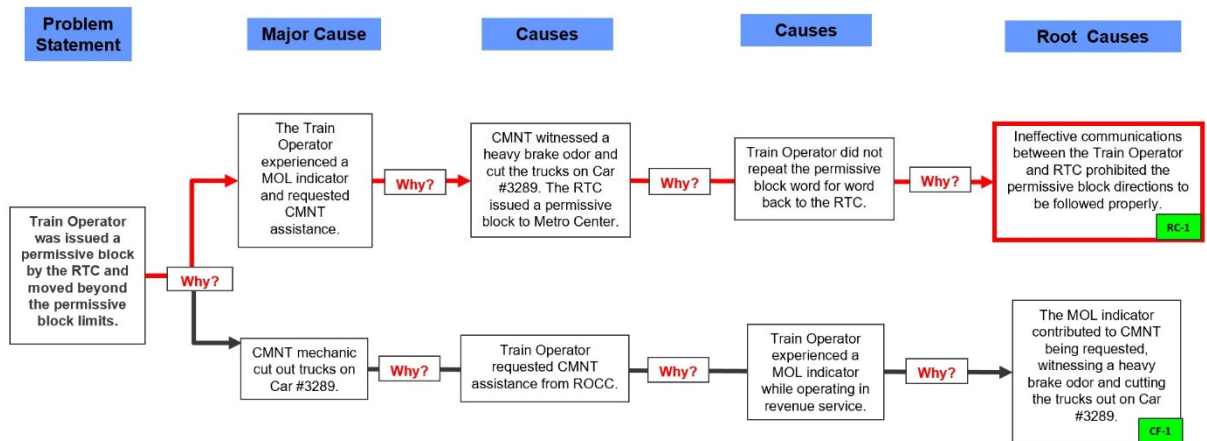
E22386 – Improper Rail Vehicle Movement – McPherson Square Station

The probable cause of the improper rail vehicle movement incident was a human factors failure to perform in accordance with established procedure, which resulted in the Train Operator exceeding their permissive block. Contributing factors included ineffective communications as the RTC issued permissive block instructions to the Train Operator and those instructions were not repeated word for word (100%) back to the RTC.

Corrective Action Code	Description	Responsible Party	Due Date
101262_SAFE CAPS_RTRA_001	(RC-1) RTRA Management will ensure the Train Operator conducts refresher training focusing on radio communications and train operations when blocks are cut out.	RTRA SRC	Completed
101262_SAFE CAPS_RTRA_002	(RC-1) RTRA Management will ensure the Train Operator receives an in-service evaluation monitoring all phases of operating the train to include proper radio communications and word for word repeat backs.	RTRA SRC	Completed
101262_SAFE CAPS_ROCC_001	ROCC Management will conduct safety talks with all Rail Traffic Controllers to emphasize the importance of receiving word for word repeats backs from all personnel and vehicle movement requests via the radio.	ROCC SRC	Completed
101262_SAFE CAPS_ROCC_002	ROCC Management will post and distribute Safety Bulletin SB-22-06A Requirements for Post-Accident and Post Incident Testing.	ROCC SRC	Completed

101262_SAFE CAPS_SAFE_001	SAFE Management will establish procedures to conduct observations of word for word repeat backs of radio transmissions in order to recommend feedback to ROCC Management.	SAFE SRC	Completed
