**WMSC Commissioner Brief: W-0187 – Serious Injury – Cheverly Station – June 3, 2022**

Washington Metropolitan Area Transit Authority  
Department of Safety (SAFE)  
Office of Safety Investigations  
**FINAL REPORT OF INVESTIGATION A&I E22340**

<b>Date of Event:</b>	06/03/2022
<b>Type of Event:</b>	Serious Injury
<b>Incident Time:</b>	23:23 hours
<b>Location:</b>	Cheverly Station, Track 2
<b>Time and how received by SAFE:</b>	23:53 hours – ROCC
<b>WMSC Notification Time:</b>	13:45 hours on 06-04-2022
<b>Responding Safety Officers:</b>	WMATA: SAFE/OSO Construction WMSC: N/A Other: N/A
<b>Rail Vehicle:</b>	N/A
<b>Injuries:</b>	Dislocated Right Ankle with Four Fractures
<b>Damage:</b>	N/A
<b>Emergency Responders:</b>	Prince George's County Medical, Metro Transit Police Department (MTPD)
<b>SMS I/A Incident Number:</b>	20220620#101089

**Cheverly Station – Serious Injury**  
**06/03/2022**  
**Table of Contents**

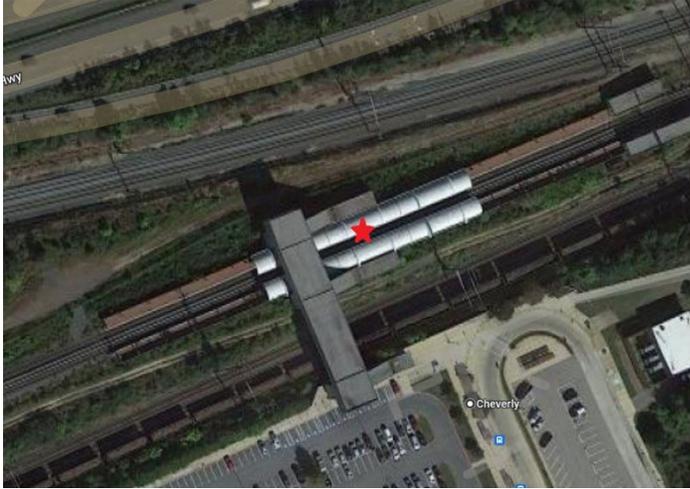
Figure 1: Approximate location of the fall noted by red star, on Track 2, from Platform 2, Cheverly Station  
\*Not to scale, oriented North

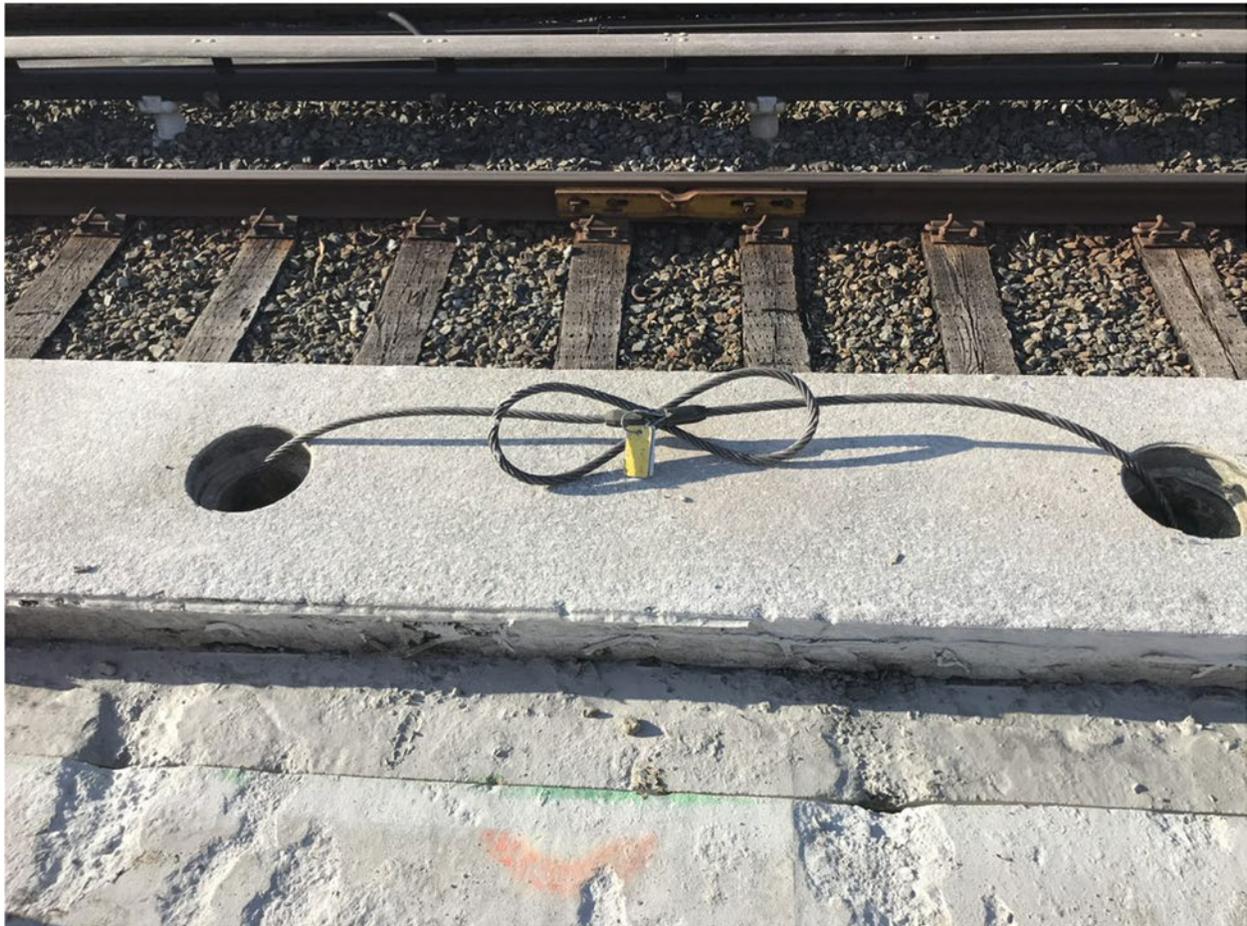
The Construction Manager stated the Foreman lost footing and fell from atop a piece of granite being removed from the platform, and the Contractor then landed in the track bed. The Construction Manager advised the granite then slipped away from the platform, landing on the track bed, pinning, and crushing the Foreman's leg underneath it.

*Figure 2: Intact piece of granite, approximately 300-500 lbs.*

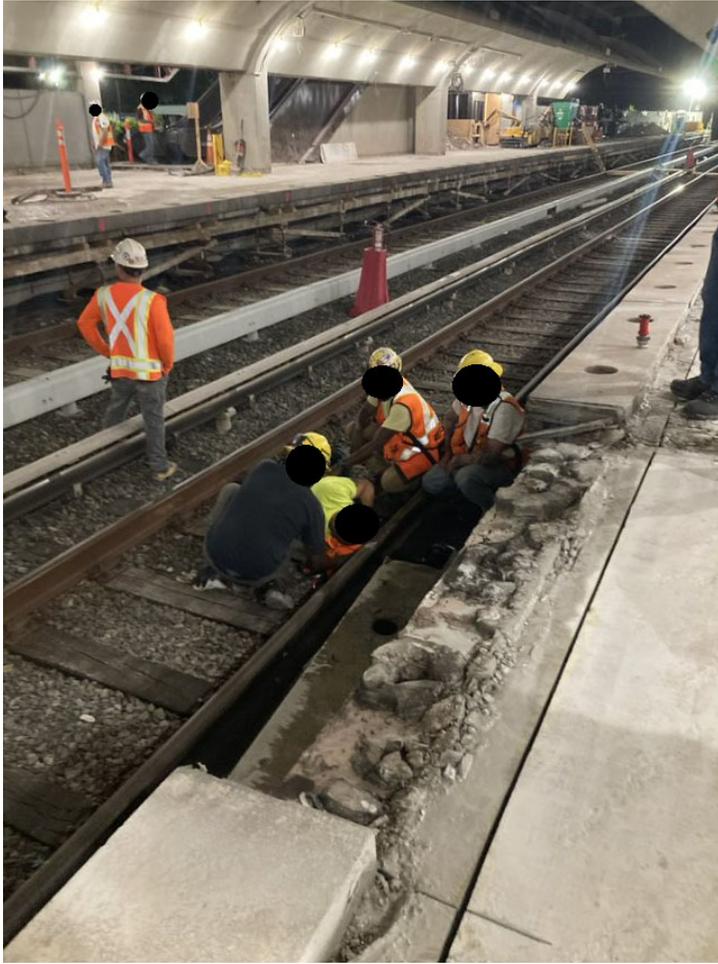
The WMATA Construction Safety Manager stated witnesses on scene and photographs he received advised that no barriers or barricades were in place warning of the potential hazard imposed by the pre-cut granite.

Figure 3: Injured Foreman having first aid administered.

*\*Note: Pre-cut nature of granite, and lack of safety barricades present, during the incident.*

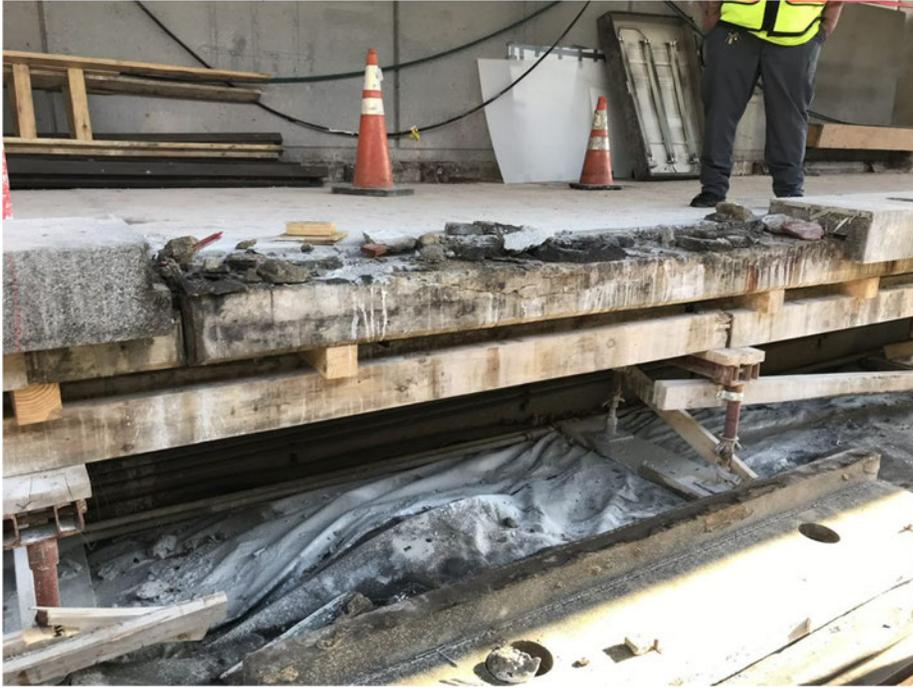
Figure 5: The exact site of the pre-cut granite, marked off, post-incident

The Construction Safety Manager stated a cease work order and safety stand down were implemented by OSO after the Foreman was evacuated. The next day, The Construction Safety Manager stated the area of the incident and adjacent work locations had orange cones with continuous red ropes placed in order to warn of the granite edge hazards.

The Construction Safety Manager stated all granite edge removal sites were roped off at approximately 15:00 hours on June 4, 2022. The Construction Safety Manager stated any personnel crossing the barrier would be removed from the respective site. OSO instructed all contract-holders of this mandatory safety implementation.

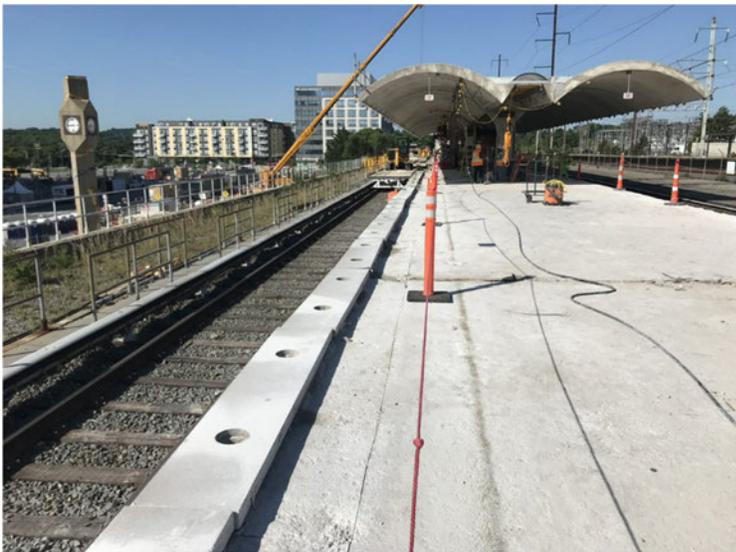
Figure 6: New Carrollton Station having similar construction performed with newly implemented safety barricading.

Safety barriers and rope were installed along the full length of the platform where granite edge pieces were being removed at three stations that were undergoing platform rehabilitation.

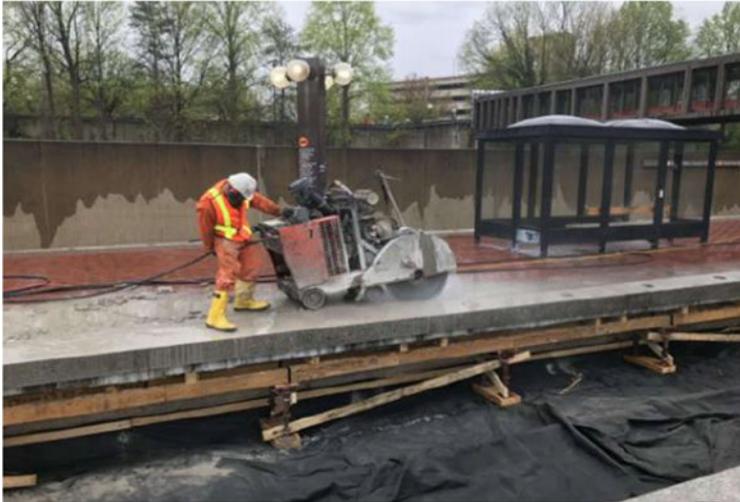
A conversation with the Project Manager of Atlantic Concrete Cutting (ACC) stated that ACC was responsible for the cutting of the granite slab that caused, then subsequently aggravated, the fall of the Foreman. The Project Manager stated the granite was typically immediately removed from the scene, by Kiewit Construction.

Figure 7: Granite being cut by an ACC employee with an industrial saw.

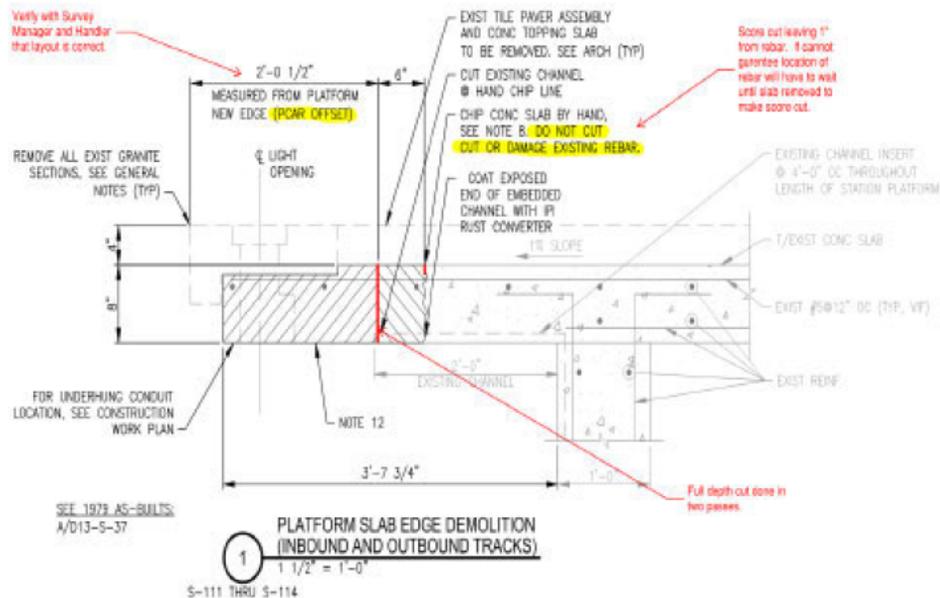
**STEP NO. 3 and 4** Snap lines off survey layed out offset. Need one line for score cut and one line for through cut. Also paint lines for tranverse cuts. Hold point is to verify lines in right location with station survey manager or handler. GPR scan to determine depths of rebar, adjust score cut depth to not touch the existing rebar. Stay minimum 1" above bar. If cannot be 100% sure of rebar location wait until slab is removed before score cut is made. Review sawcut permit for any work to progress.

SAFETY HAZARDS	MITIGATION PLAN
Knee Damage	Be sure layout guys have proper knee protection for kneeling while snapping lines.
Falling off Platform	Discuss with crews in keeping eye on edge of platform at all times as to not step back/off and fall to tracks.
