**WMSM Commissioner Brief: W-0188 – Collision, Customer Fatality – near Brookland-CUA Station – May 15, 2022**

Washington Metropolitan Area Transit Authority
Department of Safety (SAFE)
Office of Safety Investigations
FINAL REPORT OF INVESTIGATION A&I – E22300

Brookland-CUA Station – Person Struck by Train

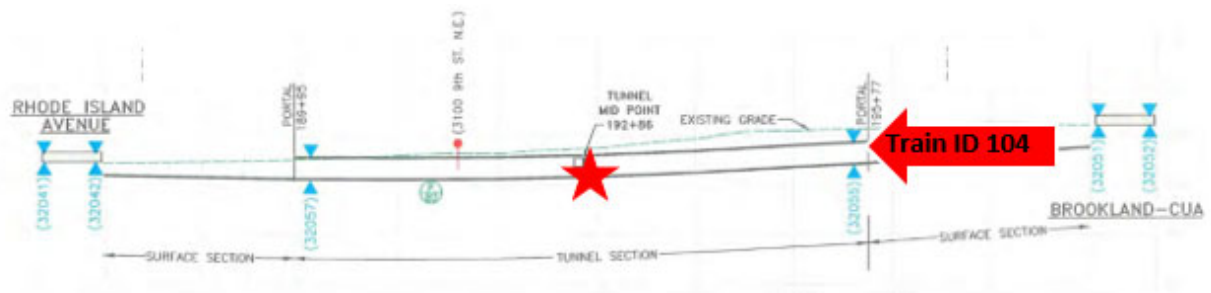
Figure 1 – This image shows the approximate location where the customer was struck by Train ID 104.

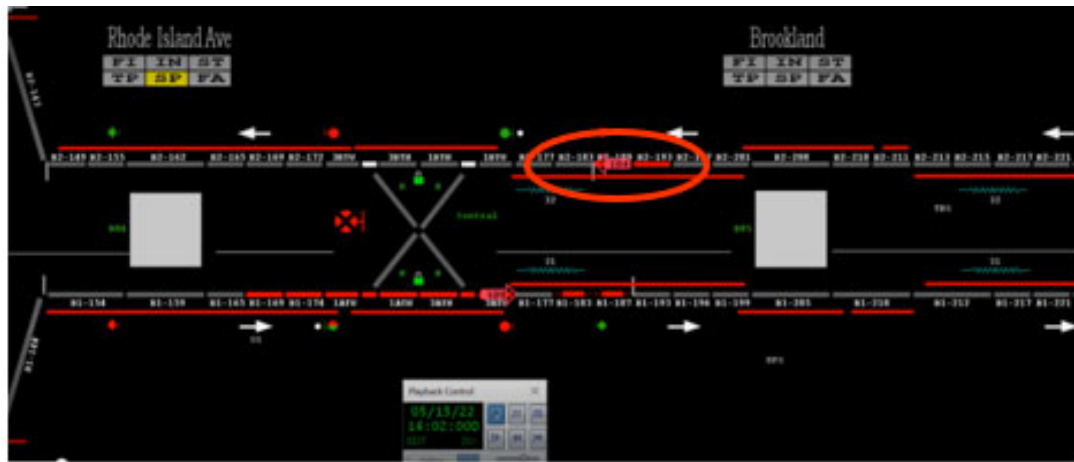
Figure 3 – Train ID 104 traversing CM B2 192+00 at approximately 14:02 hours.

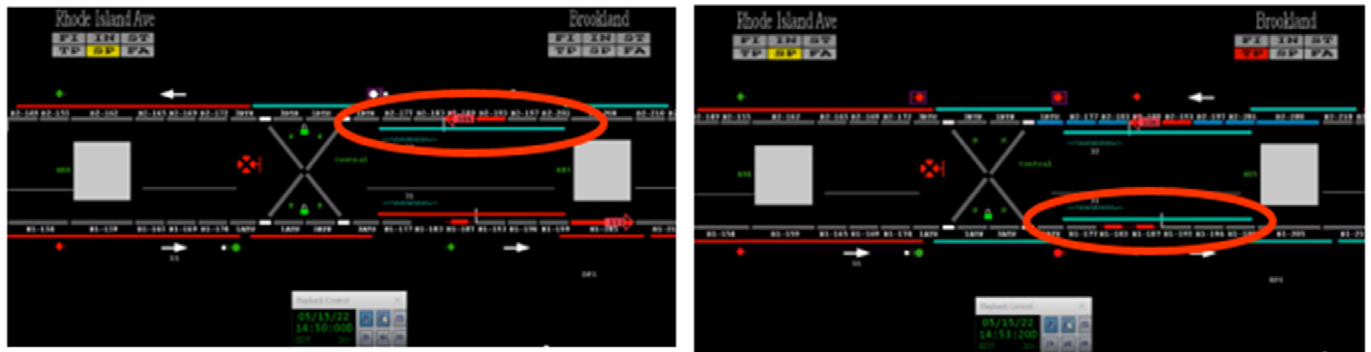
Figure 4 – Third-rail power de-energized on track 2 at 14:50 hours and on track 1 at 14:53 hours.

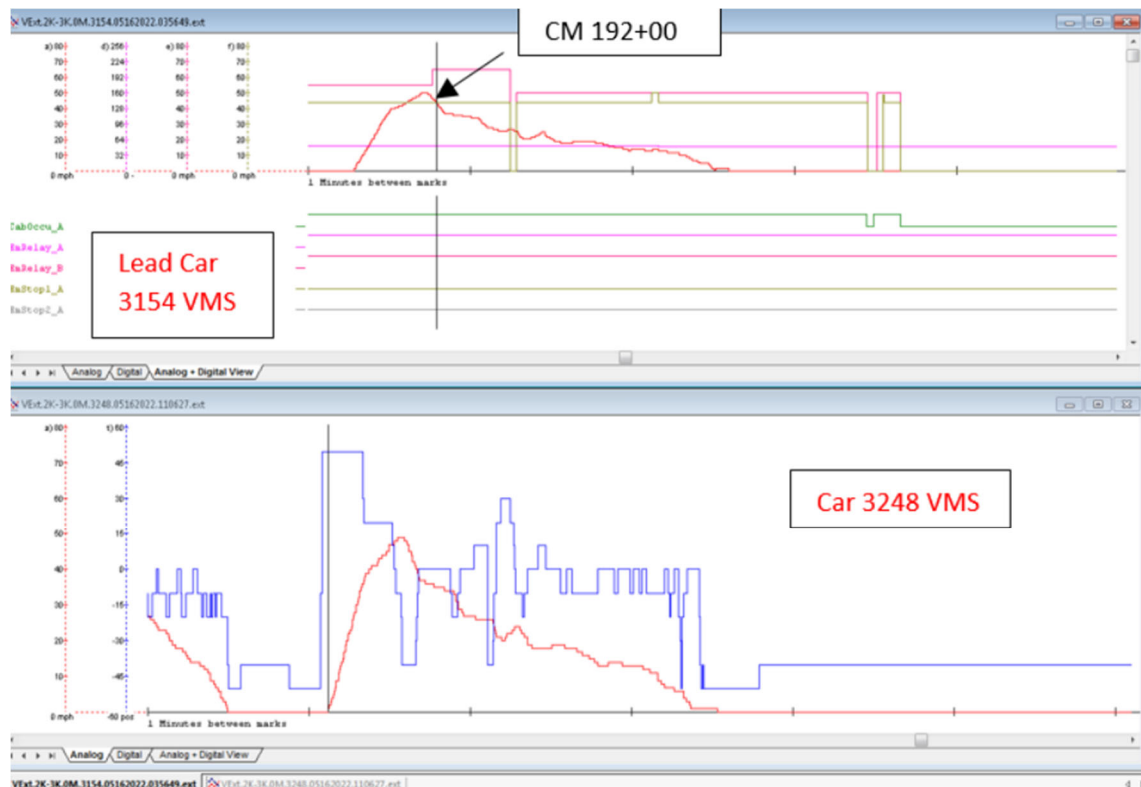
The analysis of the Vehicle Monitoring System (VMS) data shows that Train ID 104 left Brookland Station towards Rhode Island Avenue Station at 13:59:35 following this scripted timeline as follows. Train ID 104 departed B05-2, master controller in P5, limiting speed 55 mph, regulated speed 44 at 13:59:46 the train accelerates to 36 mph, master controller moved to P2, limiting speed to 55 mph, regulated speed 44 at 13:59:55 road horn activated, CM 199+29, speed 45 mph 13:59:57 road horn activated again, master controller moved to B4, speed 47 mph, limiting speed 55 mph, regulated speed 44 13:59:59 maximum speed of 50 mph reached 14:00:06 CM 192+00 (reported incident location), speed 43 mph, limiting speed 65 mph, regulated speed 44 at 14:01:18 master controller moved from B4 into coast, speed 39 mph. Balance of the trip to B04-2, master controller cycled primarily between coast and B1 until stopping at B04-2 and opening the doors.

Figure 5 – VMS data representing the speed and actions of Train ID 104 as it traveled between Brookland-CUA and Rhode Island Avenue Stations.

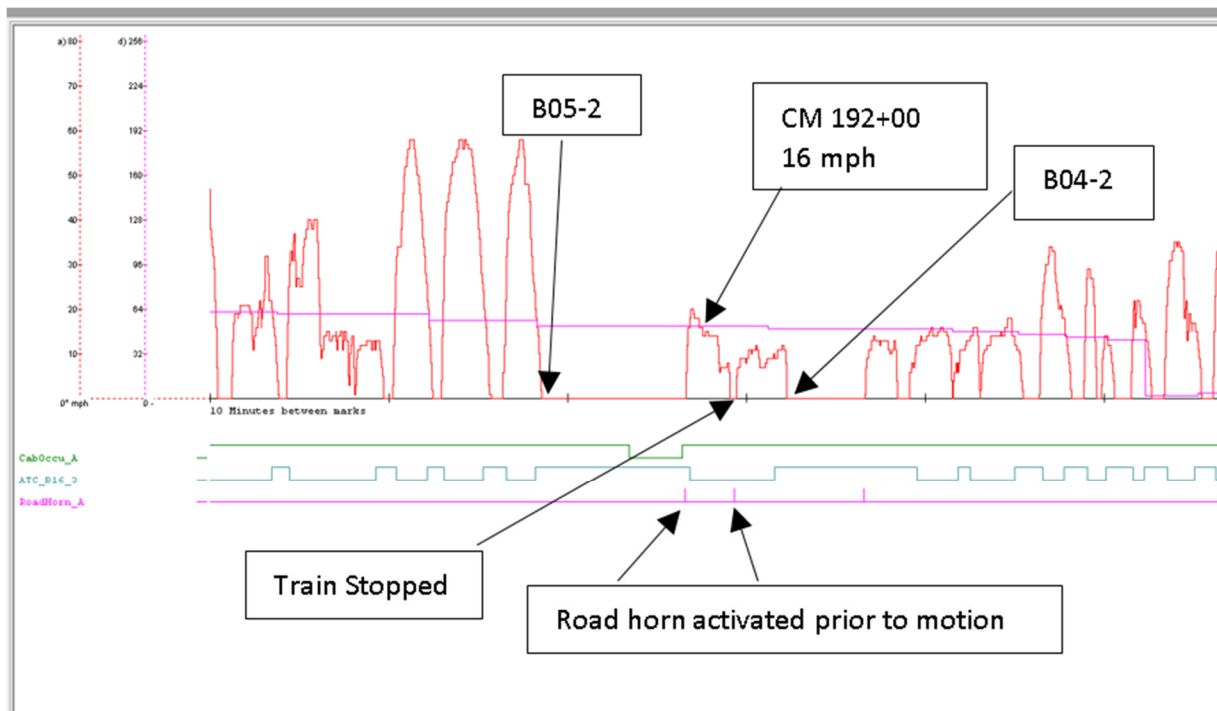
The Train Operator of Train ID 105 conducted the initial track inspection on track 2 alone in the operating cab. MSRPB dictates a maximum inspection speed of 15 mph. As the train traversed the area of the decedent, it was traveling approximately 16 mph, stopped a short distance beyond the location, and continued until reaching Rhode Island Avenue Station and reporting a clear track inspection.

Figure 6 – VMS Representation of Train ID 105's inspection between Brookland-CUA and Rhode Island Avenue Stations.

- The initial track inspection by Train ID 105 was conducted by a single Train Operator. They were unable to locate the person, likely due to the decedent's position on the left side of the train, while the Operator's cab is on the right side of the train. Glare and light conditions in the portal area also likely contributed to their inability to observe the decedent.

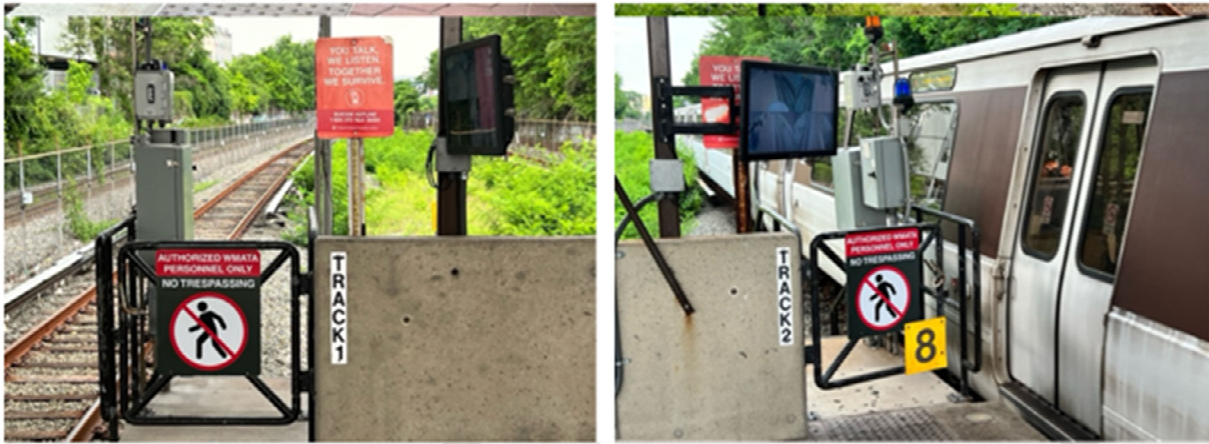
The probable cause of the Brookland/Rhode Island Avenue Station person struck by train event was an intentional action by the person to bypass gates marked as “No Trespassing” to enter the rail right-of-way where they encountered Train ID 104 and encroached into the dynamic envelope of the train.

Image 1 – Brookland-CUA Station End Gates on track 1 and track 2.

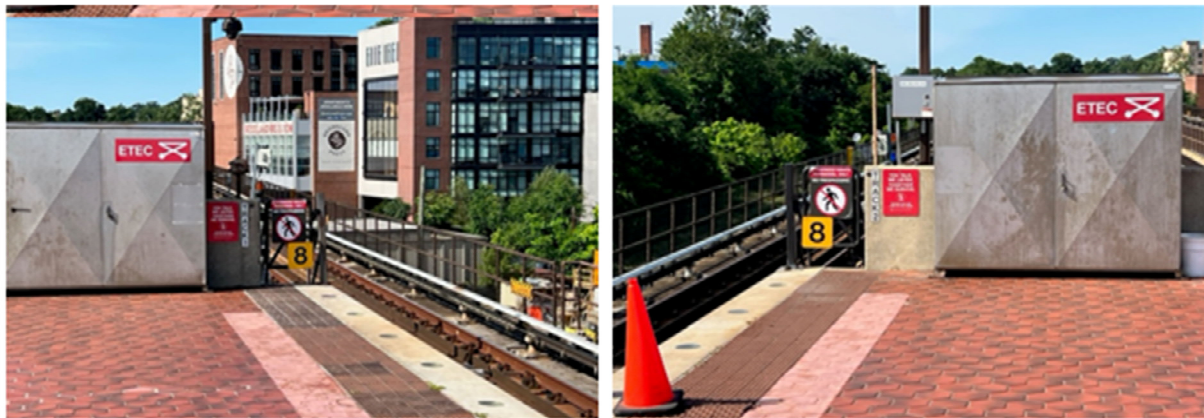
Image 2 – Rhode Island Avenue Station End Gates on track 1 and track 2.
