WMSC Commissioner Brief: W-0189 – Evacuation for Life Safety Reasons – Ballston-MU Station – August 11, 2022

FINAL REPORT OF INVESTIGATION A&I E22513

Evacuation for Life Safety Reason, Ballston-MU Station

August 11, 2022

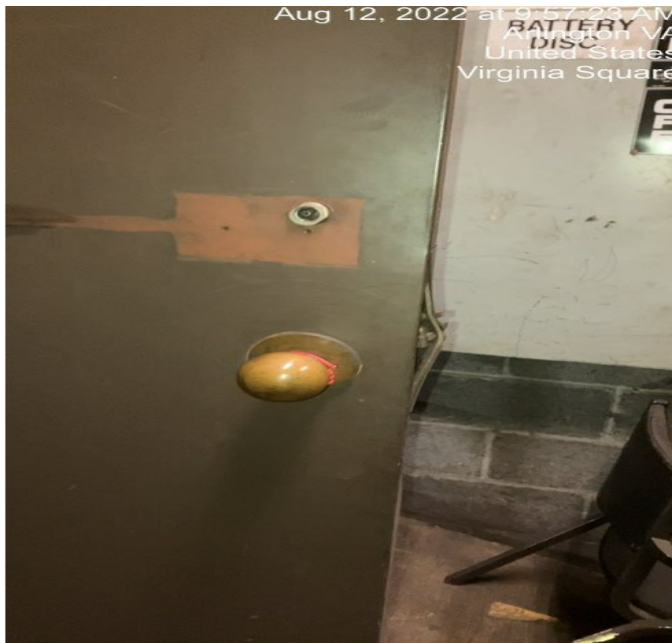
Figure 1 - ACFD breached Room 121 door.

- The Station Manager stated that the fire department breached the door of room 121 to gain entry and located the source to be a leaking battery that was emanating fumes.

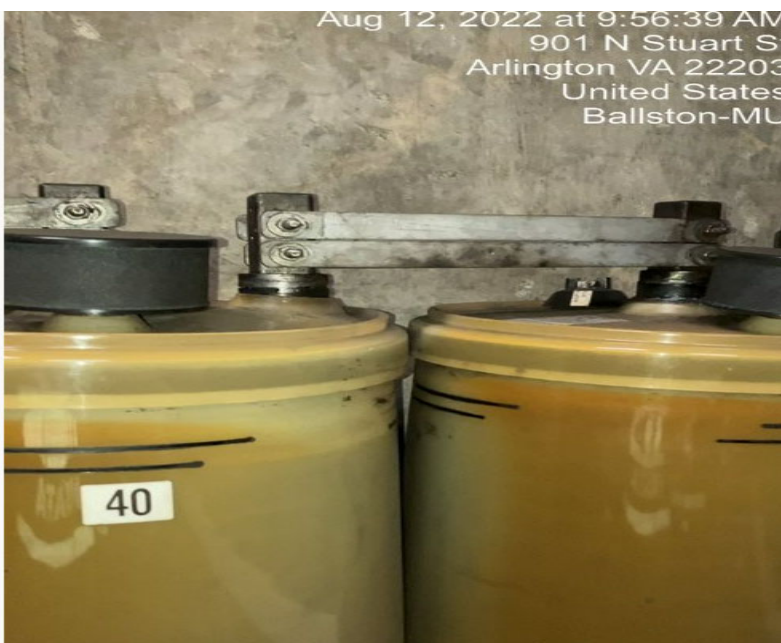
Figure 3 – Rechargeable Batteries in Room 121.

On August 22, 2022, TRPM concluded after investigating this incident that the UPS had an internal fault causing the DC output voltage to be 181 VDC instead of 131 VDC. The DC output feeds the battery bank and the AC room DC panel. Since the battery bank was overcharged at 3 volts per cell instead of 2 volts per cell, it caused the bank to overheat. The battery bank entered into the overload condition approximately 15 hours after the failure.

The overheating caused the acid inside each cell to boil and produce the gas. The battery room exhaust fan exhausted the gas into the station. TRPM personnel verified a 181 VDC output with a multimeter.

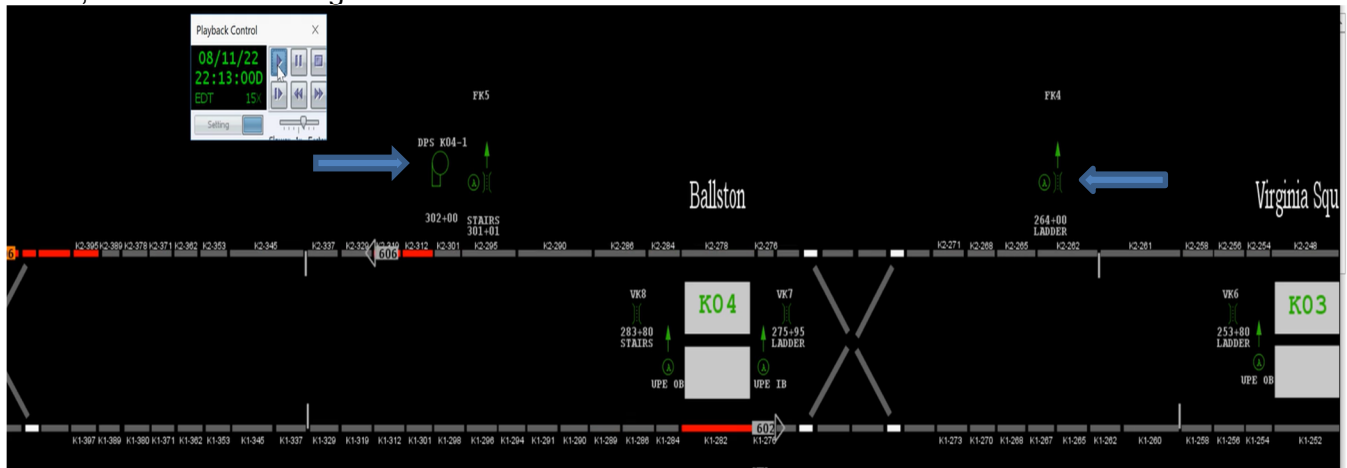
Figure 4 AIMS Ballston Station Fan activation

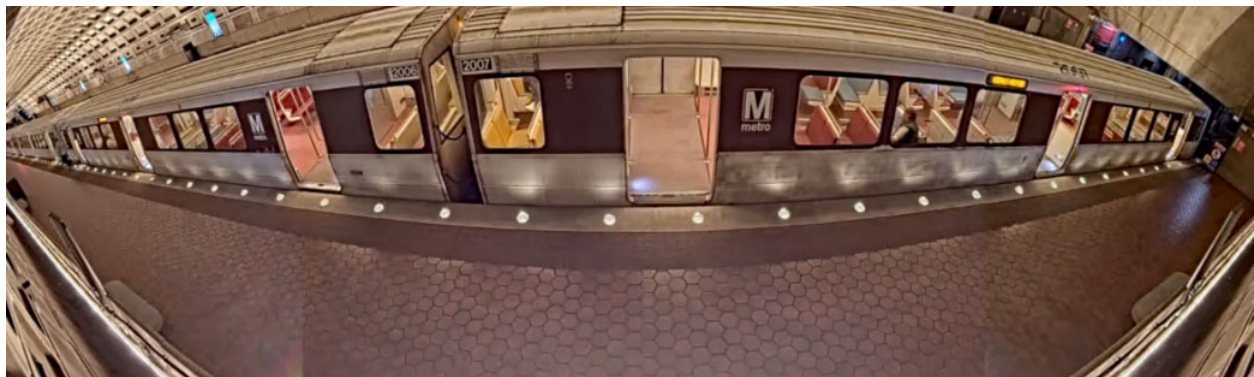
A review of CCTV and AIMS Playback determined that between 22:13 hours – 22:51 hours, Orange Line Train IDs 904, 901, 905, 902, and Silver Line Train IDs 607, 604, and 622 bypassed Ballston-MU Station. However, CCTV and AIMS playback confirmed Train ID 621 serviced Ballston-MU Station at approximately 22:51 hours.

Figure 5 - CCTV showed Train ID 621 serviced Ballston Station platform at 22:51 hours.

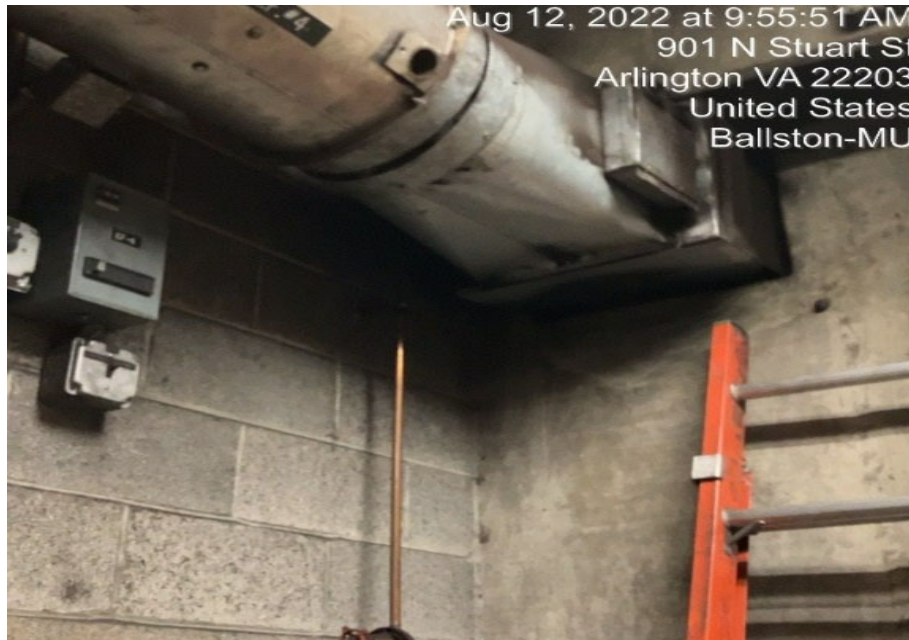
The room's exhaust fan did not function properly. According to the documentation from the previous preventive maintenance inspection, the fan was working at that time in August 2021. The exhaust fan for the room is separate from the room's ventilation system, which also did not work and did not keep the room cool as designed. In addition, Metrorail did not activate the separate tunnel ventilation fans in the station until 10:13 p.m., nearly an hour after the initial alarm.

Figure 6 - Room 121 Ventilation Fan Ballston Station.

A temporary charger with a generator was installed for mitigation purposes until permanent repairs could be made. Additionally, a new exhaust fan and associated equipment were ordered and will be replaced by the Office of Plant Maintenance (PLNT). On August 26, 2022, PLNT completed and tested the repairs on the ventilation fan system in room 121, which is fully operational.

- On August 26, 2022, PLNT completed and tested the repairs on the ventilation fan system in room 121 and is fully operational.
- Smoke Detectors in the room were replaced on August 12, 2022.

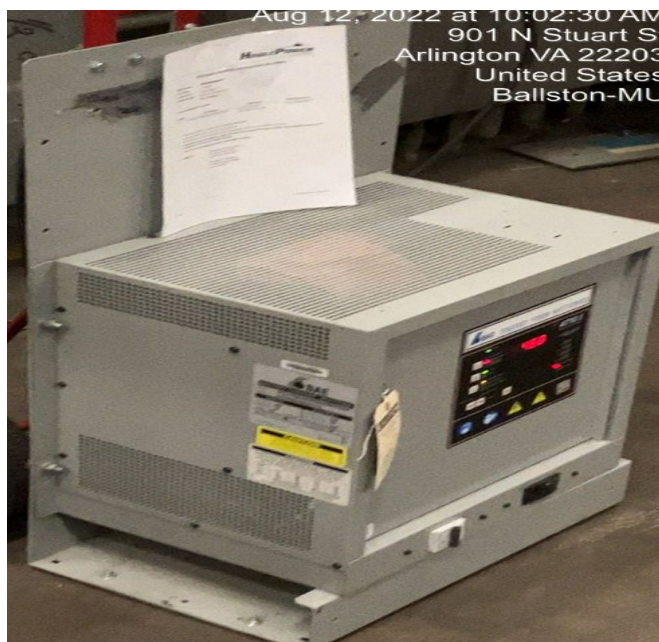
Figure 7 - Temporary Charger installed for mitigation purposes (photo taken prior to installation).
