**WMSC Commissioner Brief: W-0190 Derailment – New Carrollton Station – August 29, 2022**

**FINAL REPORT OF INVESTIGATION A&I E22558**

<b>Date of Event:</b>	August 29, 2022
<b>Type of Event:</b>	Derailment
<b>Incident Time:</b>	12:47 Hours
<b>Location:</b>	New Carrollton Station (ACS) – D2 591+00 (1B switch)
<b>Time and How received by SAFE:</b>	13:00 Hours – SAFE/OSO
<b>WMSC Notification Time:</b>	13:50 Hours
<b>Responding Safety Officers:</b>	WMATA: OSO, OSI WMSC: None Other: None
<b>Rail Vehicle:</b>	Hi-Rail Vehicle 03-135241 Flat Car 57-189164 (CR7719)
<b>Injuries:</b>	None
<b>Damage:</b>	None
<b>SMS I/A Incident Number:</b>	20220829#102508

# **New Carrollton Station (ACS) – Derailment**

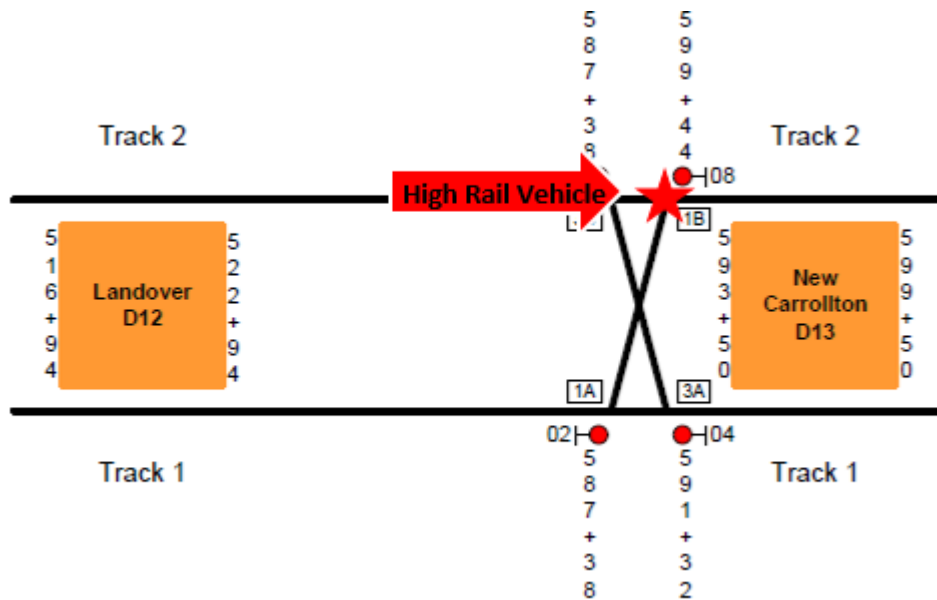
## Field Sketch/Schematics

New Carrollton Station, track 2  
CM D2 591+00 – Switch 1B

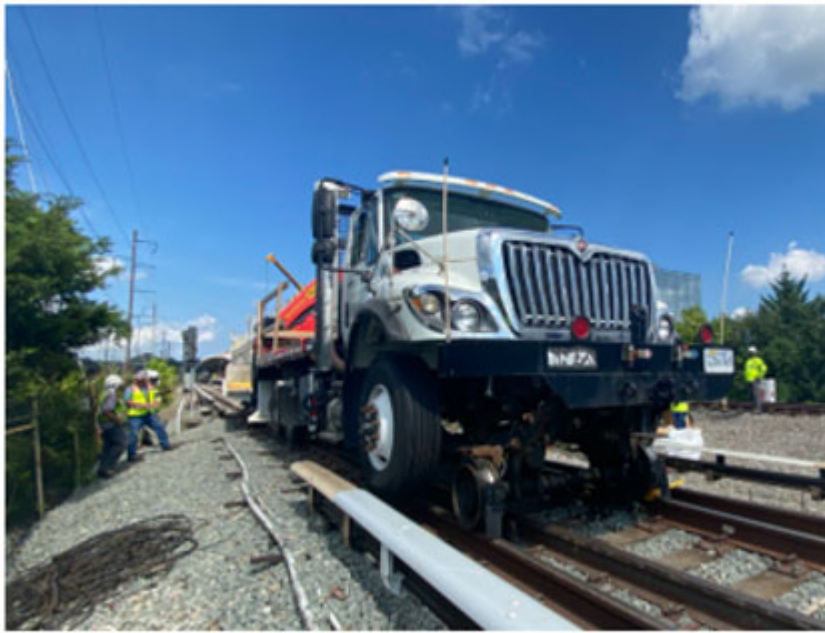
*Image 1 - Hi-Rail Vehicle 03-135241 and Flat Car 57-189164 (CR7719).*

The Office of Vehicle Program Services (CENV) conducted a post-incident inspection of flat car CR7719 on August 31, 2022 at New Carrollton Rail Yard and concluded that there was no damage and no deficiencies were noted that would contribute to a derailment.

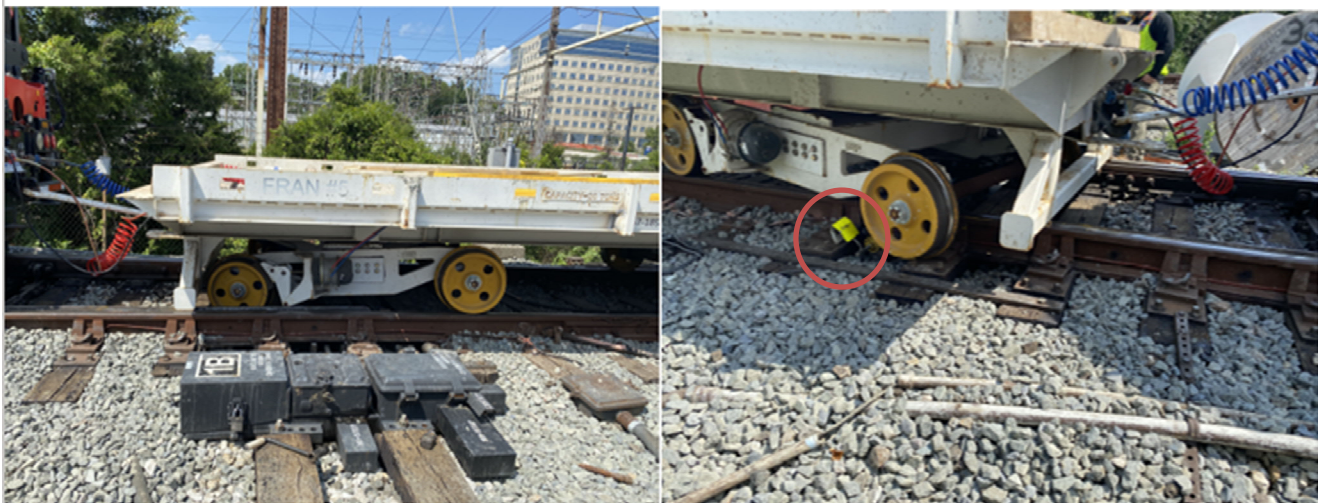
Upon receiving the phone call to move the vehicle, the Hi-Rail Vehicle Operator did not follow track movement protocol, which requires a High Rail Move Permit and Authorized Kiewit Employee to act as a spotter for the move. The Hi-Rail Vehicle Operator immediately moved, causing the Hi-Rail Vehicle to operate a trailing move over the 1B Switch, laying in reverse. The first truck of the flat car remained on the running rail, however the second axle of the second truck lifted and derailed to the field side.

*Image 2 - Kiewit Flat Car CR7719 derailed to the field side at switch 1B and Kiewit Flat Car R7719 derailed opposite the field side. Switch clamp is circled.*

At approximately 15:51 hours, Kiewit along with the assistance from CMNT rerailed the flat car. ATCM personnel inspected the derailment site after the unit was removed and found no damages to the switches or switch components. TRST personnel conducted an inspection of the roadway infrastructure and found it to be within tolerance.

After evaluation of the area, the High Rail Unit from Kiewit operated past switch 3B without any issues conducting a facing move on track 2 since 3B was laying in the normal position for a straight through move coming from Landover to New Carrollton. When the unit got to switch 1B the Unit was now conducting a trailing move since switch 1B was laying in the reverse position. There was a request made earlier in the day for switch 1B to be clamped in the reverse position for a facing move coming from New Carrollton Yard to cross from track 2 to 1. The first and second set of wheels (trucks) on the flatbed was forced over the closed reverse point, staying on the running rails, the third set of wheels on the flatbed was attempting to be forced over the closed point; the flatbed unit wheel trucks were forced off the running rail causing the derailment.

Preliminarily, there was no ATC equipment damaged, with the exception of the clamp that was used on the switch point. The derailed Unit was railed without any issues. Once the Unit was railed it was moved over the switch point and pushed further up the track so the switches and throw rods could be inspected. No damage was observed to the 0, 1 or 2 rods. The reverse point was pushed over slightly, and the reverse side was not fully tucked. The Unit was crossed over from track 2 to 1 and cleared the area. ATC crews then conducted and full PMI on all 4 Interlocking Switches and adjusted 1B.”
