WMSC Commissioner Brief: W-0191 – Serious Injury – Largo Town Center Station – July 28, 2022

Washington Metro Area Transit Authority
Department of Safety (SAFE)
Office of Safety Investigations (OSI)
FINAL REPORT OF INVESTIGATION A&I E22446

Largo Town Center Station – Serious Injury

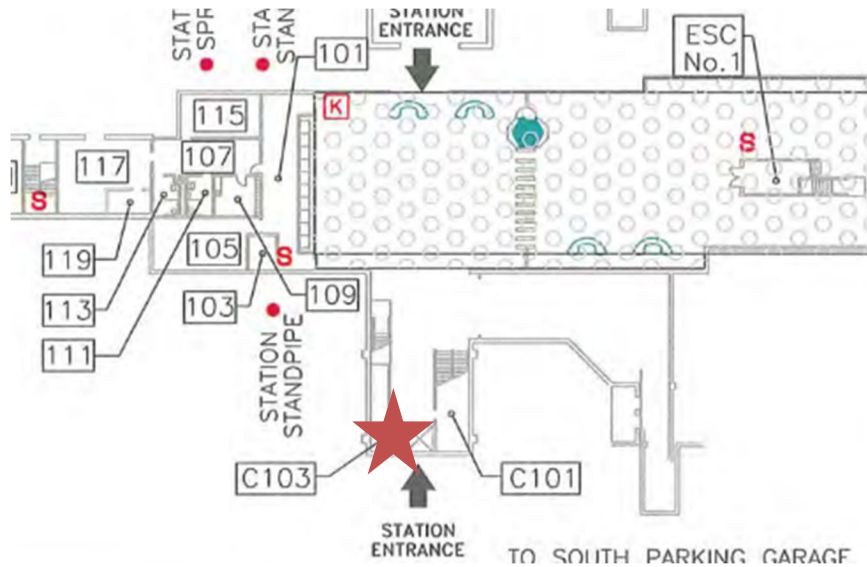
On Thursday, July 28, 2022, at approximately 12:20 p.m., an Office of Elevator and Escalator (ELES) Technician's right middle finger was partially amputated as they reinstalled a metal landing plate on an escalator at Largo Town Center (now called Downtown Largo) Station.

The probable cause of the Serious Injury event was a human factors error (rushing). A contributing factor to the injury was the lack of a proper tool to lower the landing plate, which would have prevented the employee's hands from being within a pinch point. The ELES Technician reported a time constraint pressure to complete the assignment so they could respond to their second assignment before their shift ended. The ELES technician also reported years ago an L-shaped tool was issued that assisted with removing and re-installing landing plates to avoid injuries like the one sustained; however, they were not issued the tool.

Figure 1: Depicts the ELES Technician's approximate location when they injured their finger.

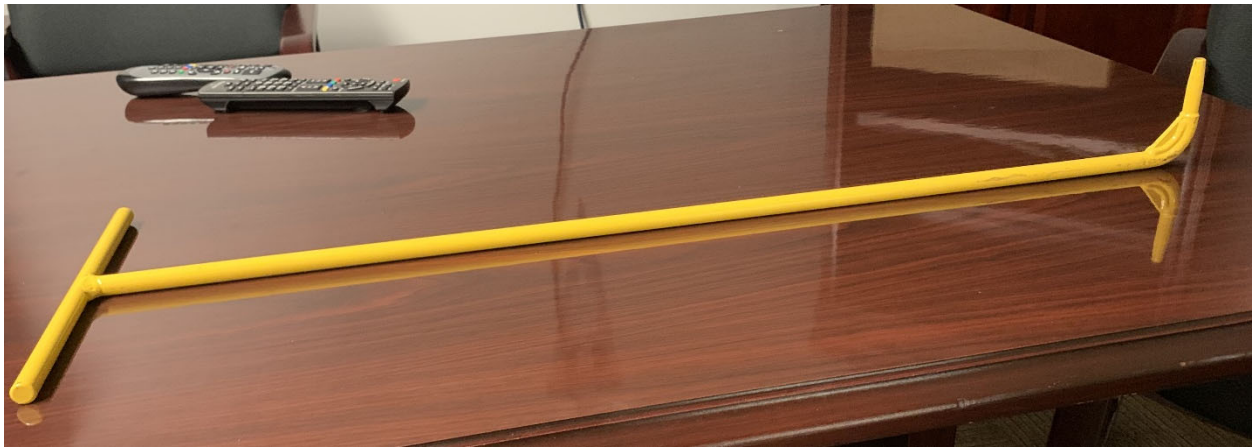
- The ELES Technician partially amputated their right middle finger reinstalling a landing plate.
- The ELES Technician reported that they were rushing to complete the assignment and did not have a special "L" shaped tool so they could ergonomically reinstall the landing plate and minimize interaction with pinch points.
- There is no training or SOP on how to properly remove and reinstall landing plates. It is considered a normal part of operations.
- The serious injury was reported to the ROCC several hours after the fact.
- The ELES Supervisor was not familiar with injury reporting procedures.

Figure 2 - L-Shaped tool used to lift and lower landing plates

Corrective Action Code	Description	Responsible Party	Estimated Completion Date
101849_SAFECAPS_ELES_01	Pinch Points & Hand Injuries Prevention Toolbox Talk	ELES	Completed
101849_SAFECAPS_ELES_02	Conduct a campaign and make sure all ELES mechanics have the "L" shaped tool	ELES	11/30/2022
101849_SAFECAPS_ELES_03	ELES will review the current process for communicating injuries and/or emergencies on WMATA issued communication devices.	ELES	12/31/2022
101849_SAFECAPS_ELES_04	ELES EOC will streamline communication regarding injuries and/or emergencies with the ROCC.	ELES	04/01/2023
101849_SAFECAPS_ELES_05	ELES will review whether there is industry guidance on the need to develop a Work Instruction, training, or bulletin to address how to properly remove and reinstall landing plates.	ELES	12/31/2022
