WMSC Commissioner Brief: W-0192 – Evacuation for Life Safety Reasons – Greenbelt Yard – July 11, 2022 and July 12, 2022

Prepared for Washington Metrorail Safety Commission meeting on December 13, 2022

Greenbelt Rail Yard – Evacuation for Life Safety Event (GAS LEAK)

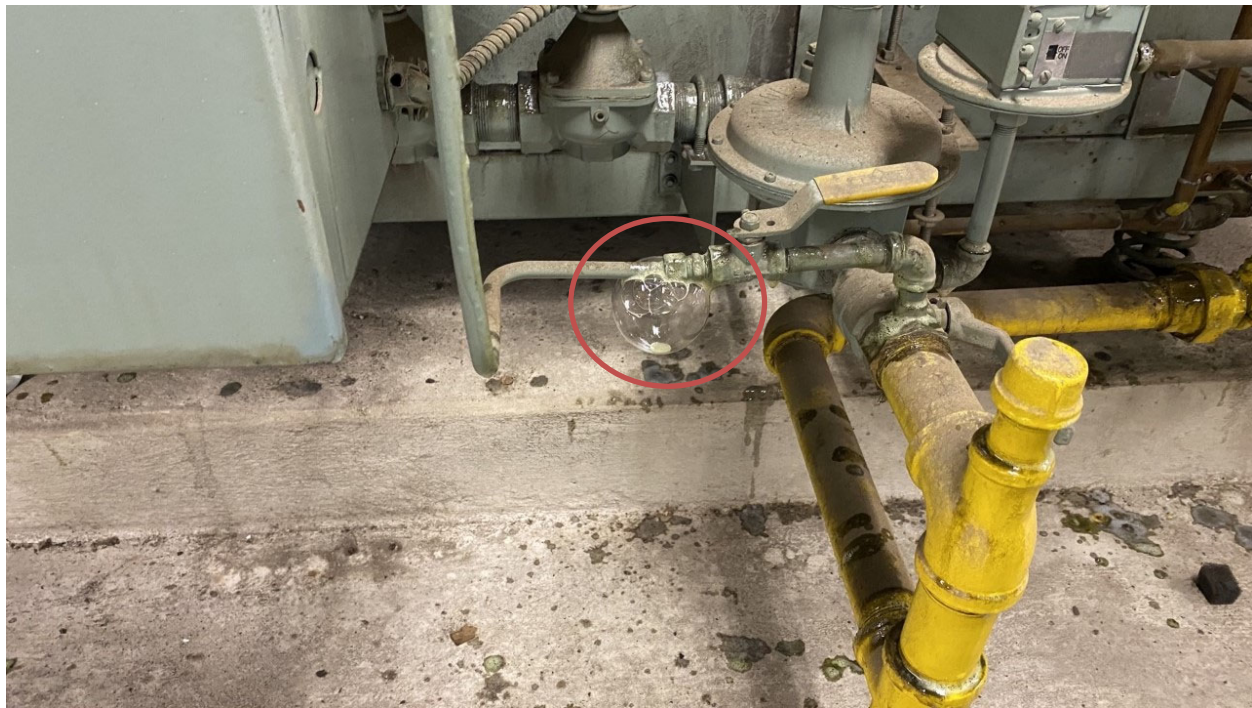
The probable cause of the Evacuation for Life Safety Reasons (Gas Leak) event was a mechanical failure, that resulted in a leak from a 3/8" tube attached to the gas valve located on the external portion of the HVU.

Figure 2 - Gas leak located on HVU#1 using bubble test method.

At approximately 19:05 hours, members of the PLNT Maintenance Unit repaired and pressure tested the source of the leak. It was determined that the source of the leak was a 3/8" gas line valve/pipe, which was disassembled and repaired. At approximately 19:10 hours, the Plumber Unit reported to MOC that the building was safe for occupancy. CMNT supervision was notified and the all-clear sign was given for employees to return to normal operations.
