WMSC Commissioner Brief: W-0195 – Evacuation for Life Safety Reasons – Dupont Circle Station – July 30, 2022

Prepared for Washington Metrorail Safety Commission meeting on January 24, 2023

Incident Date: 07/30/2022 Time: 21:07 hours
Final Report – Evacuation for Life Safety Reasons
E22451

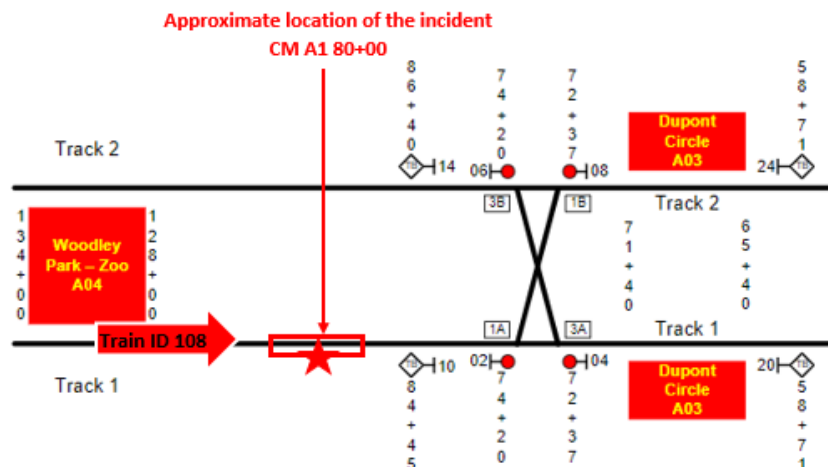
Field Sketch/Schematics

Between Woodley Park Station and Dupont Circle Station – CM A1 80+00

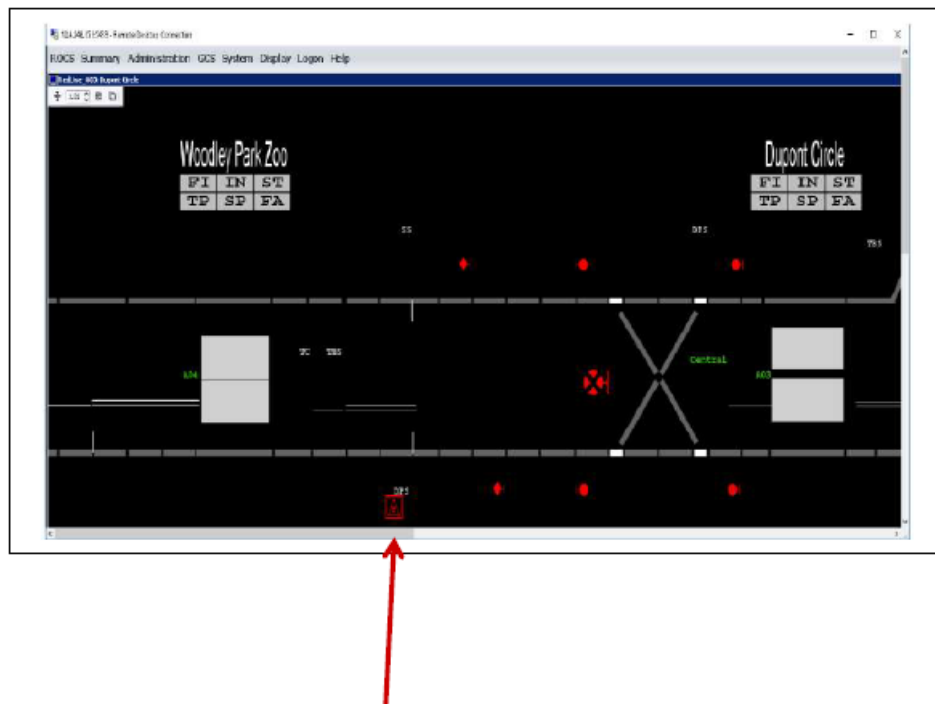
Fire Alarm at DPS #2 at 21:07 hours

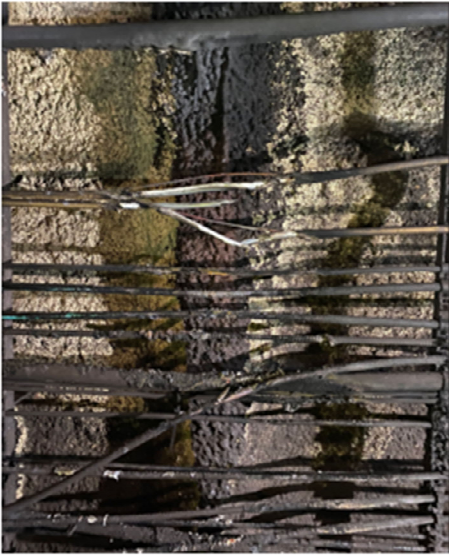
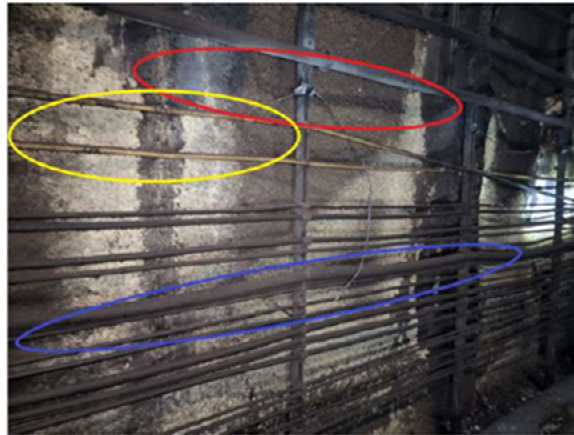
Red – Low Voltage Yellow – COMR Fiber Optic (Inactive) Blue – High Voltage

Image 1 – Burned cabling at A1 88+00

- The damage area was noted to occur primarily in the vicinity of CM A1 87+00 to 85+00
- ATC: Approximately 300 feet of damaged ATCM cable
- COMR: Three amplifiers and approximately 1,000 feet of cable damaged
- Low Voltage: Damage to junction boxes and approximately 100 feet of cable damage

- Damaged Low Voltage, ATC and COMR equipment and cabling replaced.
- Low voltage personnel have begun visually inspecting the electrical infrastructure in underground tunnels to identify electrical hazards such as loose cables, broken receptacle

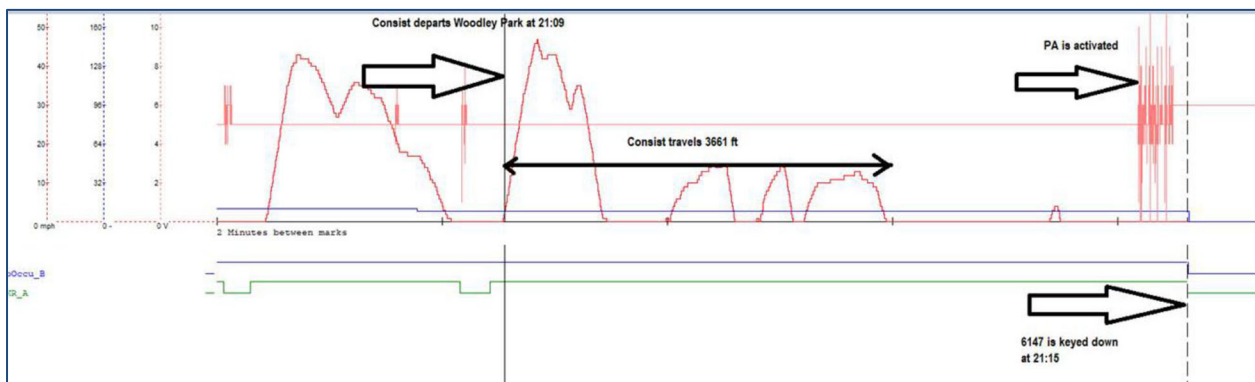
Figure 1 - VMS graphical output indicating total distance traveled by Train ID 108 towards Dupont Circle and PA activations.

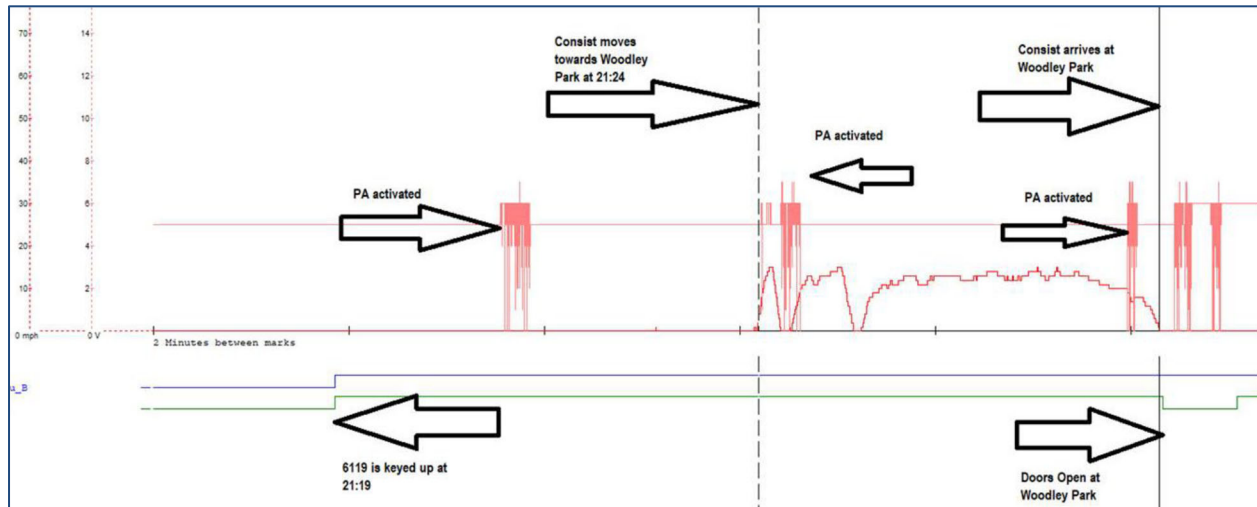
Figure 2 - Additional output of Train 108's return to Woodley Park Station on Track 1.

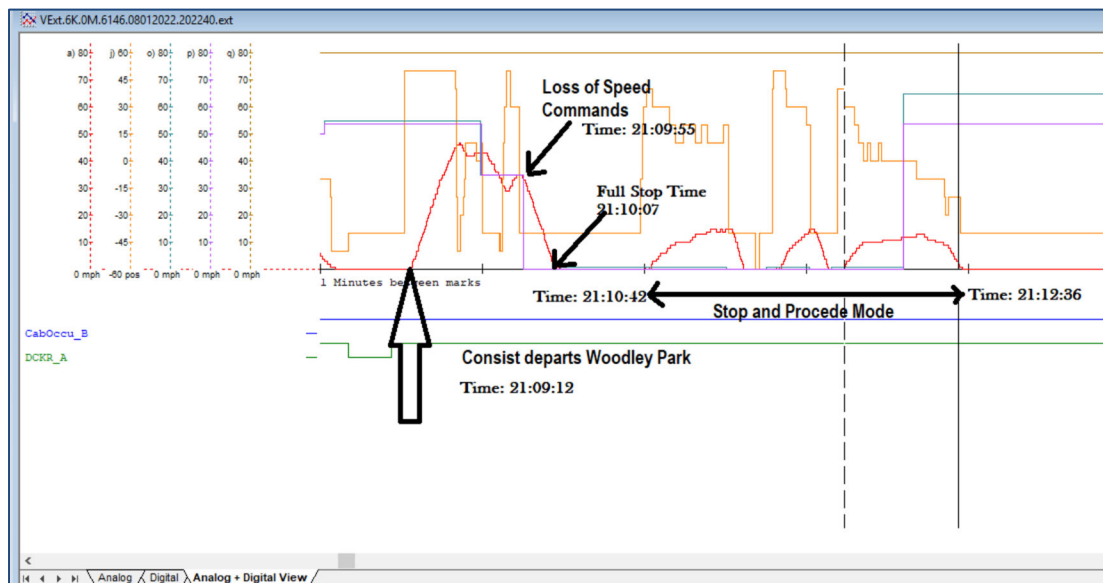
Figure 3 - Train ID 108's Presence of Speed Commands during move towards Dupont Circle on Track 1.

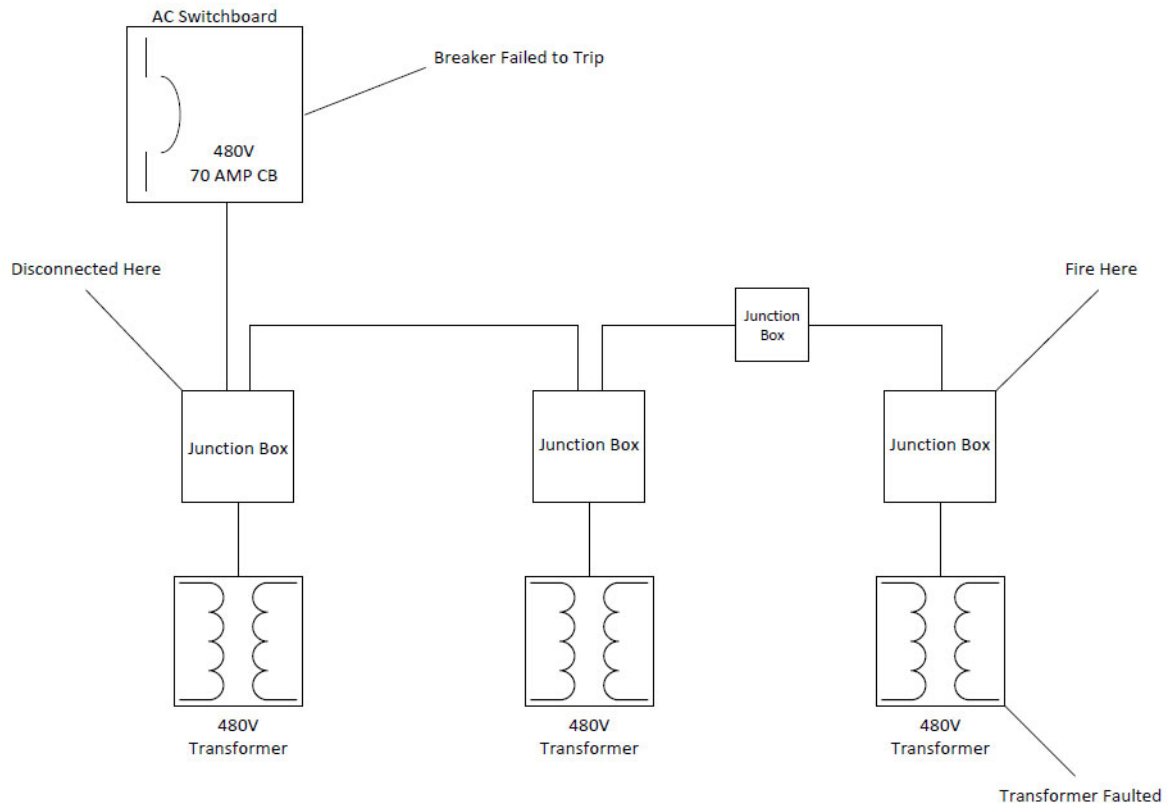
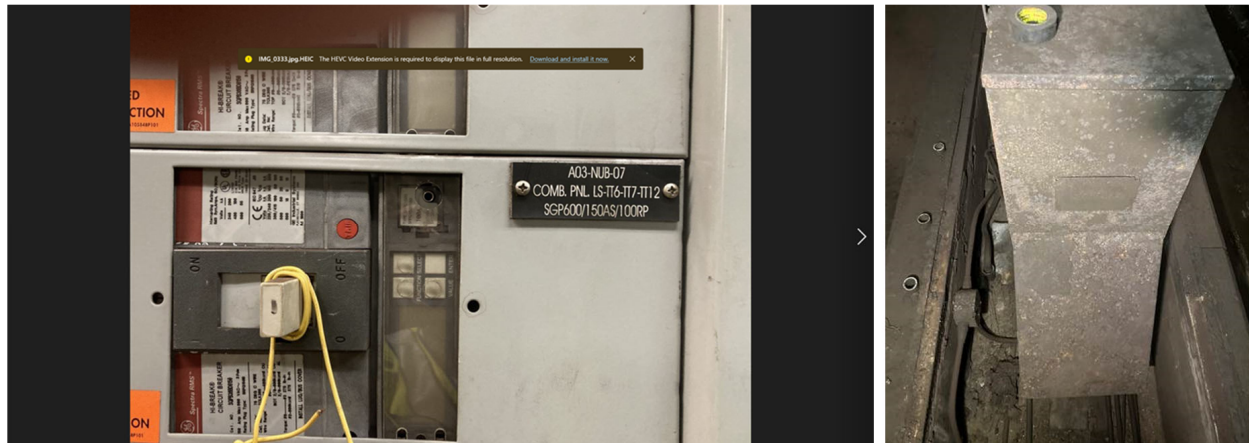
Appendix E – Low Voltage Sketch and Image

- Failure of the 70-amp breaker to trip as designed supplied voltage to transformers on the circuit was discovered.
- Insulation of the conductors failed due to excess current and heat.

Image 2 - The original AC one-line drawing depicts a 70A breaker when in fact, the switchgear was upgraded and the breaker is now a 150A with a 100A trip setting. "NUB" on name plate stands for "North Utility Board" and TT6, TT7, and TT12 are the 3 transformers that are being fed.
