WMSC Commissioner Brief: W-0196 – Improper Roadway Worker Protection – Medical Center Station – July 16, 2022

Washington Metro Area Transit Authority
Department of Safety – Office of Investigations (OSI)
FINAL REPORT OF INVESTIGATION A&I E22424

Date of Event:	July 16, 2022
Type of Event:	Improper RWP – Train Passing Personnel at Excessive Speed
Incident Time:	09:40 Hours
Location:	Between Grosvenor and Medical Center Stations - CM A1 497+00
Time and How received by SAFE:	09:50 Hours – SAFE/IMO
WMSC Notification Time:	10:46 Hours
Responding Safety Officers:	WMATA: N/A WMSC: N/A Other: N/A
Rail Vehicle:	L6005/04x6042/43x6060/61
Injuries:	None
Damage:	None
SMS I/A Incident Number:	20220716#101560

CM A1 497+00 Between Grosvenor Station & Medical Center Station – Improper RWP

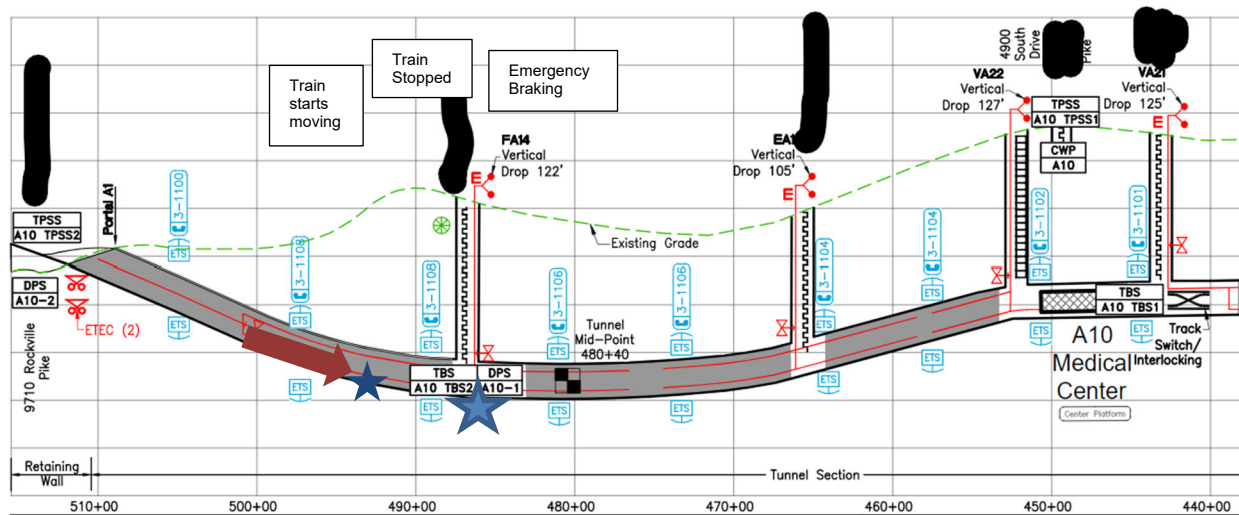
Field Sketch/Schematics

Grosvenor Station to Medical Center Station, Track 1 at CM 497+00

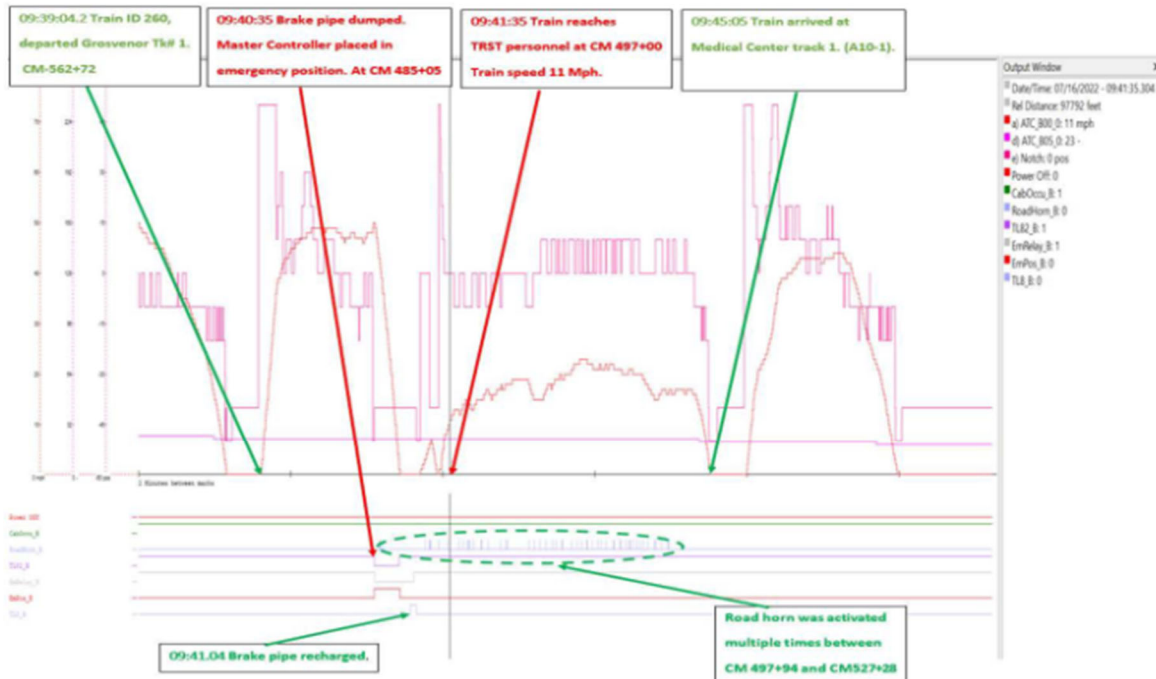
VMS Data Visualization L6061:

The brake logs were downloaded from the entire consist and there were no faults logged with the friction brake system during the time of incident in question. The train performed as designed.

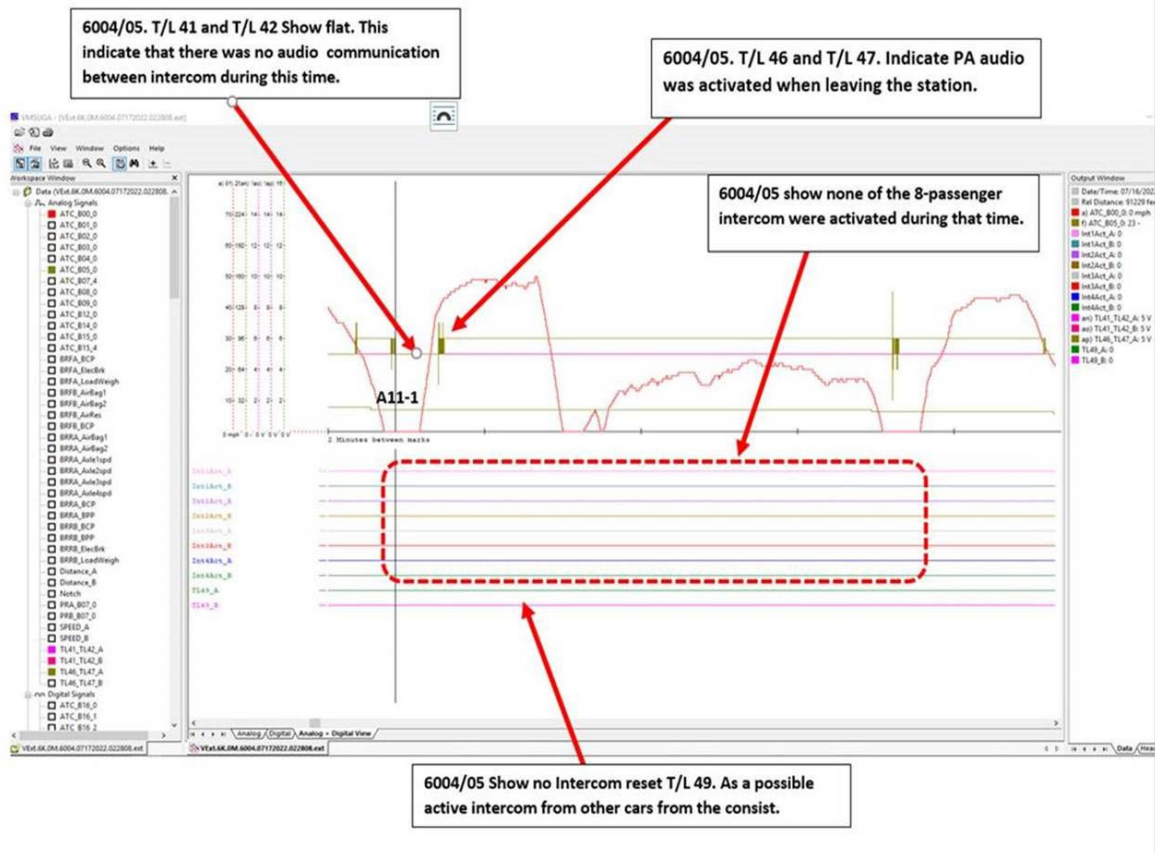
6004/6005 VMS Data:

Based on the data, there was no activation of emergency intercom from Grosvenor Station to Medical Center Station. There was only a PA audio activated when departing Grosvenor Station. See VMS Graph above.

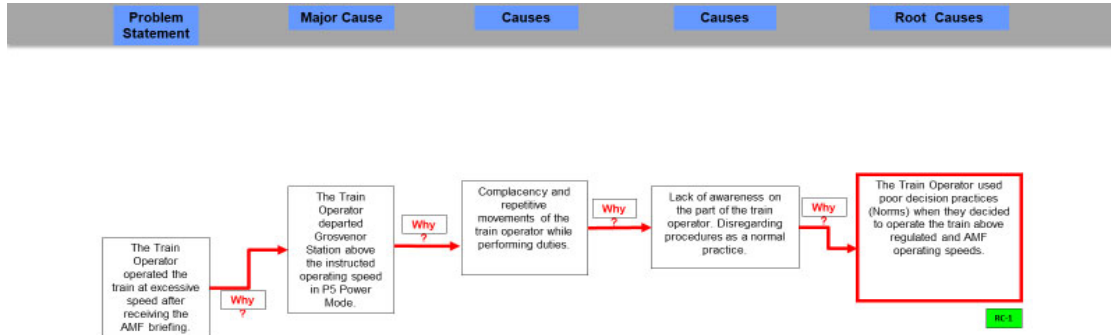
Appendix D – Root Cause Analysis

The probable cause of the train passing personnel at Excessive Speed event on July 16, 2022, was failure to perform in accordance with established rules and procedures by the Train Operator. A Contributing Factor to the event was the Train Operator's lack of awareness to the potential outcomes of their actions. The Train Operator's actions were not in accordance with the procedures established within the MSRP Section 5 – RWP 5.13.6, *Rail Vehicle Operator Procedures during AMF*.

Corrective Action Code	Description	Responsible Party	Due Date
99097_SAFE CAPS_RTRA_001	Train Operator reviewed RWP Safety Notice with Division Superintendent.	RTRA	Completed
99097_SAFE CAPS_RTRA_002	RTRA Management conducted a "Ways of Working Safely" Sprint with an emphasis on AMF/RWP Compliance.	RTRA	Completed
99097_SAFE CAPS_OPMS_001	Train Operator completed Roadway Worker Protection Requalification.	OPMS	Completed
