WMSC Commissioner Brief: W-0197 – Evacuation for Life Safety Reasons – Eastern Market Station – September 9, 2022

Washington Metropolitan Area Transit Authority
Department of Safety (SAFE)
Office of Safety Investigations
FINAL REPORT OF INVESTIGATION A&I E22581

Eastern Market, Track 2 – Evacuation for Life Safety Reasons

September 9, 2022

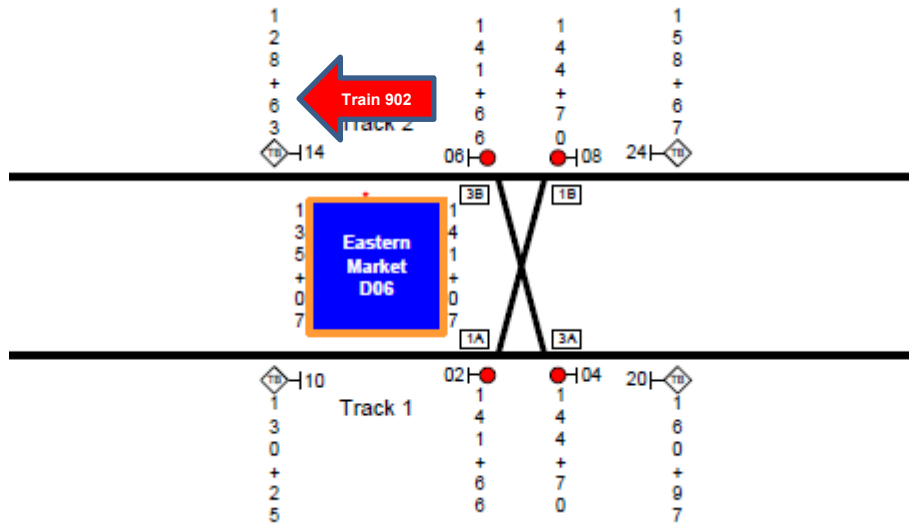
Field Sketch/Schematics

Location is approximate and Not to scale.

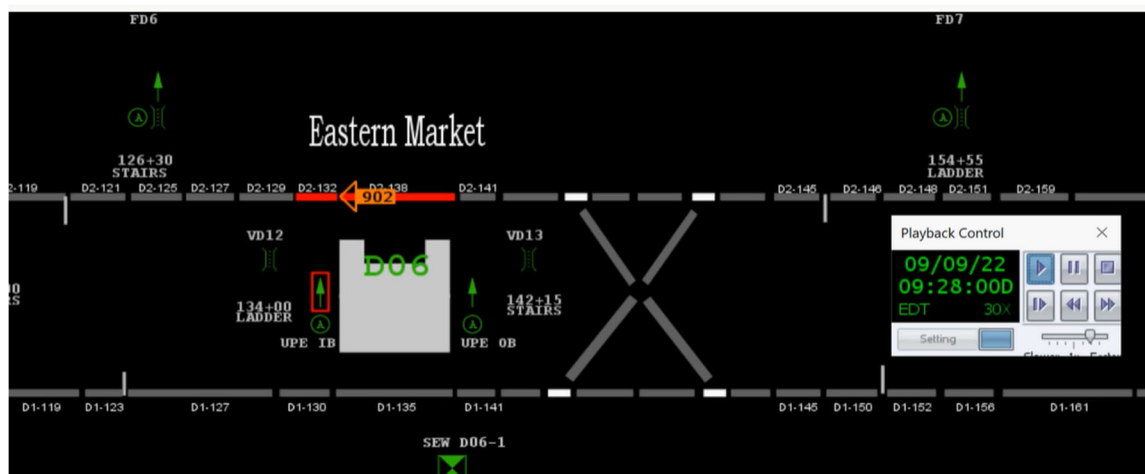
Figure 1 – Train ID 902 at Eastern Market Track 2

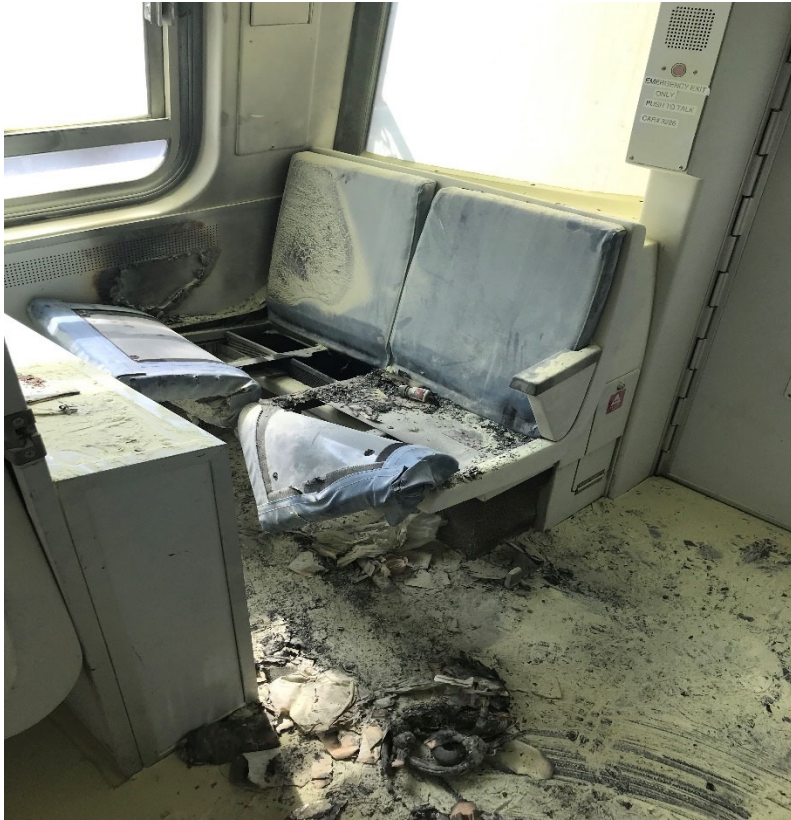
Damage from the fire included the left seat and side panel in the portion of the cab area of car 3286 that is open to riders when the car is not being used as a lead car of a train.

CENV completed their inspection on car 3286, reported in the fire incident. The operator's cab area left seat and side panel were found burnt, and a considerable amount of combustible material such as paper and trash were observed on the floor with burn damage. Based on the evidence, the fire source was external and not related to train components failure or malfunction.

Figure 5 – Post-event photo of seat damage
