WMSM Commissioner Brief: W-0200 – Evacuation for Life Safety Reasons – Carmen Turner Facility – September 1, 2022

Washington Metropolitan Area Transit Authority
Department of Safety (SAFE)
Office of Safety Investigations
FINAL REPORT OF INVESTIGATION A&I E22570

Carmen Turner Facility – Evacuation for Life Safety Reasons

Carmen Turner Facility – Bus Maintenance Shop, Building F

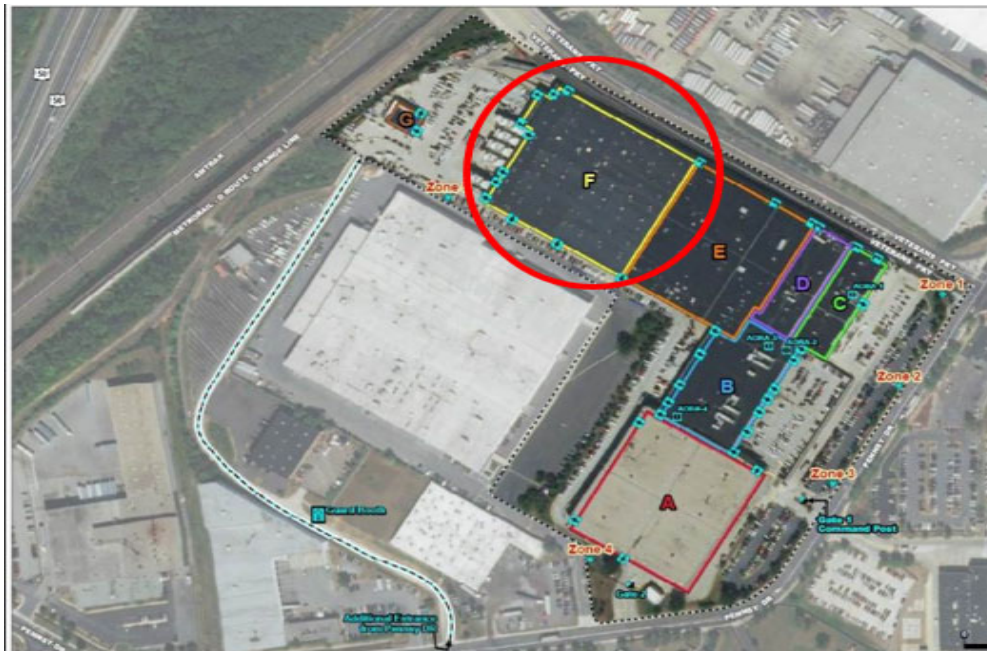
Field Sketch/Schematics

In this case, the alarm requiring Metrorail personnel to evacuate was triggered by a compressed natural gas (CNG) sensor near Room F105 near the Bus Maintenance Shop in Building F. Building F is physically attached to the rest of the facility (buildings A, B, C, D and E). Building F was the only building evacuated at approximately 10:54 a.m., 17 minutes after the initial alarm. WMATA policy requires alarms to be verified before evacuation is initiated. The ROCC (located in a different attached building) did not require evacuation and remained fully operational during this event.

Office of Systems Maintenance (SMNT), Communications Section (COMM) identified the impacted area as near Room F105.
