Inspection Form

Washington Metrorail Safety Commission

Inspection Date	YYYY/MM/DD 2022/02/03	Report Number	20220203-WMATA-LBW-01
Rail Agency Name	Washington Metropolitan Area Transit Authority	Rail Agency Department	Name
Rail Agency Department	Rail Transportation	Contact Information	
Inspection Location	Shady Grove Yard 15903 Somerville Drive Rockville, MD 20855

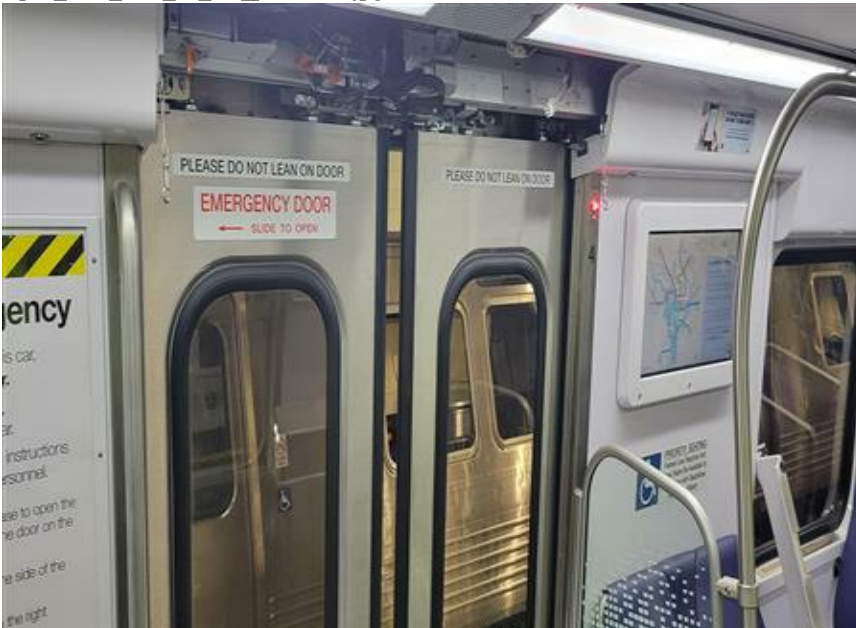
Open_door_with_no_fall_protection.jpg

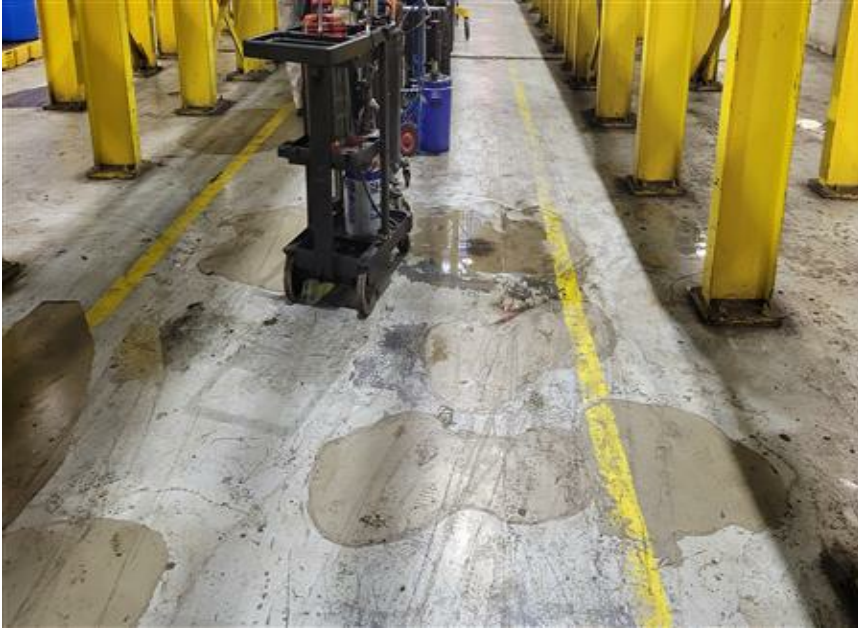
Drain_not_open.jpg

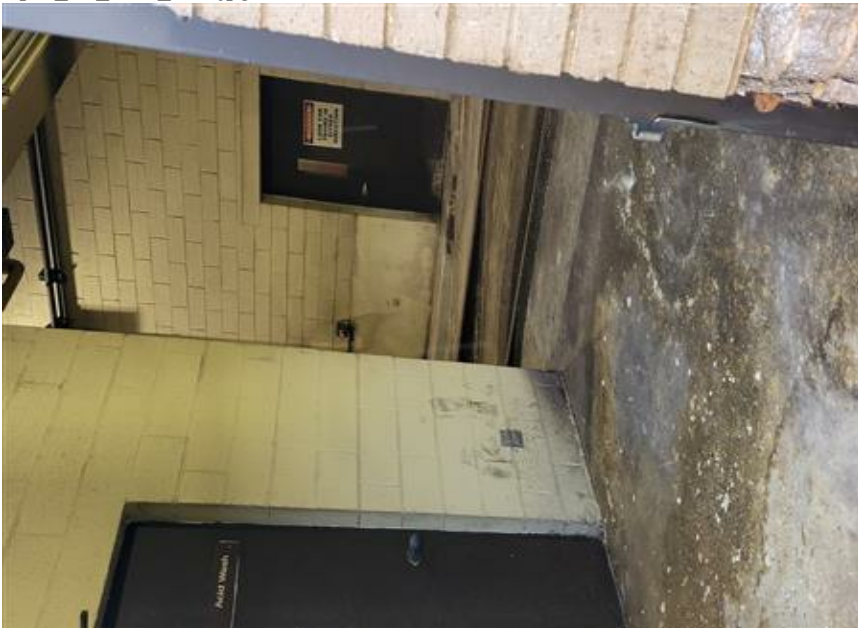
Open_car_wash_door.jpg
