Inspection Form

Washington Metrorail Safety Commission

Inspection Date	YYYY/MM/DD 2022/04/07	Report Number	20220407-WMATA-KEK-50
Rail Agency Name	Washington Metropolitan Area Transit Authority	Rail Agency Department	Name
Rail Agency Department	WMATA	Contact Information	
Inspection Location	A08 Friendship Heights Train Control Room

Inspection Activity #	1	Inspection Subject	Train Control Room Follow-up Inspection			Activity Code					
Job Briefing Employee Name/Title	N/A	Accompanied Inspector?	Yes	Out Brief Conducted	Yes	Time	09:00 AM	Outside Shift			
Related Reports	#3980	Related CAPS / Findings	WMSC-21-C0082 - Structural Inspections								
Related Rules, SOPs, Standards, or Other	Ref	Rule or SOP			Standard		Other / Title		Checklist Reference		
	ATC-1000 Rev 4.0, ATC-2000	MSRPH			WMATA ASP, Sec #3, ATC MCP - Sec 3.3.8		20222803-WMATA-KEK-49		1020 Form - Rev 4.0		
Inspection Location	Main Track	Yard	Station	OCC	RTA Facility	WMSC Office	Track Type	At-grade	Tunnel	Elevated	N/A
					X						
Line(s) & Track Number	A08 Friendship Heights Train Control Room				Chain Marker and/or Station(s)		From		To		
							298+15		304+15		
Vehicles	Head Car Number		Number of Cars		Equipment		Camera

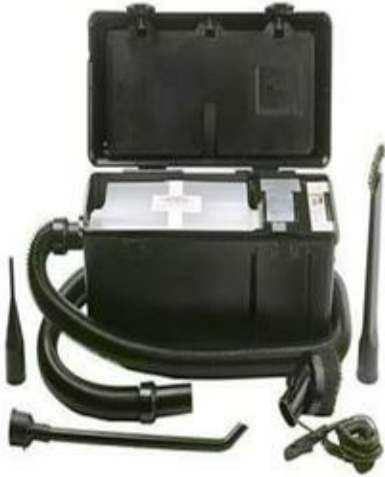
Photos:
Electronic_Vacuum_Cleaner.png

3M 497AJM 120V Portable Electronic Vacuum Cleaner

Recommended Finding?		No		
							Remedial Action Required?		Yes		
							Recommended Reinspection?		Yes		
Remedial Action	<p>Monitor water leaks and report promptly for mitigation; equip room with temporary HVAC system until deteriorated system is repaired; perform a deep clean of the rooms electrical and electronic equipment housing units to avoid equipment shorts from dirt and debris; and repair the ceiling. Weekly meetings with the Environmental Department will be an ongoing effort until all repairs and cleaning are performed at A08.</p>

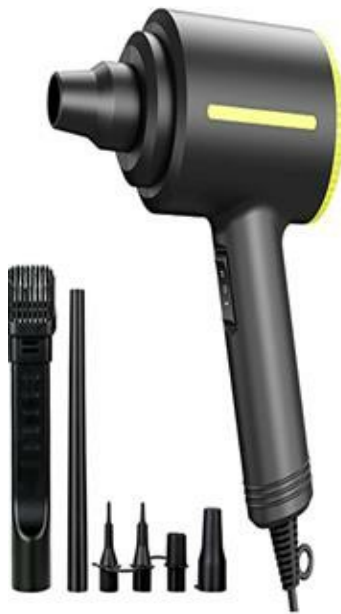
Electronic_Compressed_Air_Duster.png

Compressed Air, 500watts Electric Air Duster, 40000RPM Air Blower Replaces Canned Air Spray for Computer Keyboard Cleaner, Compressed Air Can Duster for Cleaning Dust, Reusable Dust Destroyer
