Inspection Form

Washington Metrorail Safety Commission

Inspection Date	YYYY/MM/DD 2022/10/13	Report Number	20221011-WMATA-LBW-1
Rail Agency Name	Washington Metropolitan Area Transit Authority	Rail Agency Department	Name
Rail Agency Department	SAFE	Contact Information	
Inspection Location	N2 1415+00

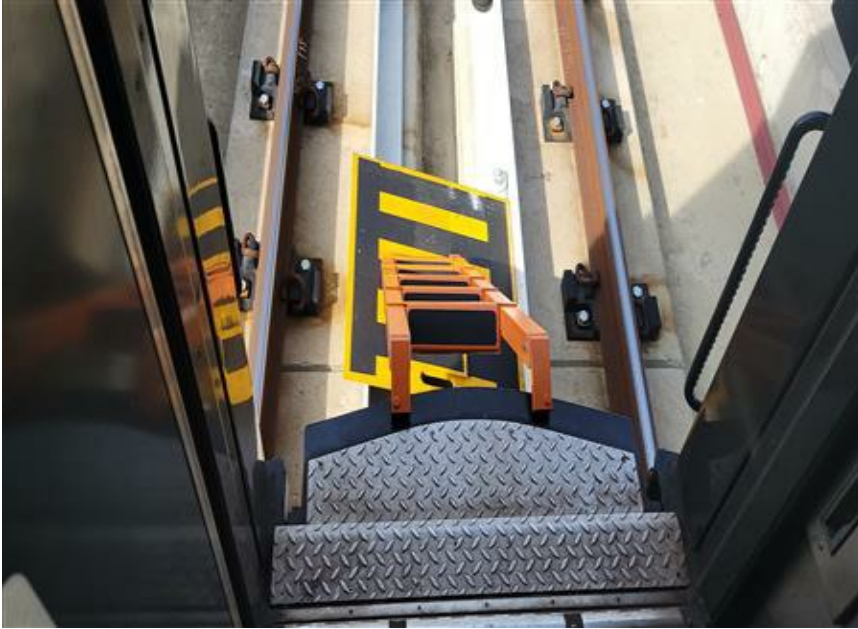
20221012_111109.jpg

Inspection Activity #	1	Inspection Subject	Emergency evacuation ladder and landing board			Activity Code					
Job Briefing Employee Name/Title	EP-11	Accompanied Inspector?	Yes	Out Brief Conducted	Yes	Time	09:30 AM	Outside Shift	Yes		
Related Reports	20221009-WMATA-LBW-01	Related CAPS / Findings									
Related Rules, SOPs, Standards, or Other	Ref	Rule or SOP			Standard	Other / Title			Checklist Reference		
Inspection Location	Main Track	Yard	Station	OCC	RTA Facility	WMSC Office	Track Type	At-grade	Tunnel	Elevated	N/A
	X									X	
Line(s) & Track Number	N2 1415+00			Chain Marker and/or Station(s)			From		To		
							N2 1415+00 - Silver Line Phase II			N2 1416+00 - Silver Line Phase II	
Vehicles	Head Car Number		Number of Cars		Equipment						
Description	<p>The WMSC Inspectors conducted a follow up safety inspection of the Silver Line Phase II aerial evacuation ladder and board. During an earlier pre-revenue safety inspection of the Silver Line (SL) Phase II project, the WMSC identified a possible safety concern with the double emergency guard rails (EGR). These are the rails used to help prevent a vehicle from derailing off an aerial guideway. The WMSC identified that the current evacuation solution for customers may not work in double EGR locations. An inspection was scheduled to assess the current solution. The inspection team departed West Falls Church rail yard aboard train ID 800 to chain marker (CM) 1415+00. At CM 1415+00 where a Roadway Job Safety briefing (JSB) was conducted before the inspection team exited the vehicle under Foul Time (FT) protection. The current ladder board solution was installed where it was identified that the current ladder and board would not work to evacuate customers on the new SL aerial guideway. The current evacuation ladder and board solution would not allow for safe evacuation of customers in double EGR locations. WMATA will investigate possible solutions to evacuate customers and a reinspection is required.</p>						Number of Defects		1

Recommended Finding?		Yes		
							Remedial Action Required?		No		
							Recommended Reinspection?		Yes		
Remedial Action	WMATA needs to determine the required solution for
