WMSC Commissioner Brief: W-0201 – Evacuation for Life Safety Reasons – Court House Station – November 7, 2022

Prepared for Washington Metrorail Safety Commission meeting on March 7, 2023

Washington Metropolitan Area Transit Authority
Department of Safety (SAFE)
Office of Safety Investigations (OSI)
FINAL REPORT OF INVESTIGATION A&I E22724

Court House Station – Evacuation for Life Safety
November 7, 2022
Table of Contents

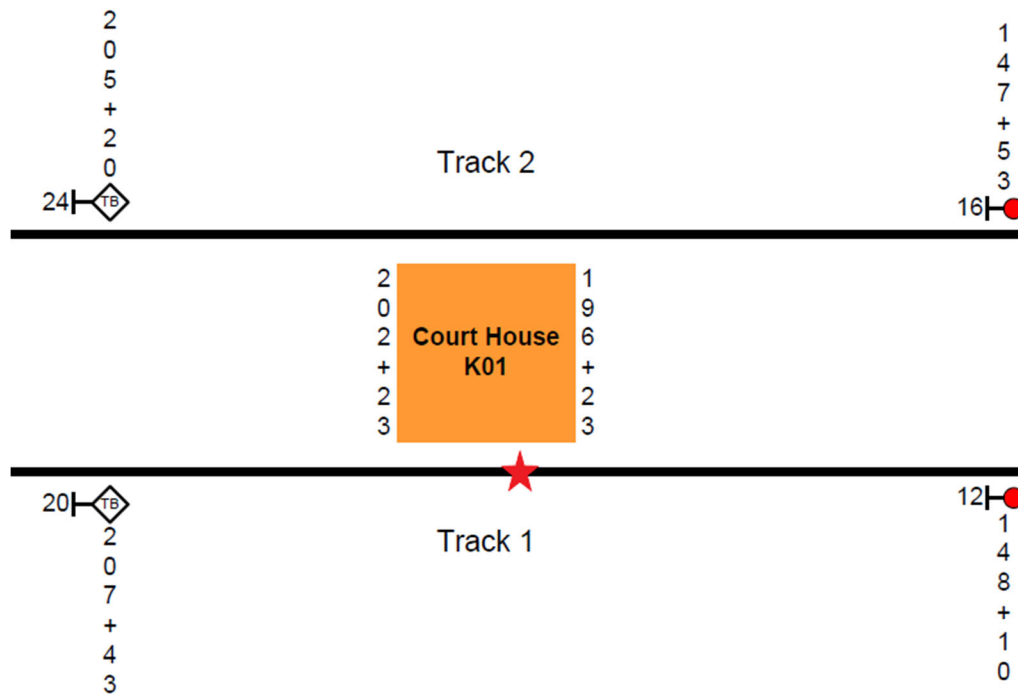
Field Sketch/Schematics

**Not to Scale. Oriented North. The approximate location of the dome vent is notated by a red star.*

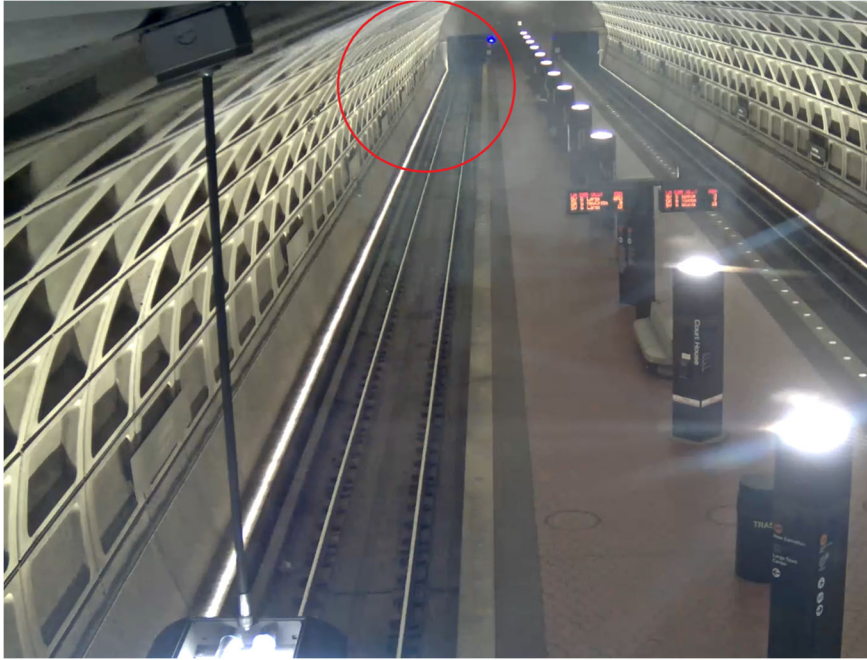
CCTV revealed that on November 7, 2022, at 19:46 hours, light-colored smoke began emitting from a ceiling vent while Train ID 603 serviced the platform on track 1; however, personnel or customers did not observe this. As Train ID 603 departed the platform, more smoke was drawn from the vent.

Figure 1: An initial plume of smoke billowed from a dome vent at approximately 19:46 hours. The ceiling vent is inside the top of the red circle.

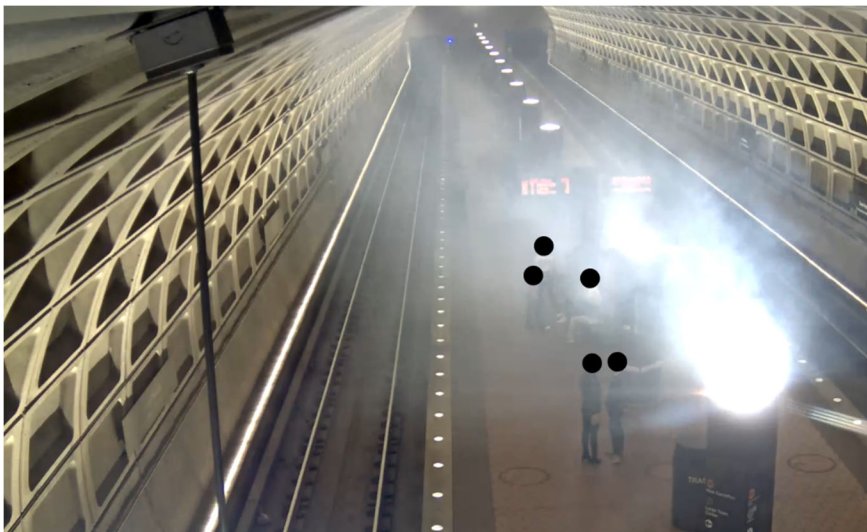
Figure 2: A second plume of smoke was observed coming from a dome vent at approximately 19:51 hours. The customers on the platform did not react to the smoke.

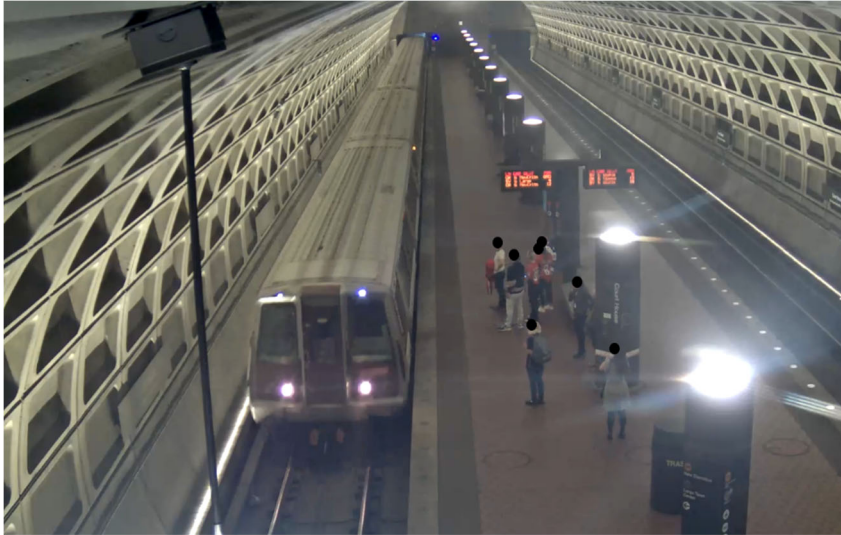
Figure 3: Train ID 909 noticed the smoky haze of Court House Station at approximately 19:56 hours.

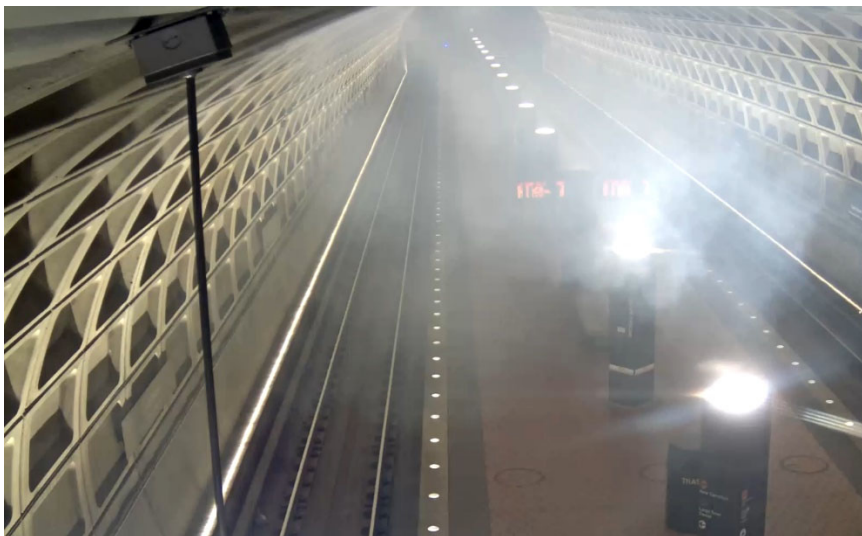
Figure 4: A third plume of smoke was observed coming from a dome vent at approximately 19:57 hours.

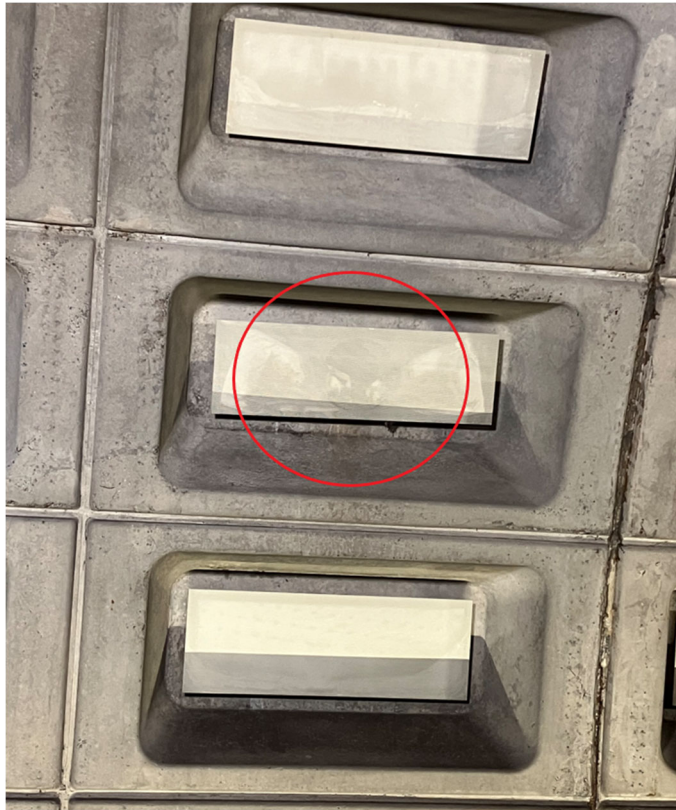
Further investigation identified the vent where the smoke entered displayed signs of dirt or soot when compared to other similar vents in the station.

The probable cause of this event was discarded smoking or similar materials from outside the Metrorail system into a grate that led to burning of debris built up in the Metrorail shaft. Contributing to deficiencies in response was Metrorail not consistently following the incident command system structure.

Figure 7: The Subject Dome Vent

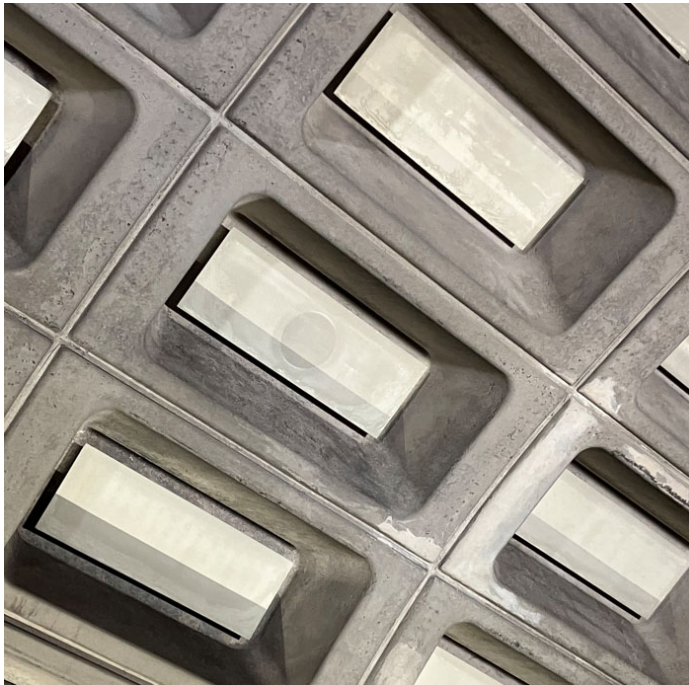
Figure 8: An example of a clean Dome Vent located nearby.
