WMSM Commissioner Brief: W-0202 – Evacuation for Life Safety Reasons – Friendship Heights Station – September 25, 2022

Washington Metropolitan Area Transit Authority
Department of Safety (SAFE)
Office of Safety Investigations (OSI)
FINAL REPORT OF INVESTIGATION A&I E22631

Friendship Heights Station – Evacuation for Life Safety

September 25, 2022

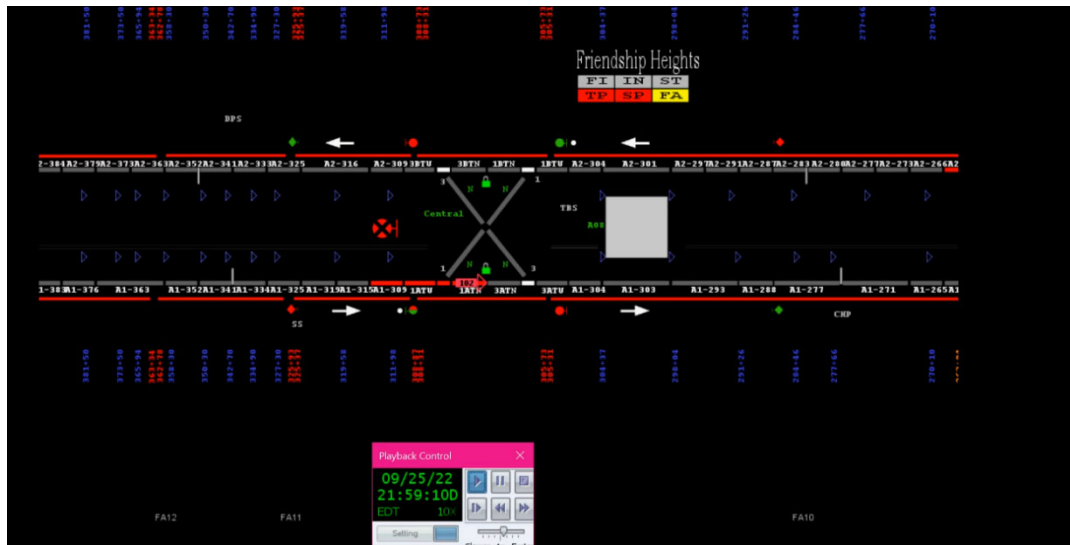
Figure 1 – Train ID 102 located at CM A1 308+00, outside Friendship Heights Station.

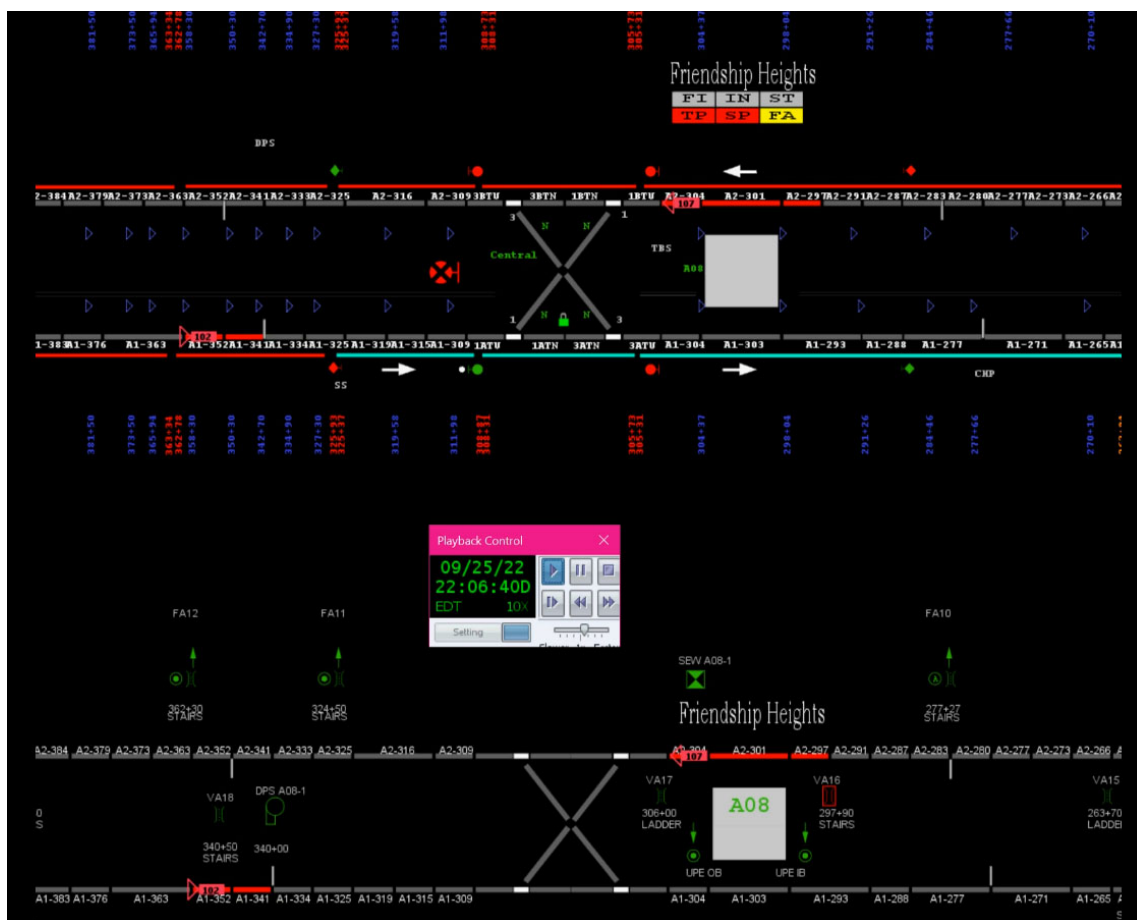
Figure 2 – Fan activation and power de-energized on track 1. Train 102 returning to Medical Center Station

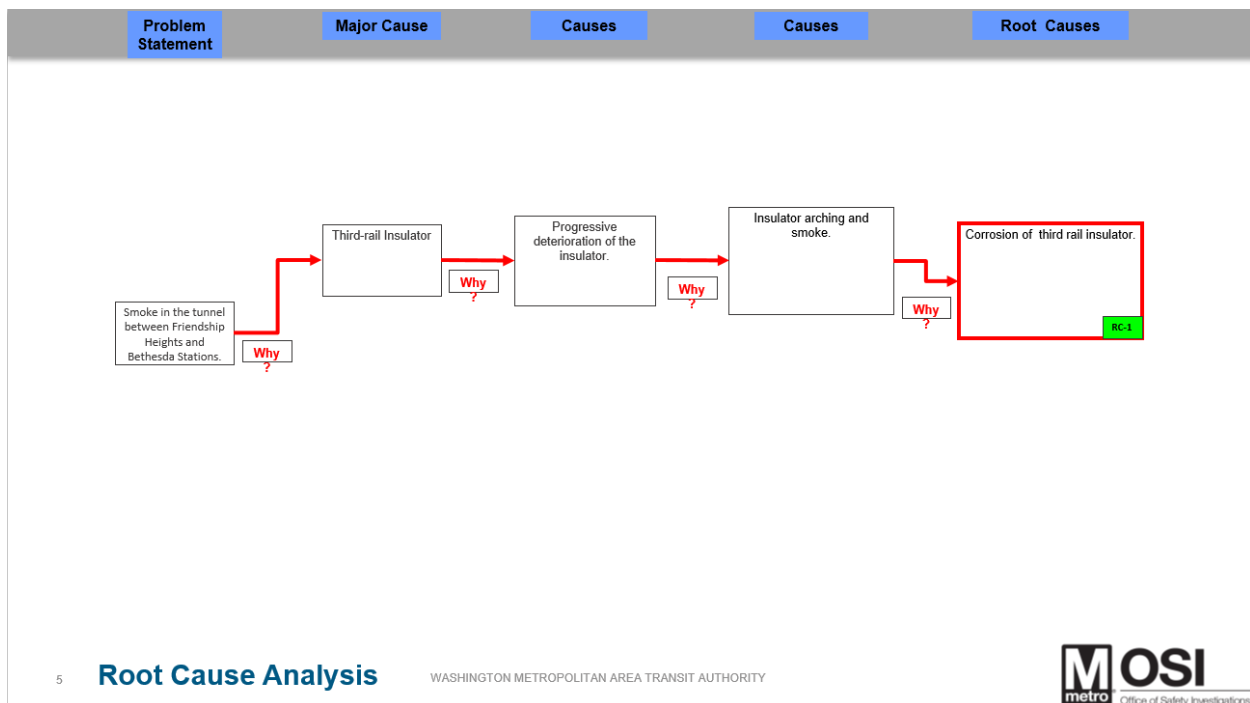
Appendix E – Root Cause Analysis

The probable cause of the Evacuation for Life Safety Reasons at Friendship Heights Station was a defective insulator that failed, resulting in smoke conditions.
