WMSC Commissioner Brief: W-0203 – Evacuation for Life Safety Reasons – L'Enfant Plaza Station – September 1, 2022

Washington Metropolitan Area Transit Authority
Department of Safety (SAFE)
Office of Safety Investigations
FINAL REPORT OF INVESTIGATION A&I E22572

L'Enfant Plaza Station – Evacuation for Life Safety Reasons

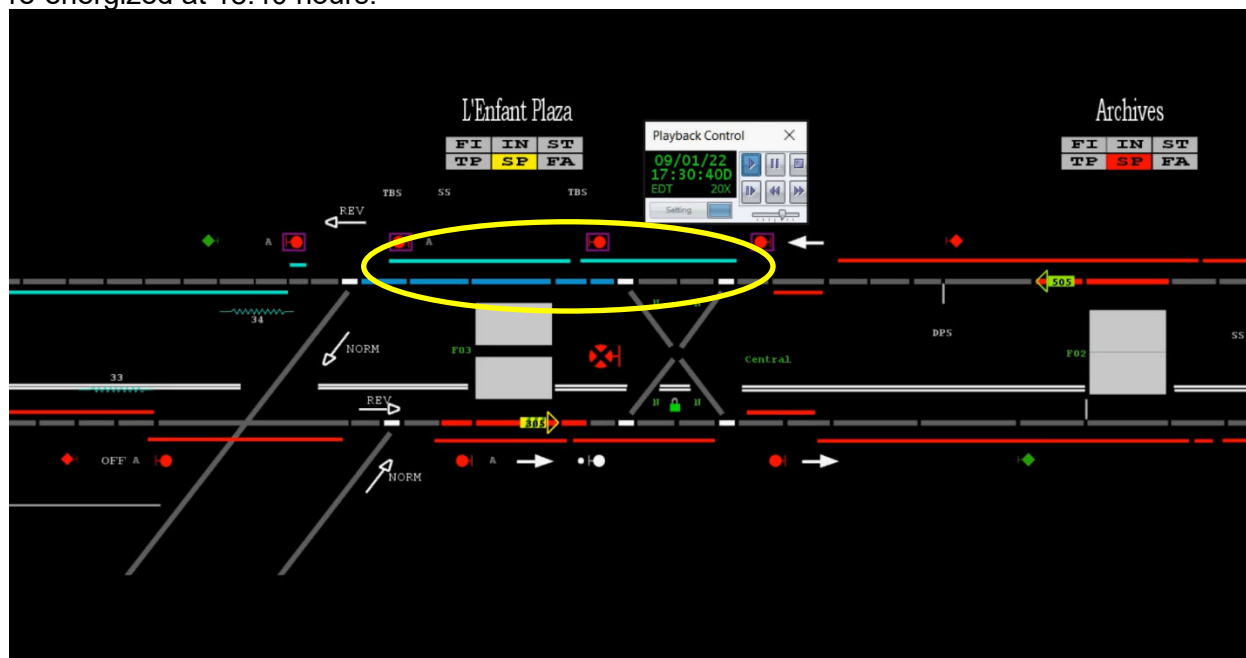
A review of the AIMS log revealed that the third rail power was de-energized at 17:30 hours and re-energized at 18:40 hours.

Figure 7: Third rail power was de-energized at 17:30 hours.

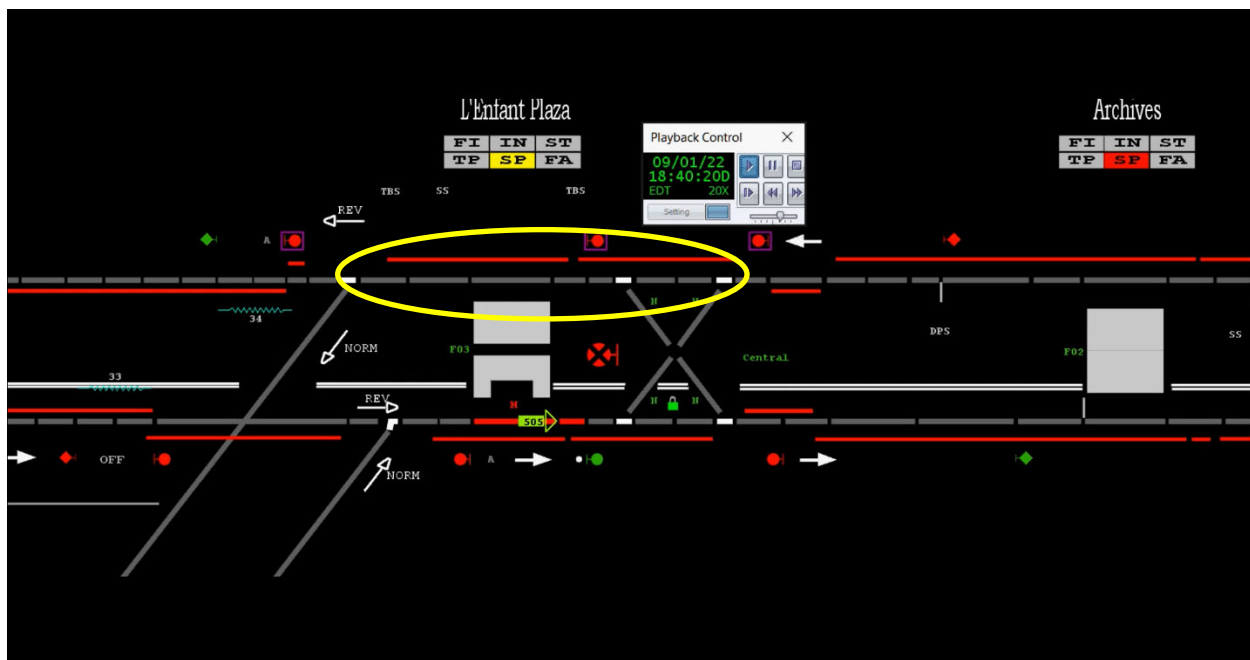
Figure 8: Third rail power was restored at 18:40 hours.
