WMSC Commissioner Brief: W-0205 - Evacuation for Life Safety Reasons - Forest Glen Station - November 14, 2022

Washington Metropolitan Area Transit Authority Department of Safety (SAFE) Office of Safety Investigations (OSI) FINAL REPORT OF INVESTIGATION A&I E22743

Date of Event:	November 14, 2022
Type of Event:	Evacuation for Life Safety Reasons – Smoke
Incident Time:	08:03 hours
Location:	Forest Glen Station, Track1
Time and How received by SAFE:	08:07 hours – SAFE/MAC
WMSC Notification Time:	08:58 hours
Responding Safety Officers:	WMATA: N/A
	WMSC: N/A
	Other: N/A
Rail Vehicle:	N/A
Injuries:	None
Damage:	None
SMS I/A Incident Number:	20221118#104200MX

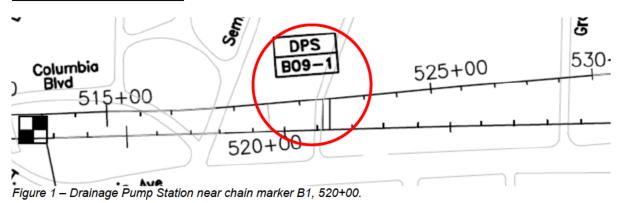
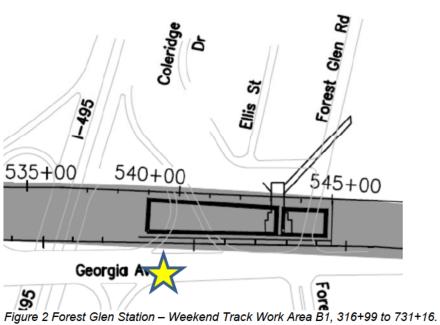
B09 Forest Glen

Forest Glen Station, Track 1

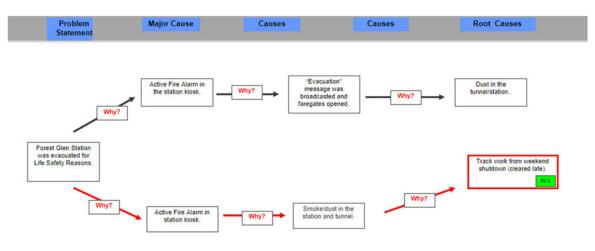
Figure 4 – Root Cause Analysis

The probable cause of the Evacuation for Life Safety Reasons event was weekend maintenance work including the replacement of switch machines, tunnel leak mitigation, fiber optic line preparation and DPS Rehabilitation. The accumulation of dust and debris from the weekend track work stirred by passing rail vehicles traveled to the DPS and caused a heat detector to activate, resulting in the activation of the fire alarm at the station. The subsequent investigation revealed no presence of smoke or fire.
