WMSC Commissioner Brief: W-0208 – Collision – Wheaton Station – October 4, 2022

FINAL REPORT OF INVESTIGATION A&I E22647

Wheaton Station – Collision

October 4, 2022

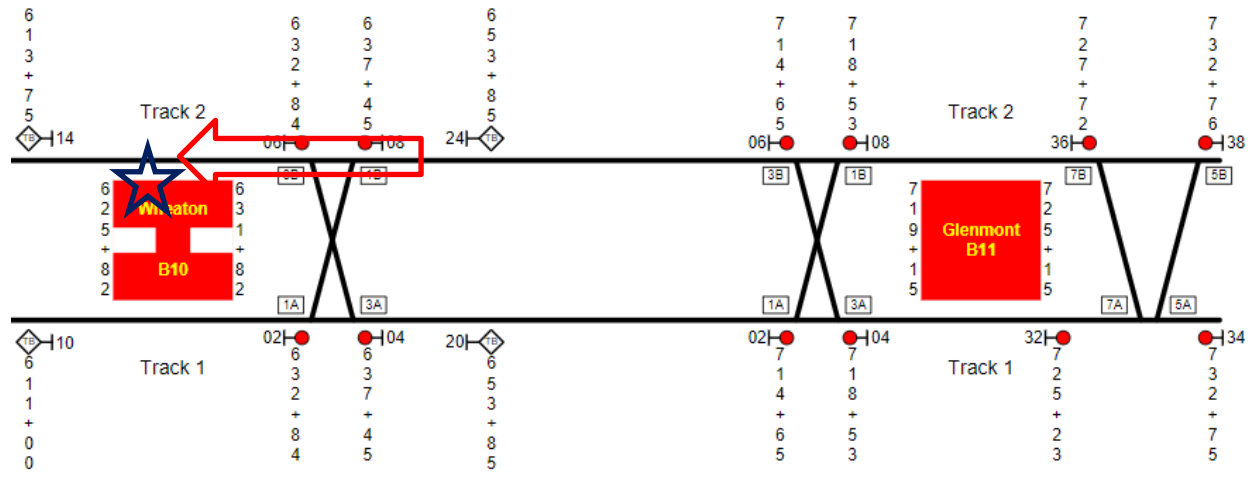
Field Sketch/Schematics

Wheaton Station is a 600-foot platform equipped with a direct fixation tangent track near the collision location. Video surveillance from the time of the event indicated that lighting of the station was adequate. The point of contact with the customer was approximately 34 feet from the end of the platform limits' 8-car marker.

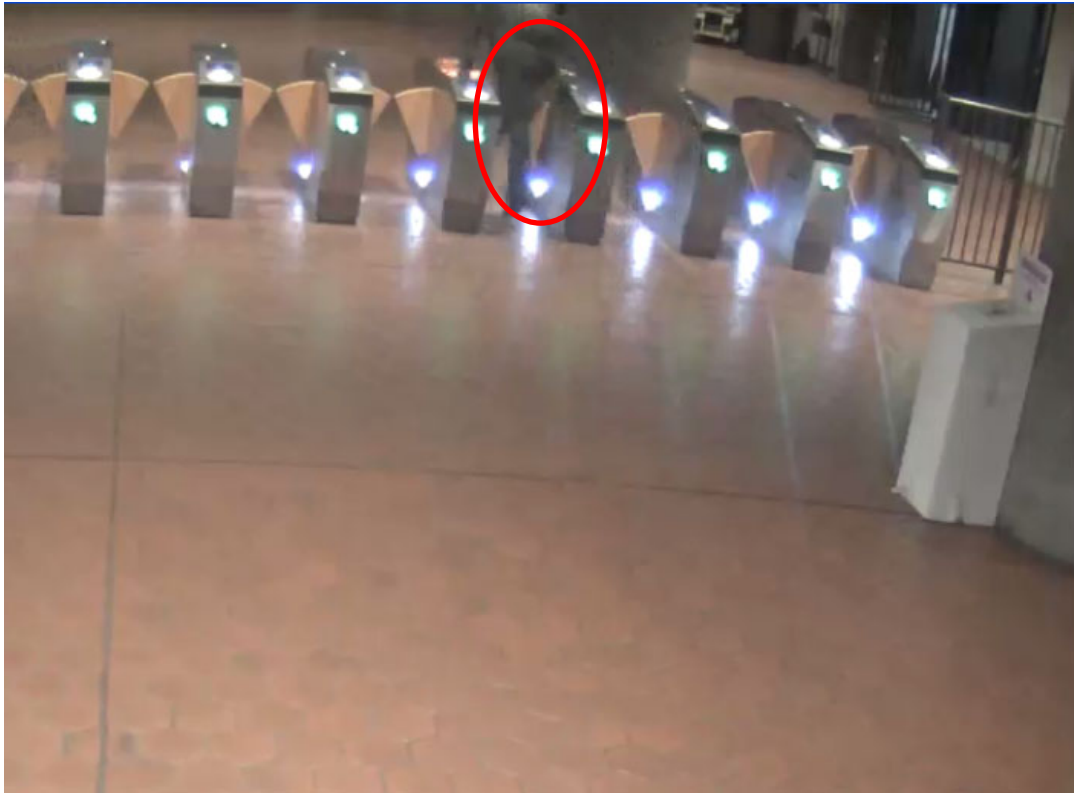
Figure 1 - Fare Evader #1 climbs over fare gate

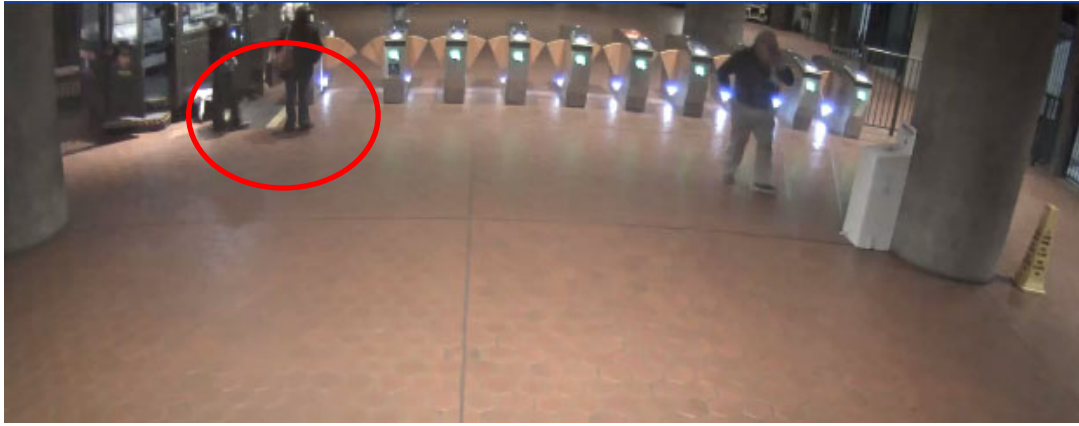
Figure 2 - Station Manager leaving the kiosk to communicate with fare evaders.

The Station Manager returned to the kiosk at 23:10 hours. During those four minutes, the customer remained motionless on the roadway and there were no other customers on the platform to witness the fall.

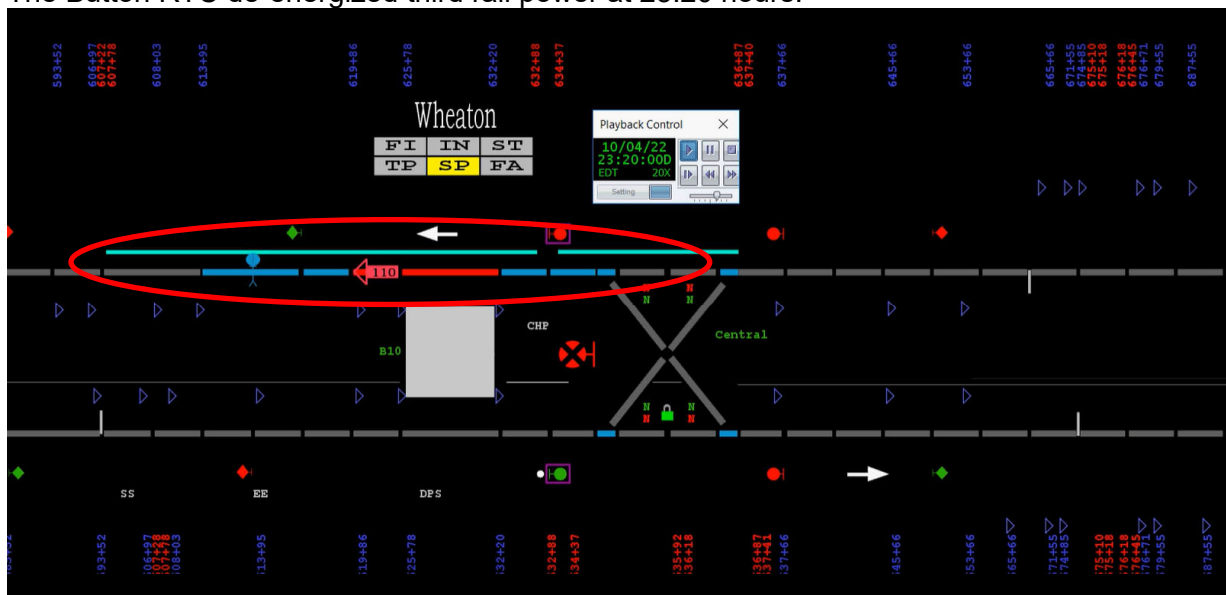
Figure 3 - AIMS Playback showed Power de-energized at 23:20 hours.

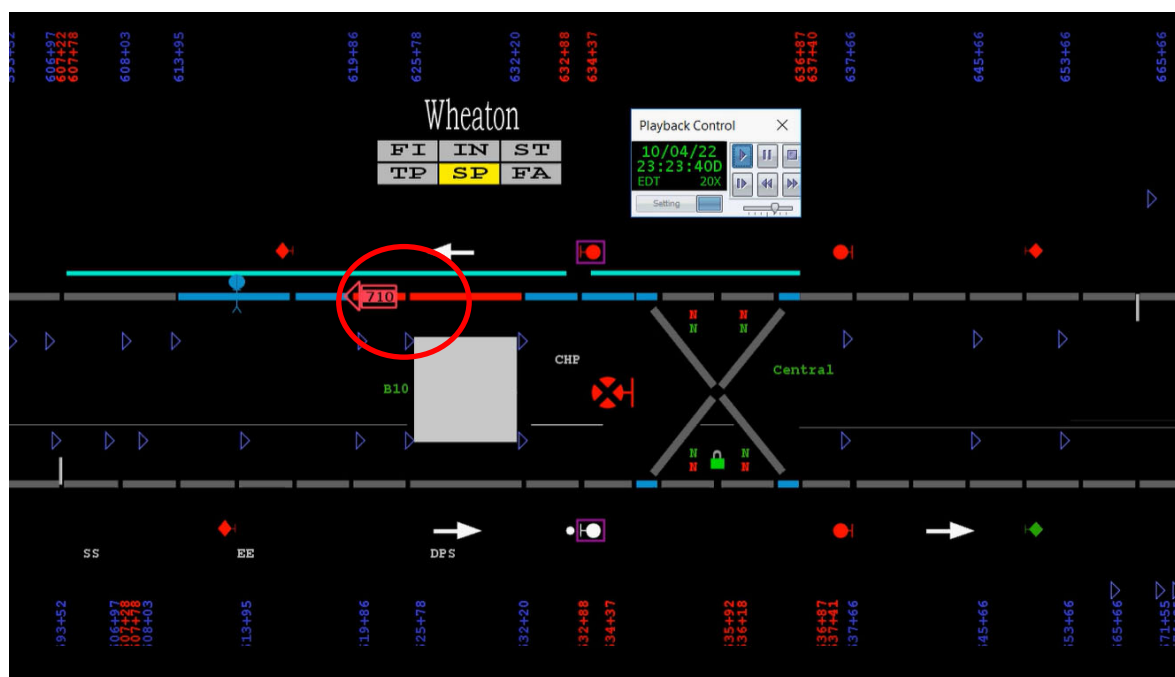
Figure 4 - Train ID 110 changed to Train ID 705 at 23:23 hours.

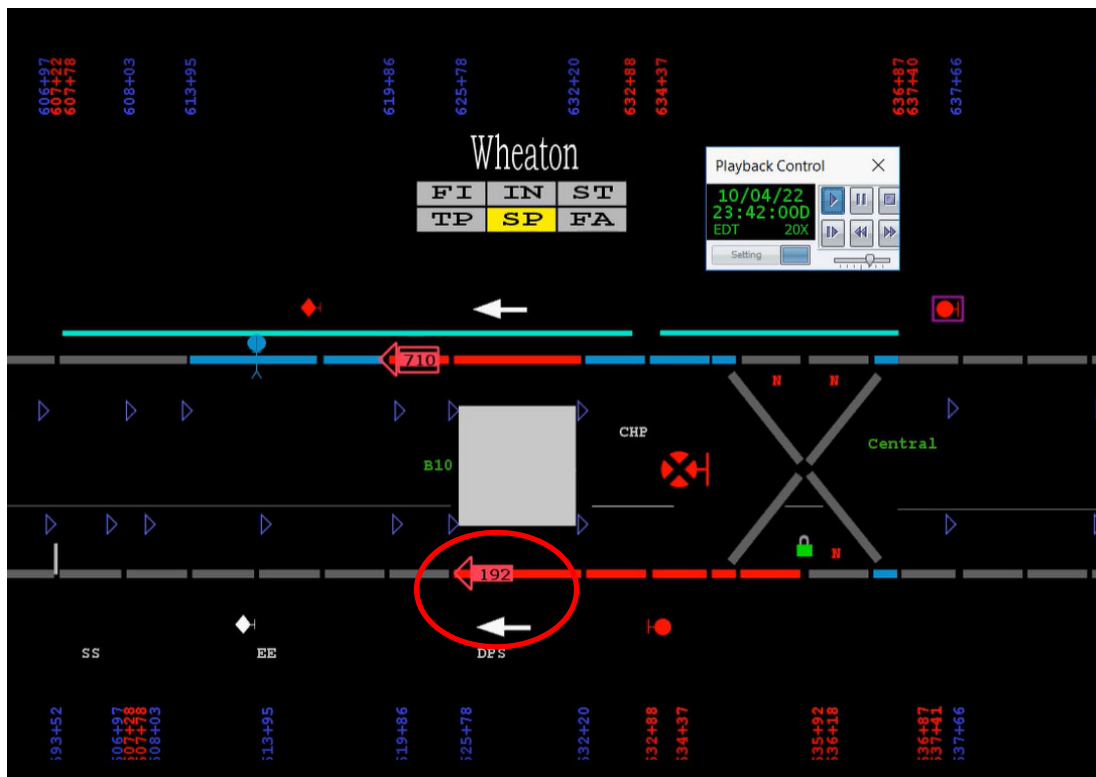
Figure 5 - First train to single-track and service Wheaton Station, track 1, at approximately 23:42 hours.

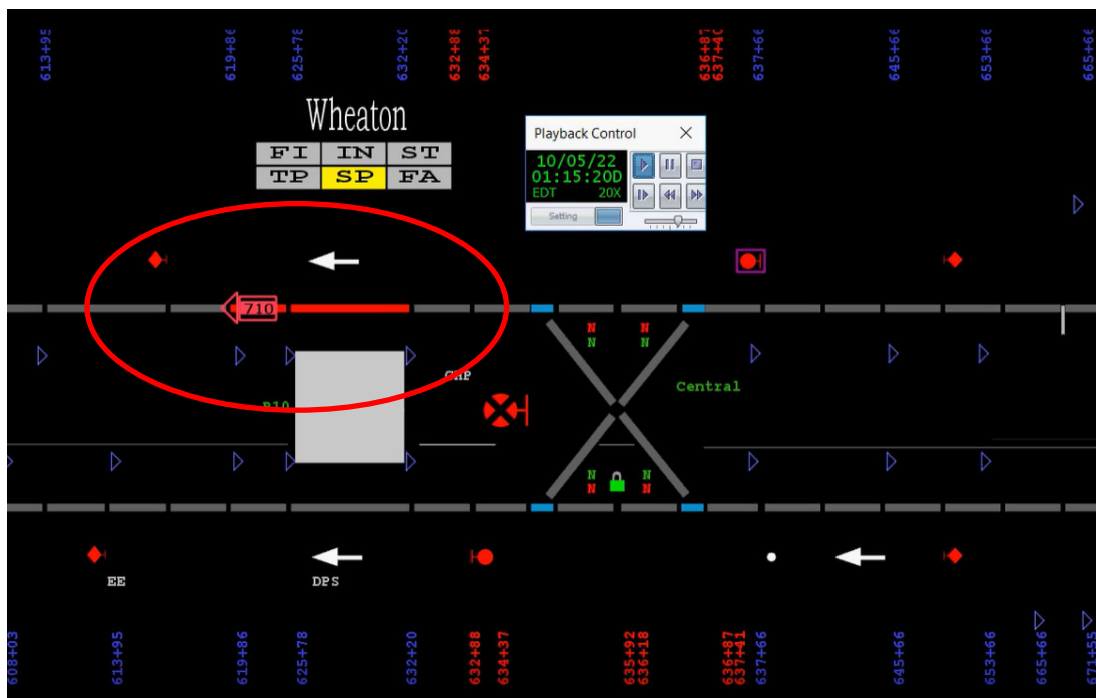
Figure 6 - Third rail power energized to move Train ID 710 to the nearest rail yard.

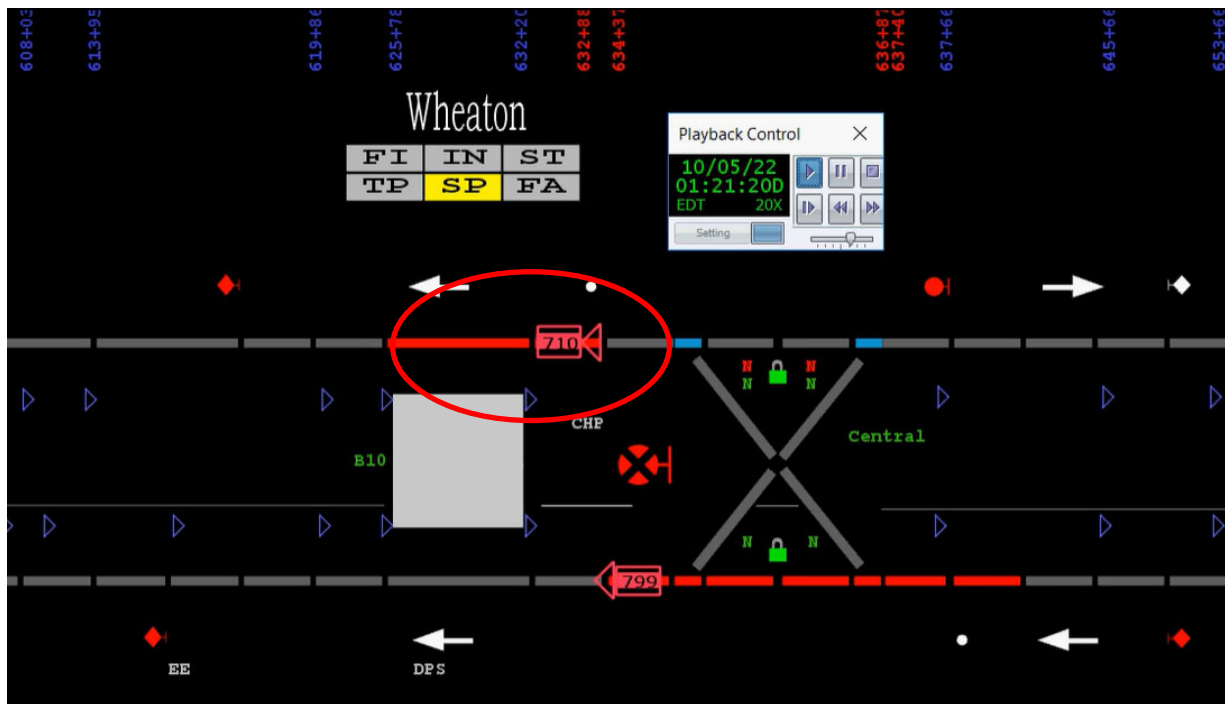
Figure 7 - Incident train leaving the area at 01:21:20 hours.

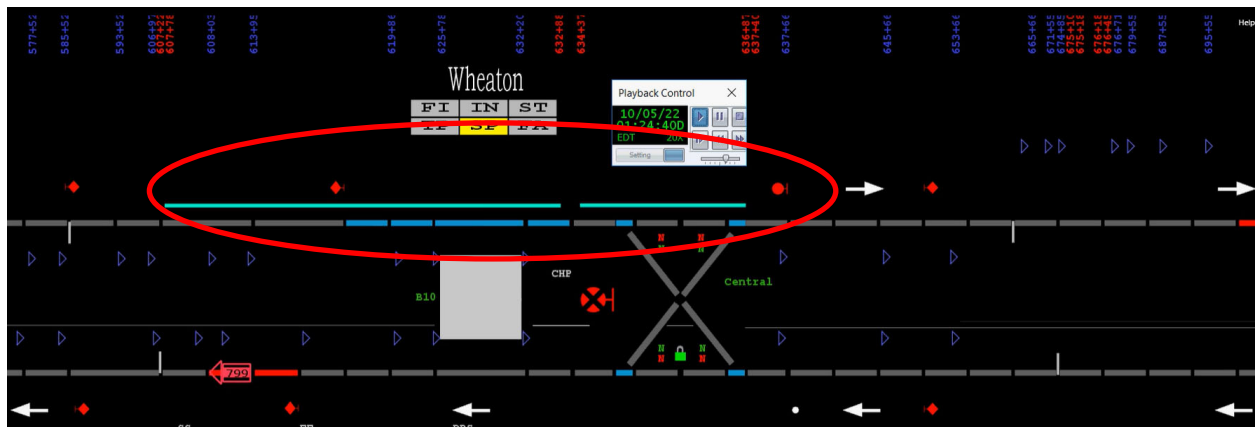
Figure 8 - Power Desk de-energized third rail power.

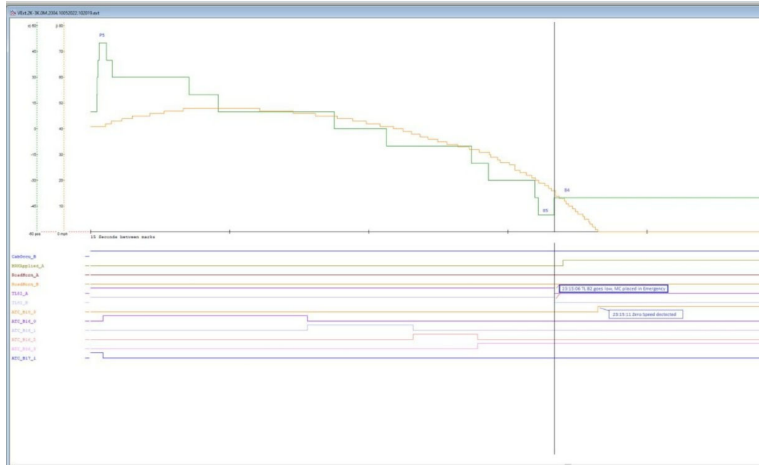
Event Recorder Data

“CMOR IIT downloaded and analyzed the VMS Data. VMS data determined that after the Master Controller was placed in emergency at 23:15:06.46 hours, the train came to a complete stop at 23:15:11; this indicated the train functioned as intended with a deceleration rate of -3.2 mph. VMS data does not show the road horn was activated at the time of the incident; however, the road horn was activated at 15:57 before the incident and at 04:30 hours on 10/5 after the incident. No additional logs are required at this time; however, CMNT should perform the recommendations below.”

23:15:06 hours	347 feet into the station, the TL 82 Emergency Trainline signal goes low (MC Handle in Emergency position) Speed 16 mph (Distance - 1701653)

23:15:07 hours	Second F4 Marker detected (Distance 1701664)
23:15:07 hours	After the Second F4 marker, 2005 travels an additional 6 feet before the Brakes applied signal goes high train speed 13 mph (Distance - 1701670)

23:15:11 hours	After the Brakes were applied, Train travels an additional 25 feet before coming to a complete stop, with the train stopping approximately 34 feet short of the 8-car marker (Distance - 1701695)

- Perform complete under-car inspection.
- Perform Brake Rates and Master Controller checks.
- Visually inspect the wheels for flats on the lead car. If any flats and/or spalling are noted/found, the entire consist MUST have all wheels inspected.
- Document all inspections, findings, and corrective actions in Maximo.
- Re-establish VMS communication with all subsystems.
- Perform successful DI inspections.
- CENV has No Hold on cars.

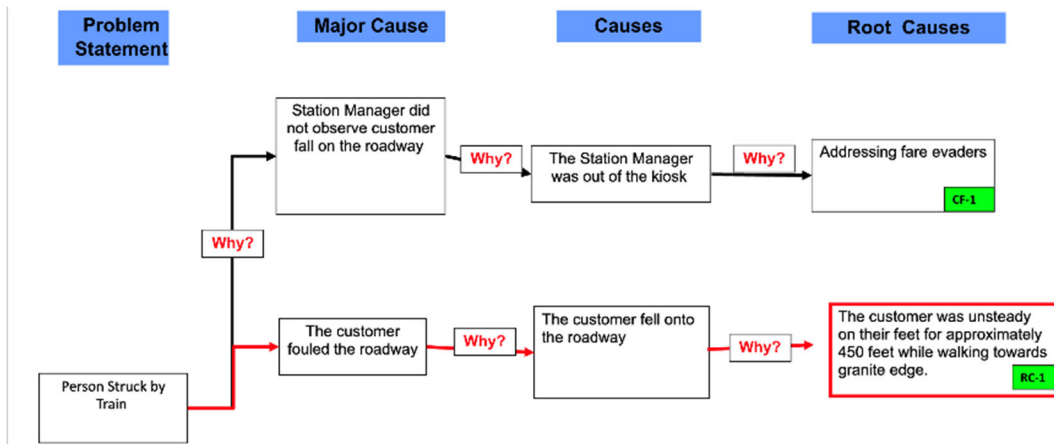
Attachment 1 – Root Cause Analysis page 1 of 1.

The probable cause of the Wheaton Station person struck by train event was an accidental fall that resulted in a customer laying within the train's dynamic envelope. Contributing Factors to the event were the lack of witnesses to the fall and the customer wearing dark clothing, which prevented the Train Operator from observing the customer earlier. No mechanical defects or human-based errors were identified.

No recommendations for this event. No response-related deficiencies, mechanical defects, or human-based errors were identified.
