WMSC Commissioner Brief: W-0209 – Collision – Friendship Heights Station – October 6, 2022

FINAL REPORT OF INVESTIGATION A&I E22652

Date of Event:	October 6, 2022
Type of Event:	Collision
Incident Time:	17:21 hours
Location:	Friendship Heights Station, Track 1
Time and How received by SAFE:	17:25 Hours - SAFE/MAC
WMSC Notification Time:	18:48 Hours
Responding Safety Officers:	WMATA: None WMSC: None Other: None
Rail Vehicle:	Train 111 - L7710/11x7542/43x7567/68x7655/54T
Injuries:	Serious Non-Life Threatening Injures
Damage:	TWC Antenna
Emergency Responders:	District of Columbia Fire and Emergency Medical Services (DCFEMS), Montgomery County Fire and Rescue Services (MCFRS), Metro Transit Police Department (MTPD)
SMS I/A Incident Number:	20221006#103367MX

Friendship Heights Station – Collision

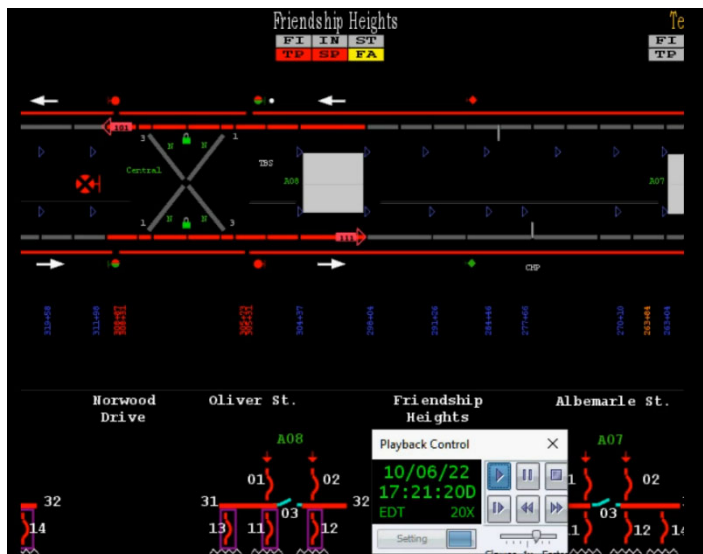
Figure 1 - Train ID 111 at Friendship Heights Station, track 1 at 17:21 hours.

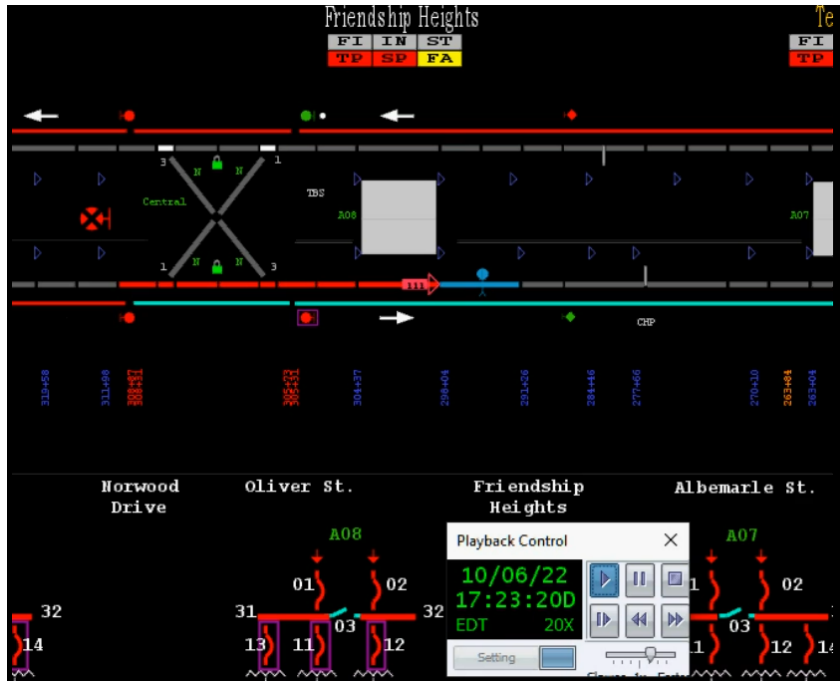
Figure 2 - Third rail power deenergized at 17:23 hours.

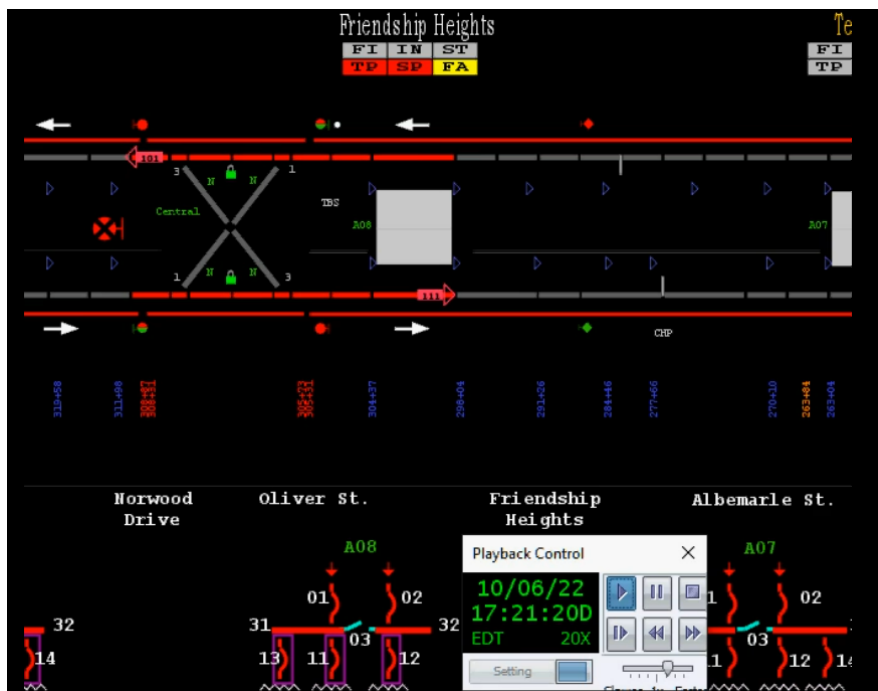
Image 1 – Train ID 111 at Friendship Heights Station, track 1 at the time of the incident.

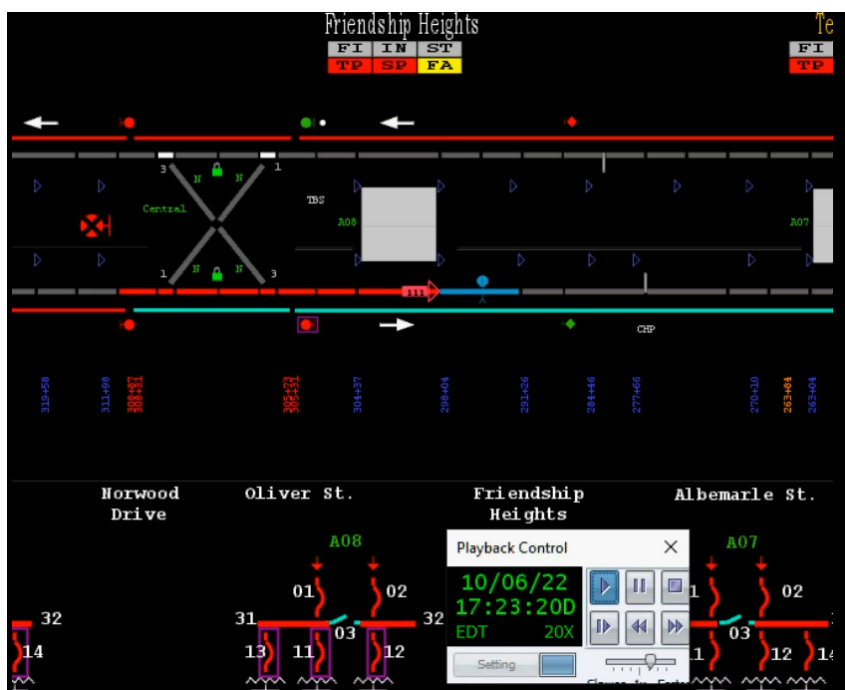
Image 2 – Third rail power deenergized at 17:23 hours.
