**WMSC Commissioner Brief: W-0210 – Derailment – Greenbelt Rail Yard – September 10, 2022**

**FINAL REPORT OF INVESTIGATION A&I E22585**

# Greenbelt Yard – Derailment

September 10, 2022

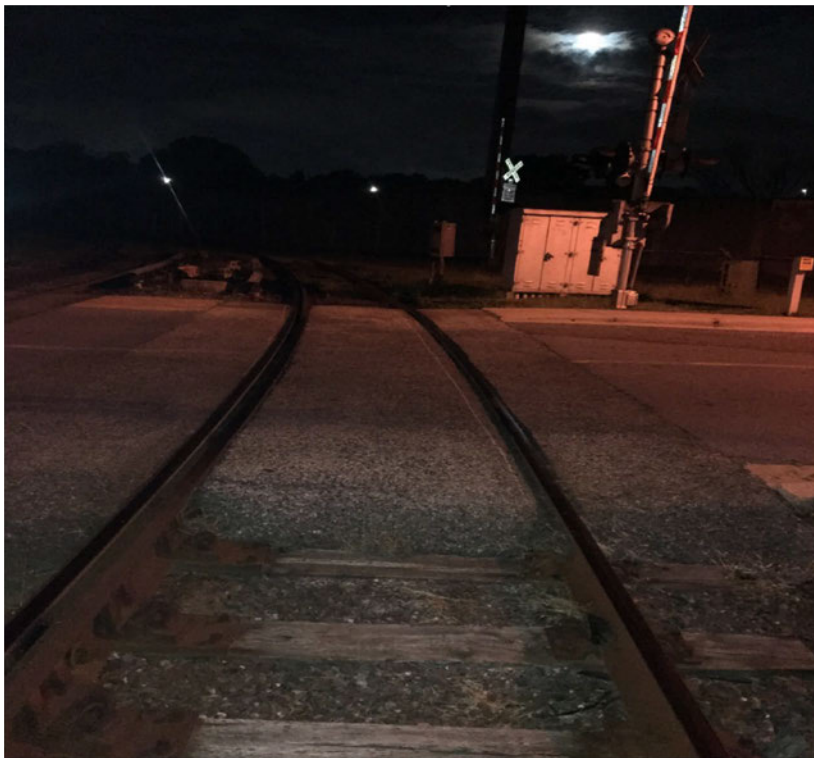
*Figure 2: Shows a view of the grade crossing CR 7972 traversed when it derailed.*

Prior to the Hi Rail Operator arriving at the grade crossing, two other contractors operating similar Kiewit Hi Rail vehicles were given lunar signals and absolute blocks to the L-Line Bridge shutdown. The first two Kiewit Hi Rail vehicles traversed this grade crossing without any issues. CR 7972 came to a complete stop at the grade crossing and then proceeded at the required speed. When the Hi Rail Operator began to traverse the grade crossing at slow speed, the tires engaged with the paved area and the hi rail wheels disengaged from the running rails. The Hi Rail Operator was unaware they were off the rail until they crossed the grade crossing and the hi rail wheels dropped to ground, derailing to the left side near the third rail.

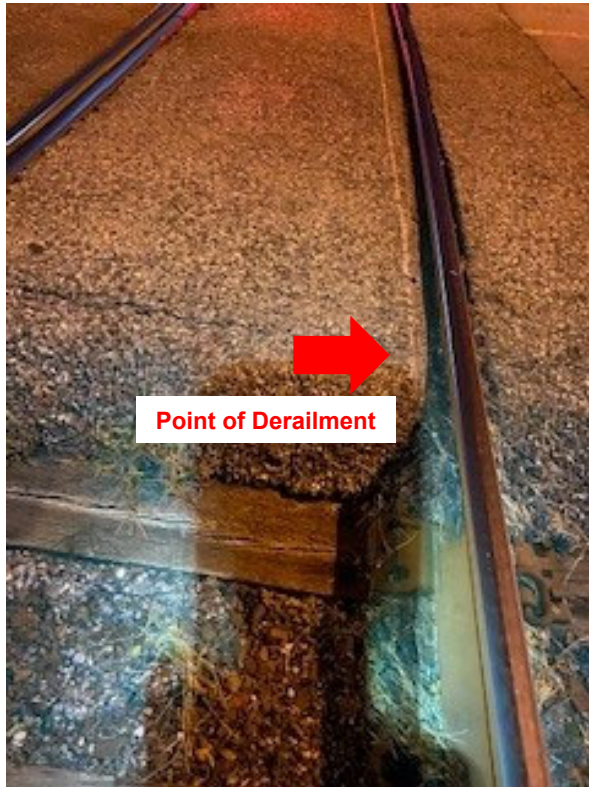
Figure 3: Shows the view looking at the beginning of the grade crossing where the point of derailment occurred.

The point of derailment shows that the Hi Rail vehicle derailed as soon as it started to traverse the grade crossing. As CR 7972 traversed the grade crossing, the rear rail gear was dragged along the asphalt.

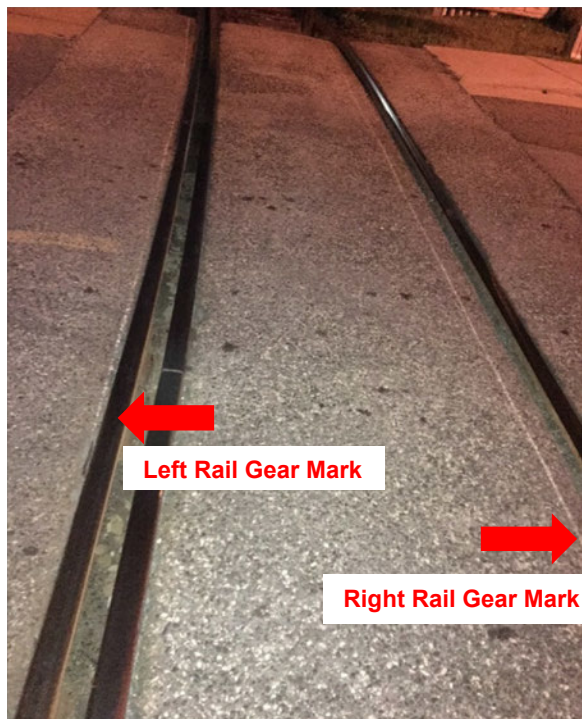
Figure 4: Shows a center view that captures the left and right rail rear gear markings.

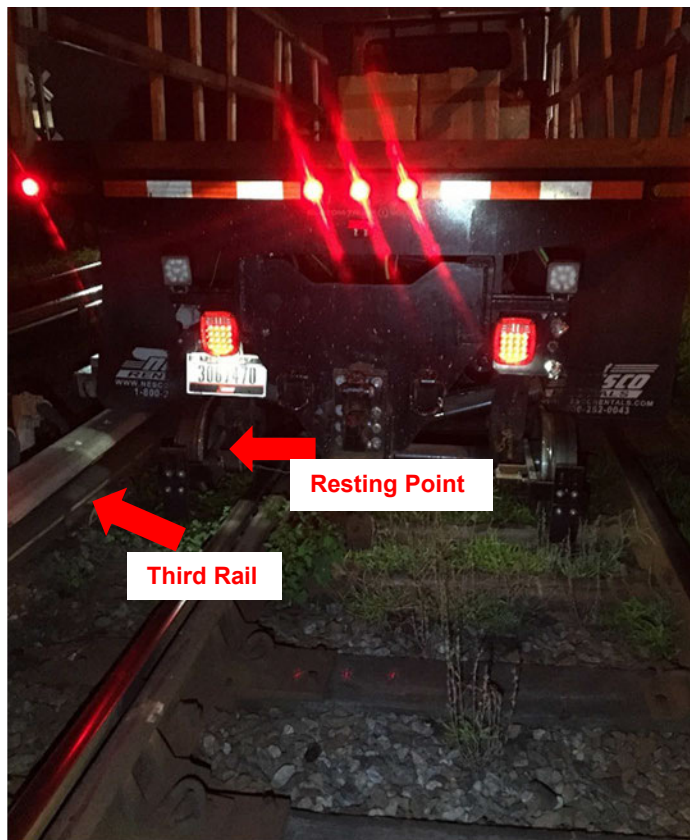
Figure 5: Shows a view from the rear of landing point of CR 7972 after derailment.

The resting point of CR 7972 was the western side of the grade crossing, with the hi rail gear in close proximity to the third rail. There was no damage to the third rail nor the Hi Rail vehicle. During the investigation, both Kiewit and CENV reported concerns about the asphalt at the grade crossing. When CENV conducted their preliminary inspection, they identified there was a bulge in the asphalt where the left rear tires would have been at the point of derailment.

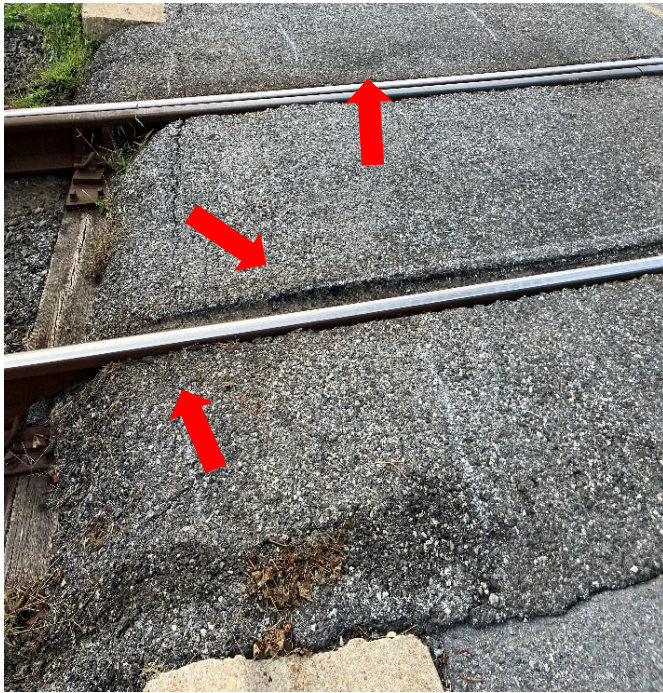
The asphalt was bulging at the grade crossing where the left rear tires would have been when the vehicle derailed. Metrorail's road crossing pavement height specification considered only rail wheel flange and not the additional width of a rubber tire on a hi rail vehicle. At the point of derailment, the asphalt was approximately 0.4 inches above the top of the rail on the right side of the rear wheel set and 0.6 inches above the top of the rail on the left side of the forward wheel set.

Figure 6: Shows the asphalt at the beginning of the grade crossing that is uneven, with some ridges and bulging.

As a long-term mitigation, Metrorail resurfaced the asphalt around the grade crossing and cleaned the flangeways.

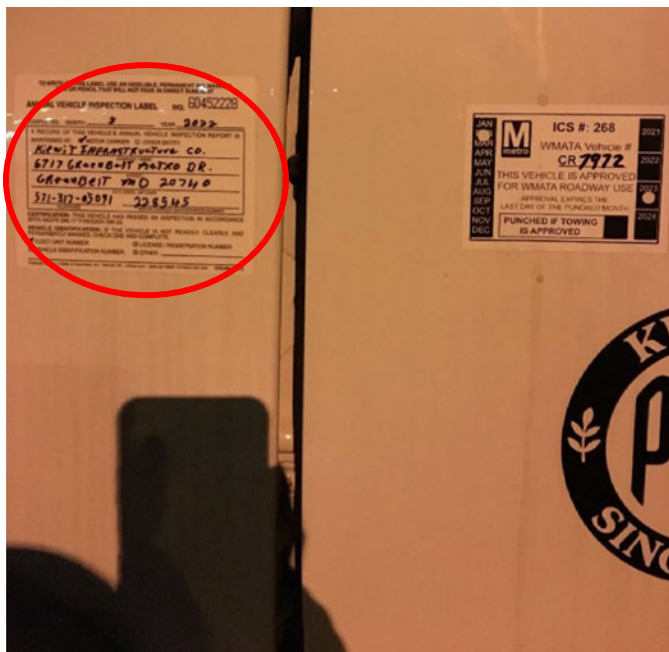
Hi Rail vehicle CR 7972 was inspected in August 2022 and certified for mainline operation. As a result of the derailment, the sticker on CR 7972 was removed and the unit was placed out of service. The inspection sticker was only removed from CR 7972. Kiewit was asked to review the mounting of the hi-rail gear because it lightened during the test through the Greenbelt Yard grade crossing even with the correct tire pressure. Prior to returning for use on WMATA property, the vehicle must be reinspected and certified by CTEM.

Figure 7: Shows the sticker that confirms CR 7972 recently passed inspection.

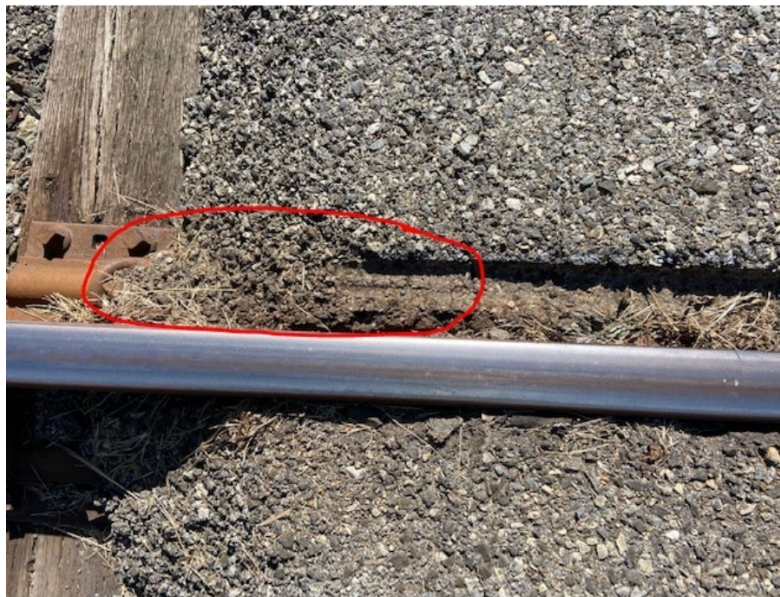
The flangeway did not meet the minimum depth of 2 inches. The flangeway was filled with debris and grease that interfered with wheel clearance and could cause wheel climbing.

MOWE personnel inspected the asphalt embedded track at the grade crossing where the derailment occurred. The flangeway width was in compliance with TRST 1000 volume 1 & 3, however the flangeway depth was not in compliance to the standard in some locations. The minimum depth should be 2" deep but when it was inspected it measured at 1 1/2". It was observed that the flangeway was full of debris and grease which might interfere with wheel clearance and cause wheel climbing to the surface. The gauge and lateral movement of rails were compliant.

*Figure 8: This image shows debris that was observed in the flangeway.*

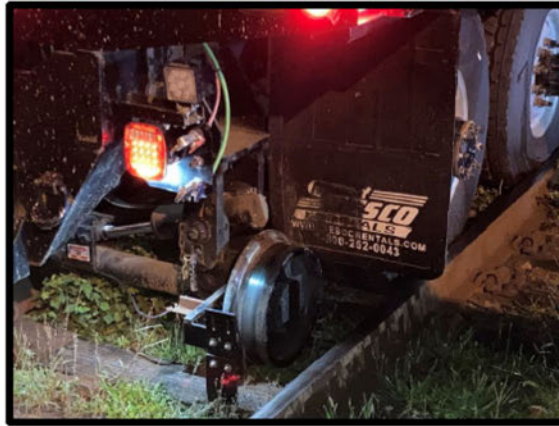
**Figure 1** – Rear of hi-rail flatbed CR7972

Inspection of the vehicle revealed that the left side tires were overinflated to 125 psi; 35 psi greater than the hi-rail maximum of 90 psi. Evaluation of the road crossing at the point of derailment (POD) found that the asphalt was higher than the top of rail (TOR) in the area of derailment. This height difference, combined with the over inflated tires and track radius all contributed as factors in the derailment; however, the root cause is most likely the raised asphalt adjacent to the rail.

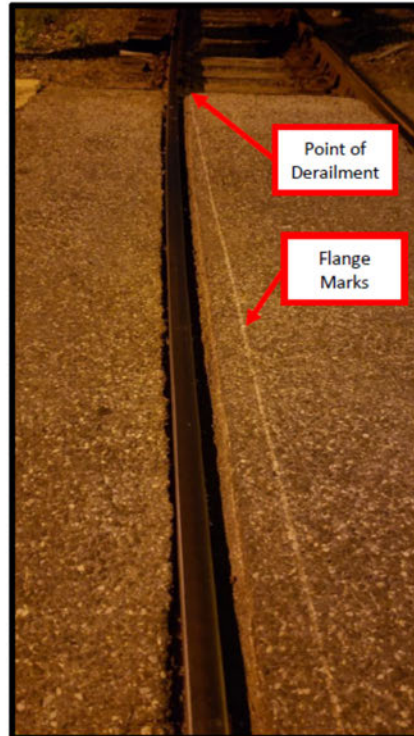
From flange marks left on the asphalt, it was determined the rail wheels lost contact with the rail upon entering of the grade crossing (Figure 2).

**Figure 2 – Point of derailment/Flange Marks**

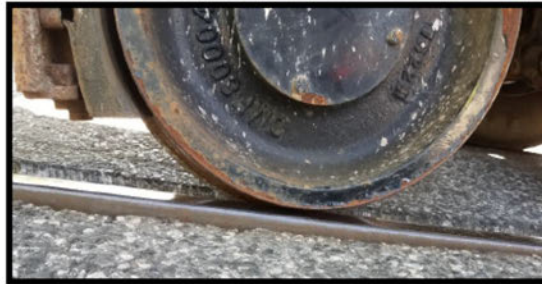
September 15, CR7972 was taken back to the road crossing with the corrected tire pressure and the rear hi-rail wheels began to climb immediately after both sets of tires were on the asphalt of the road crossing, although further into the crossing and not as extreme as the original incident (Figure 3).

**Figure 3 – Loss of contact**

Evaluation of the road crossing at the POD found that the asphalt was approximately 0.4 inches above TOR on the right side of the rear wheel set and 0.6 inches above TOR on the left side of the forward wheel set.

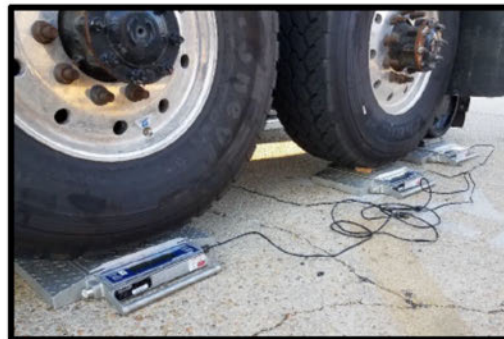
CENV requested that the hi-rail gear be reinspected by a 3<sup>rd</sup> party to ensure that it was properly adjusted. No issues with the adjustment were found (Attachment A). To confirm proper weight distribution CENV weighed the vehicles rear tandem axles and hi-rail axle. All axles were within 10% of each other indicating an acceptable distribution (Figure 4).

**Figure 4 – Wheel loading measurement**
