WMSC Commissioner Brief: W-0211 – Evacuation for Life Safety Reasons – Gallery Place Station – November 23, 2022

Washington Metropolitan Area Transit Authority
Department of Safety (SAFE)
Office of Safety Investigations (OSI)
FINAL REPORT OF INVESTIGATION A&I E22768

**Gallery Place Station – Evacuation for Life Safety Event
November 23, 2022**

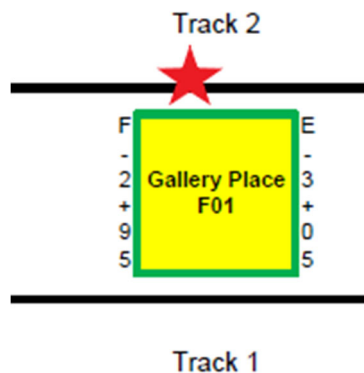
Field Sketch/Schematics

**The above depiction is not to scale. The Red Star represents the approximate location of the incident.*

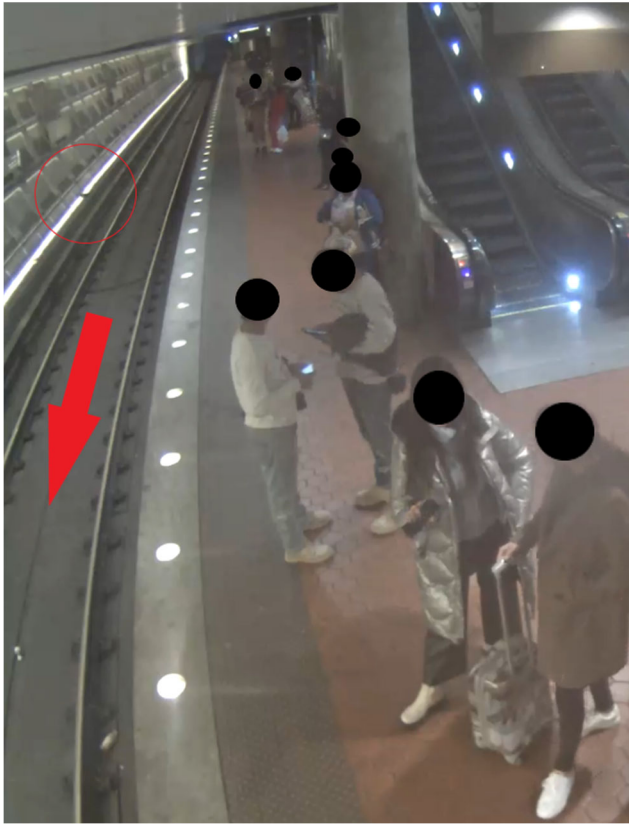
CCTV footage revealed that on November 22, 2022, at 23:04 hours, an unknown customer threw the bag from the upper-level (Red Line) Mezzanine level to the lower-level (Green/Yellow Line) where it landed on the lighted grates on Track 2 of Gallery Place Station.

Figure 1: Suspicious package is observed on Track 2 of the lower level at Gallery Place Station. Red arrow denotes direction of train travel.

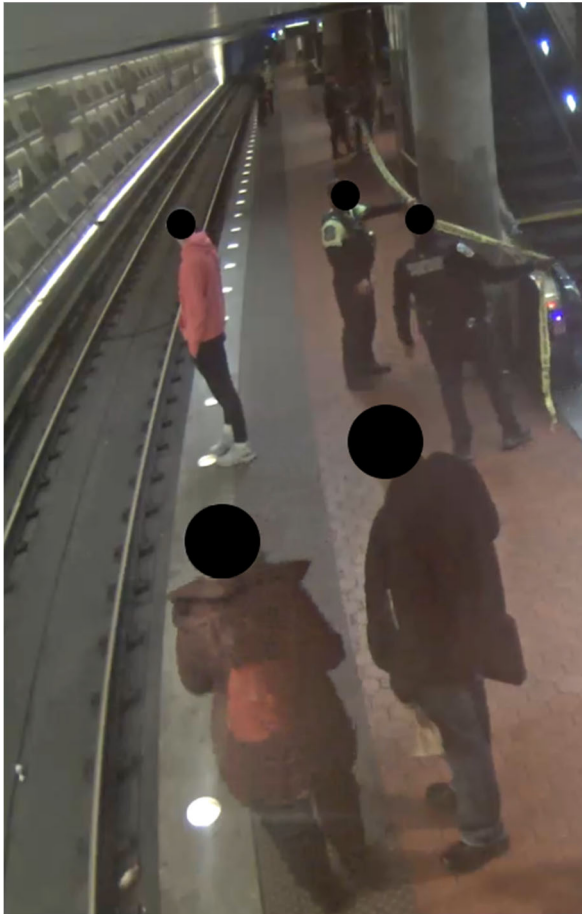
Figure 2: MTPD commenced cordoning the area at 17:43 hours.

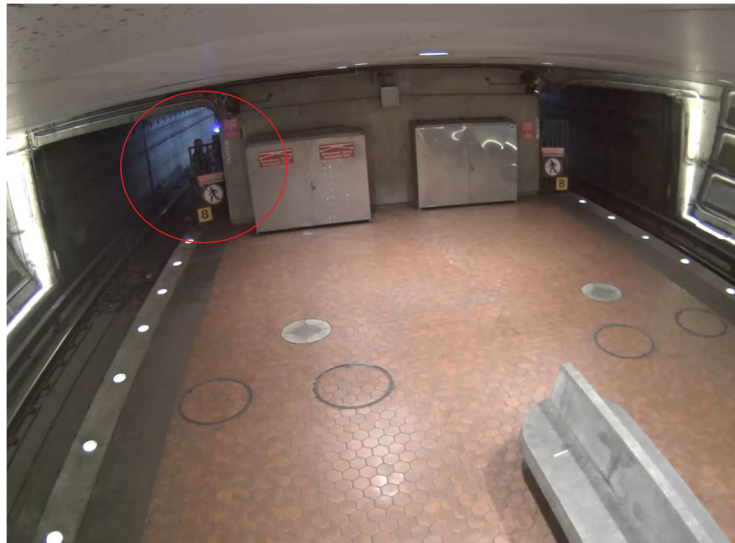
At 6:39 p.m., MTPD improperly de-energized third rail power using an Emergency Trip Station (ETS) box, which contains a button to push to de-energize power immediately in the event, for example, an individual falls onto the

Figure 3: MTPD K-9 Officer observed de-energizing the third-rail power via the ETS box at approximately 18:36 hours.

- The OEP Primary Responder stated he then went down to the lower-level with two MTPD Officers including the K-9 Officer. The OEP Primary Responder stated he observed the MTPD K-9 Officer walk down the far end of the platform and use the ETS box to de-energize the third-rail power. The OEP Primary Responder stated the MTPD K-9 Officer was not ordered to de-energize the third-rail power in this way.

- Due to this investigation
 - Completed
 - WMATA added to its Mandatory In-Service Retraining (MIR) plan for 2023 for MTPD Officers to include information on practices related to third rail power de-energization, including utilization of the ETS Box.

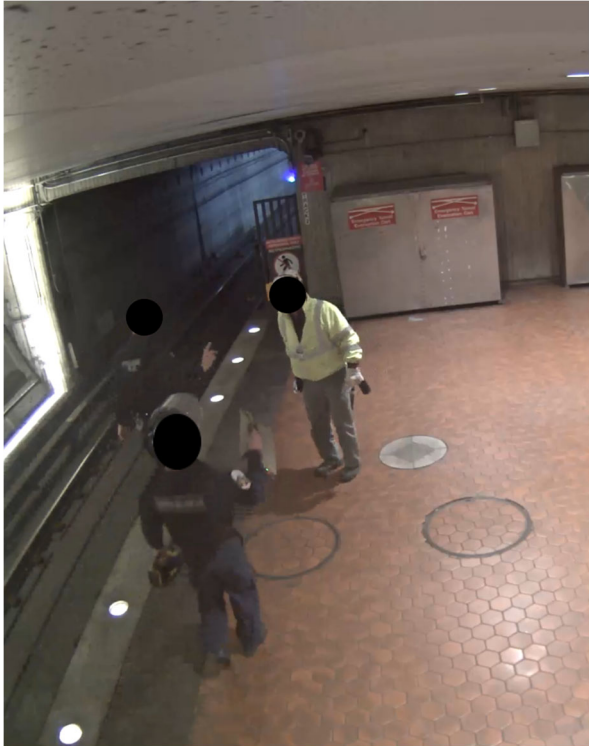
Figure 4: MPD EOD on scene at 18:42 hours.

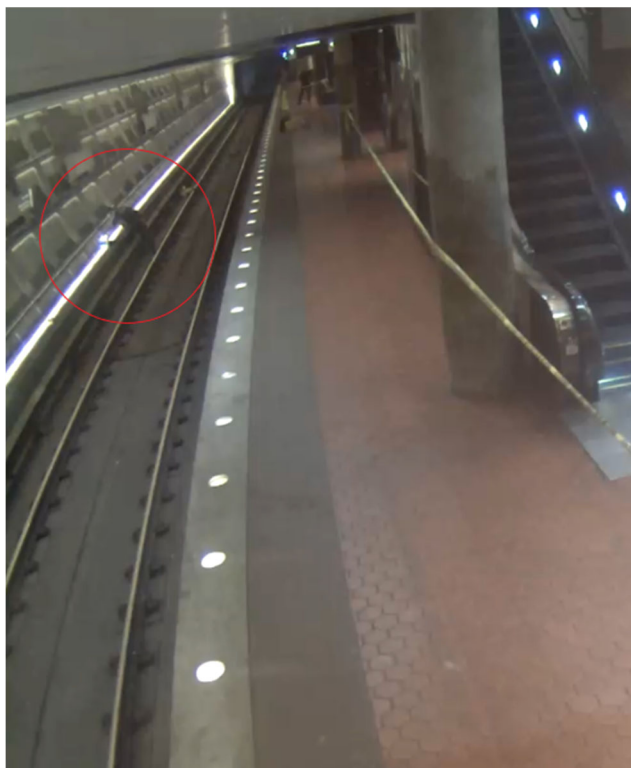
Figure 5: MPD EOD investigating at 18:44 hours.

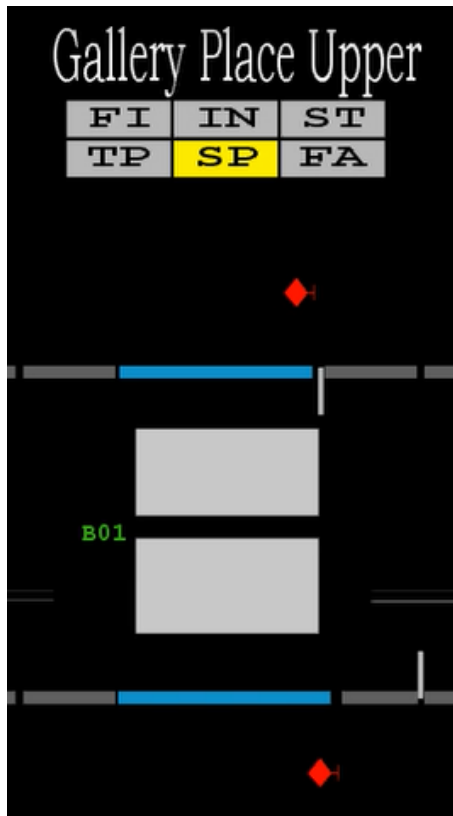
Figure 6: Upper level of Gallery Place Station commenced bypass instructions at 18:27 hours

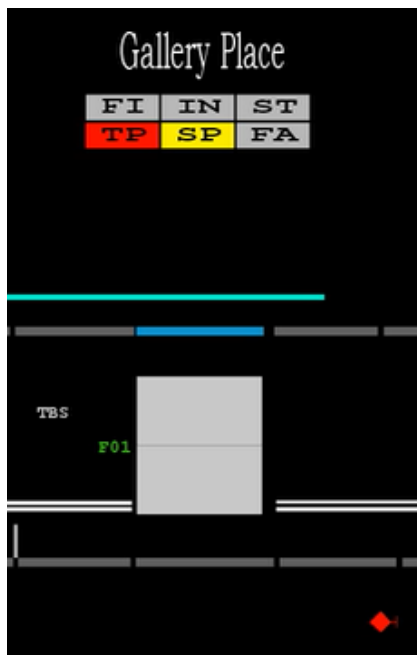
At 18:37 hours, power was de-energized from the lower level of Gallery Place Station, Track 2.

Figure 7: Power was de-energized to Gallery Place Station platform limits, Track 2 via ETS box at 18:37 hours.

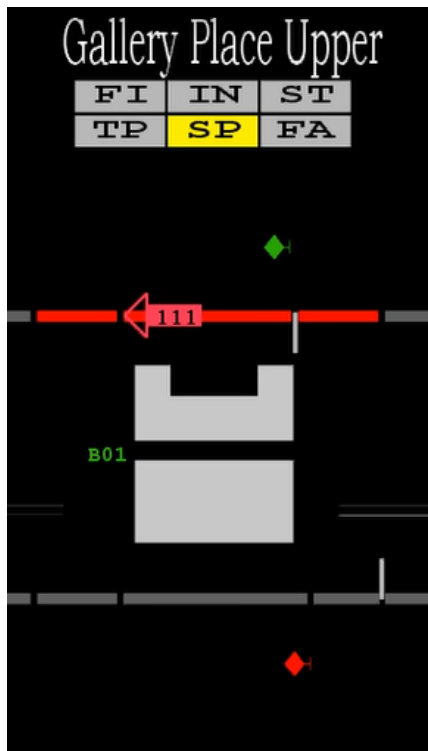
Figure 8: Service resumed on the Upper Level of Gallery Place Station at 18:47 hours.

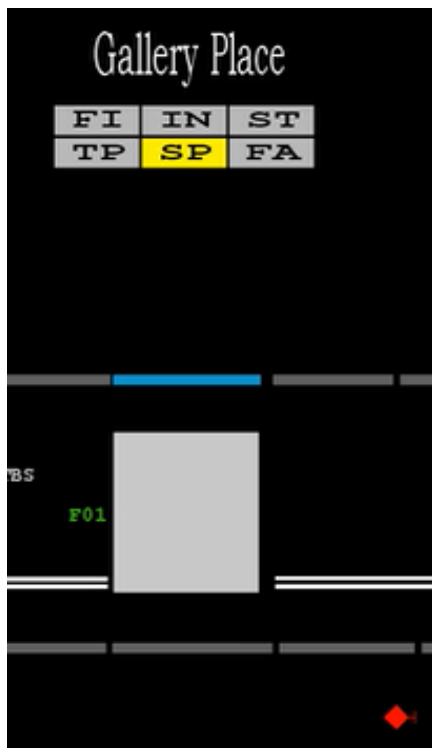
Figure 9: Power was restored to Gallery Place Station platform limits, Track 2 at 19:00 hours

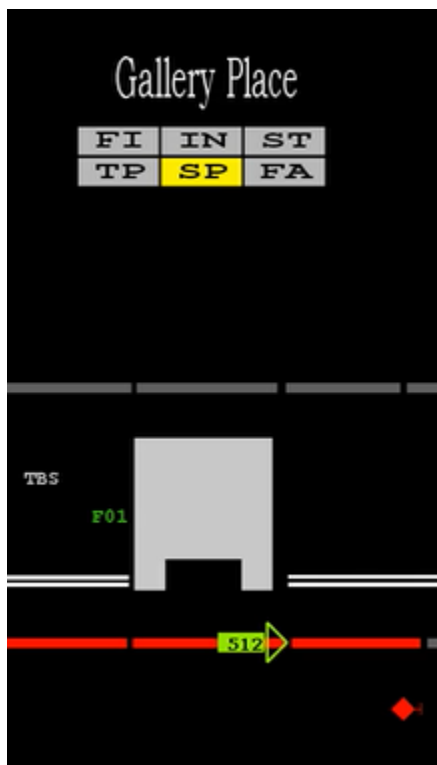
Figure 10: Normal service resumed at Gallery Place Station at 19:04 hours.
