WMSC Commissioner Brief: W-0215 – Evacuation for Life Safety Reasons – Benning Road Station – December 8, 2022

Washington Metropolitan Area Transit Authority
Department of Safety (SAFE)
Office of Safety Investigations (OSI)
FINAL REPORT OF INVESTIGATION E22797

Date of Event:	December 8, 2022
Type of Event:	Evacuation for Life Safety Reasons
Incident Time:	09:01 hours
Location:	Benning Road Station (Platform)
Time and How received by SAFE:	09:02 hours Mission Assurance Coordinator (MAC)
WMSC Notification Time:	09:10 hours
Responding Safety Officers:	WMATA: None WMSC: None Other: RTRA, PLNT
Rail Vehicle:	N/A
Injuries:	Three injuries
Damage:	None
Emergency Responders:	Metro Transit Police Department (MTPD), District of Columbia Fire and Emergency Medical Services (DCFEMS)
SMS I/A Incident Number:	20221208#104741

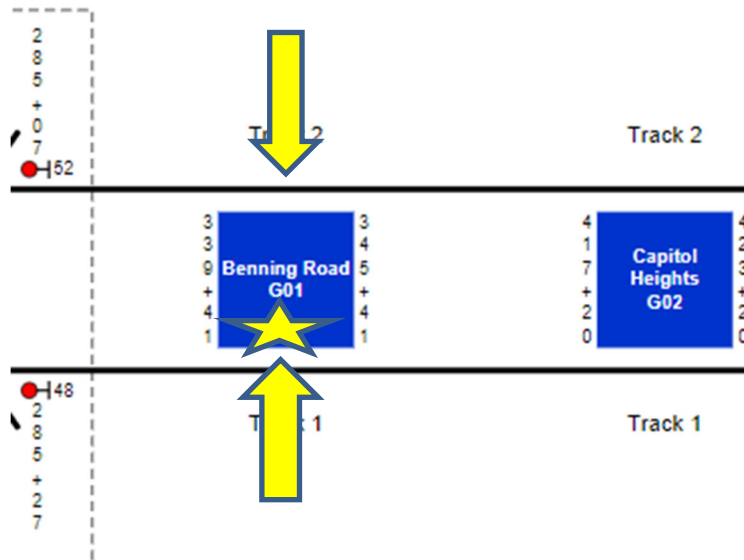
Field Sketch/Schematics

Benning Road Station, Platform
