## **WMSC Commissioner Brief: W-0169 – Serious Injury – Potomac Yard Station – March 2, 2022**

Washington Metro Area Transit Authority  
Department of Safety – Office of Safety Investigations (OSI)  
**FINAL REPORT OF INVESTIGATION A&I E22138**

# Potomac Yard Station – Serious Injury

March 2, 2022

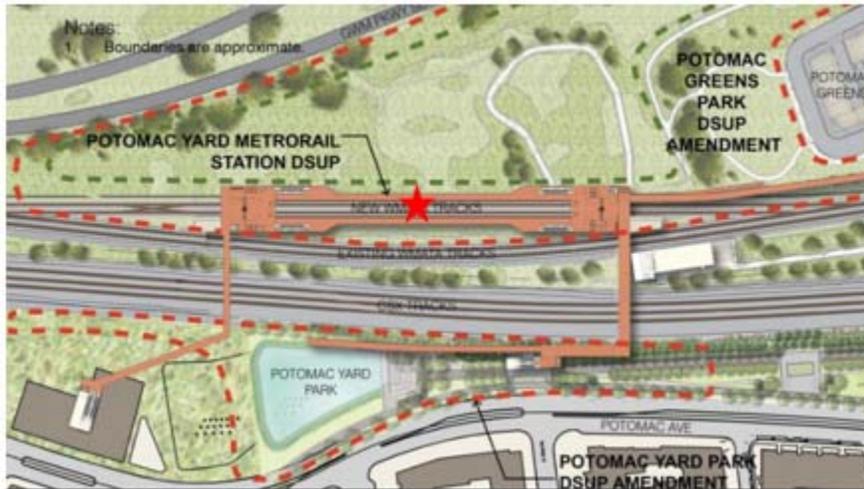
### **Field Sketch/Schematics**

The workers were installing skylights to the lower face of the canopy; they skipped two bays at the expansion joint, leaving them open. After installing the glass panels on the bottom row, Glazer #1 stepped up onto the first glass panel past the expansion joint to wait for the next piece of glass to be lifted from the crane. According to the statement from Glazer #1, while waiting for the next glass panel, they adjusted the rope connected to their vertical lifeline system and returned to fix a glass panel that had been installed. They returned to their previous position at the first glass panel past the expansion joint to wait for the next glass panel without re-adjusting the rope connected to their vertical lifeline system. While waiting for the glass panel, Glazer #1 stepped back into an open bay.

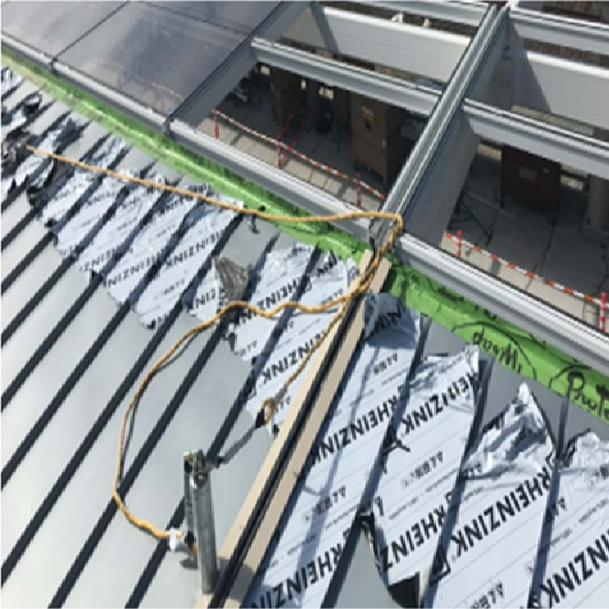
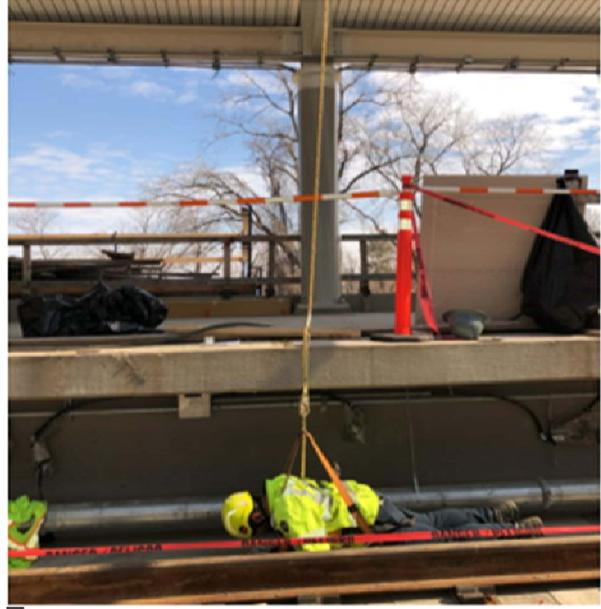
*Image 1 & 2 – Photo of the top of the canopy depicting the open bay and photo of the end state of the fall arrest system demonstrated by WMATA SAFE personnel.*

- The probable cause of the Serious Injury event at Potomac Yard Station on March 2, 2022, was the injured Glazer failed to re-adjust their personal fall arrest system when they returned to their initial location to wait for the crane to lift the next piece of glass panel. A contributing factor is the injured Glazer's lack of awareness to continually and properly adjust the fall arrest system to prevent contact with the ground. Additionally, the injured Glazer's complacency resulted in failure to recognize an opening (missing glass panel) behind their position before they stepped backward into an open bay.

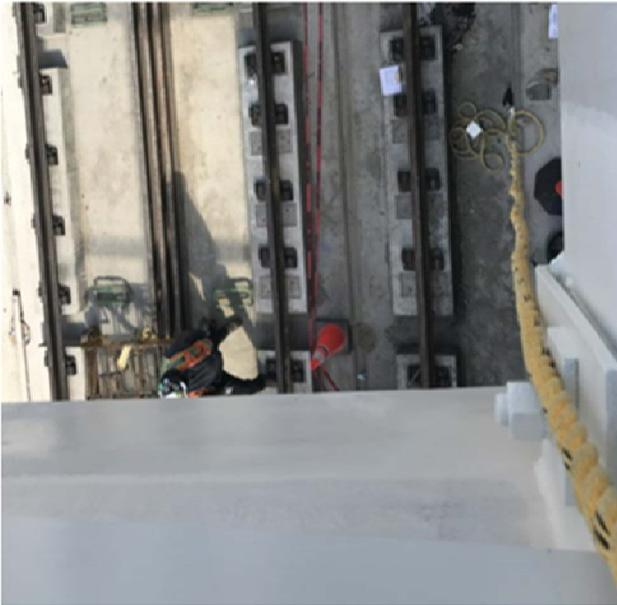
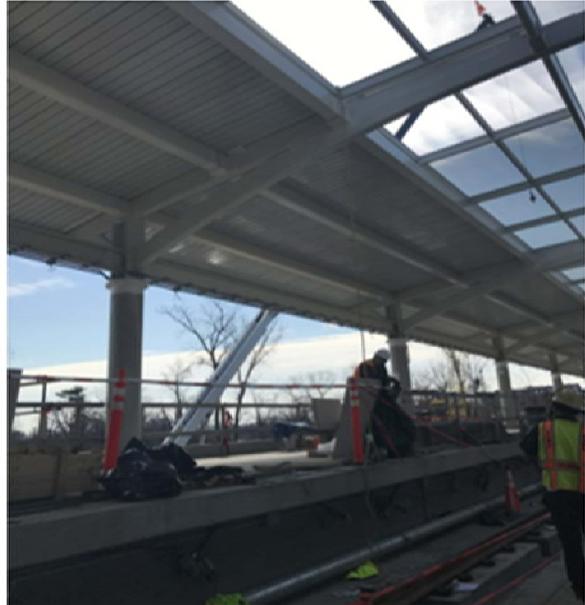
At approximately 09:35 hours, Glazer #1 fell from the canopy rooftop to the ground approximately twenty-two feet six inches (22' 6"), wearing all of their personal protective and fall protection equipment. Alexandria Fire Department and EMS were immediately contacted. At approximately 09:57 hours, the Alexandria Fire Department contacted the FLO located in the ROCC and reported the injury. At approximately 10:00 hours, OSCE Manager was dispatched to the incident site. OEP dispatched the Response and Recovery Coordinator, and at approximately 10:20 hours, OSI dispatched a Safety Investigator. Alexandria Fire Department M-206 responded to Potomac Yard Metrorail Station, provided medical assistance to Glazer #1, and transported them to George Washington University Hospital. Glazer #1 suffered a concussion, broken leg, fractured shoulder, and facial lacerations. The work at the construction site at Potomac Yard Metrorail Station was stopped, and the area where the injury occurred was cordoned off.

*Image 3 & 4 – View of the area where the fall occurred and view from the ground looking up to the area where the fall occurred*

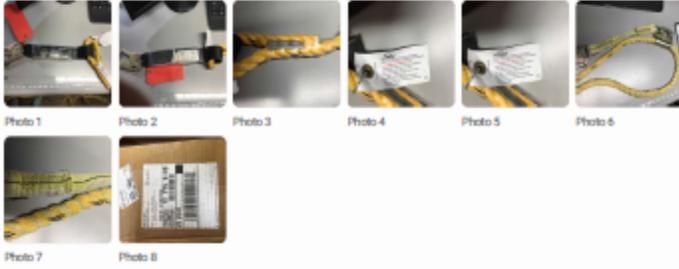
On April 22, 2022, VOSH investigated the incident and determined that no citations would be issued to WMATA, PYC and Linel, LLC. SCIC was cited under inspection number 151319.015 for \$600.00. The Guardian Inspection Report determined that the vertical lifeline passed inspection, worked, and functioned properly and noted that the rope was worn out.

VLL works properly, is functional  
rope worn out
