**WMSC Commissioner Brief: W-0217 – Red Signal Overrun, Improper Movement – Smithsonian Station – December 6, 2022**

Washington Metropolitan Area Transit Authority
Department of Safety (SAFE)
Office of Safety Investigations (OSI)
FINAL REPORT OF INVESTIGATION A&I E22793

Date of Event:	December 6, 2022
Type of Event:	Red Signal Overrun
Incident Time:	18:52 hours
Location:	Smithsonian Station, track 2 – Signal D02-08
Time and How received by SAFE:	19:03 hours, Mission Assurance Coordinator (MAC)
WMSC Notification Time:	19:21 hours
Responding Safety Officers:	Office of Safety Investigations (OSI)
Rail Vehicle:	Train ID 607 L3163-3162x3101-3100x3034-3035T
Injuries:	None
Damage:	None
SMS I/A Incident Number:	20221206#104683MX

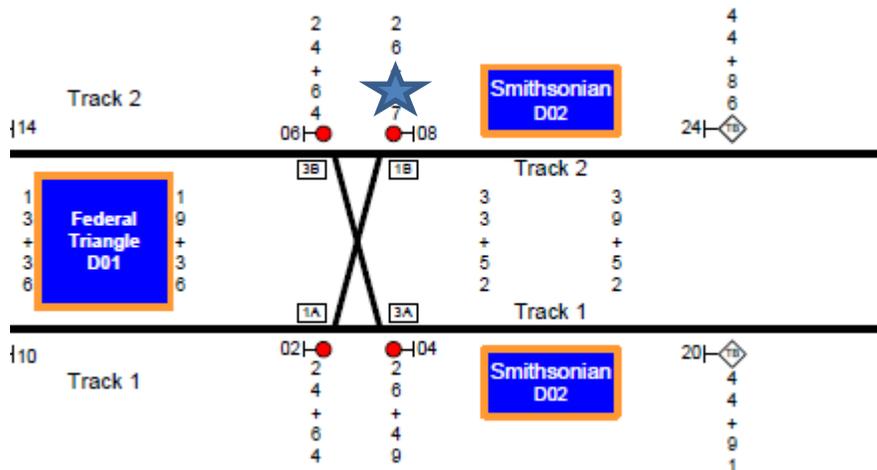
Field Sketch/Schematics

Smithsonian Station, Track 2 – Signal D02-08

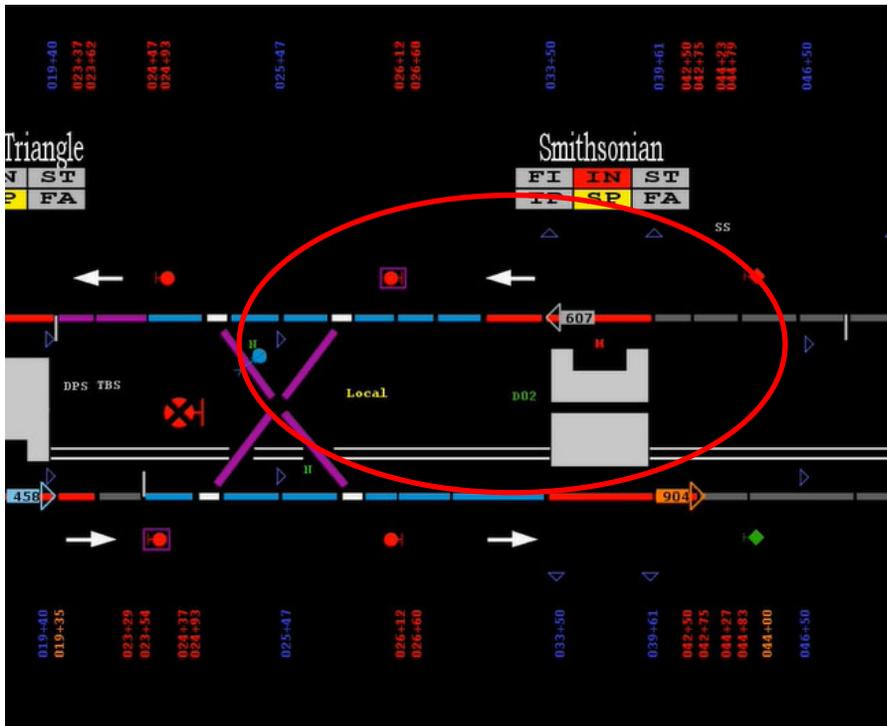
Figure 2 – Train ID 607 on the platform at Smithsonian and D02-08 signal is red.

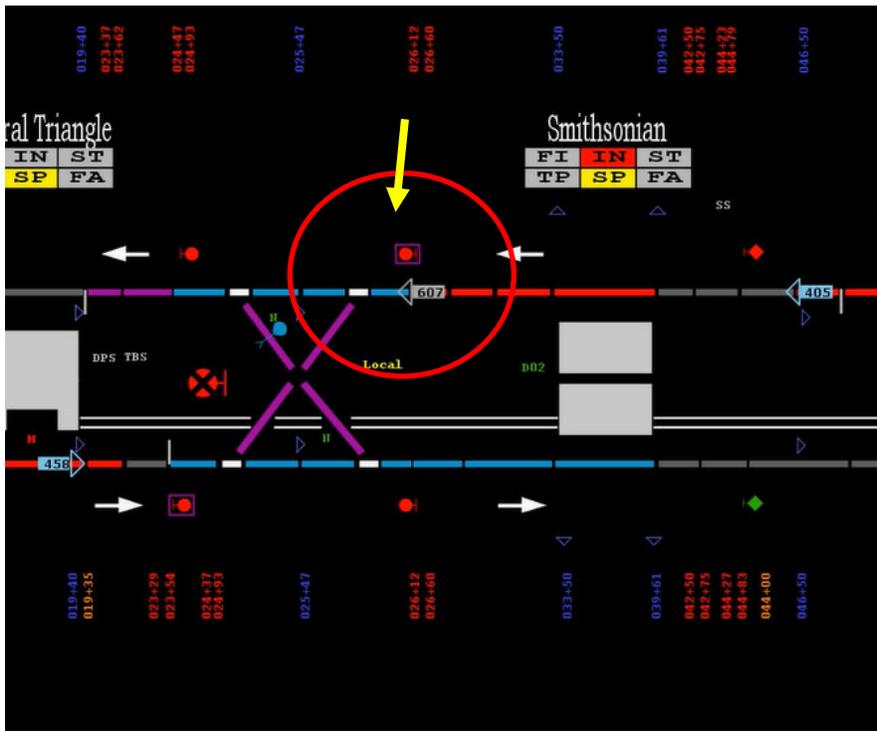
Figure 3 – Train ID 607 passing D02-08 signal red

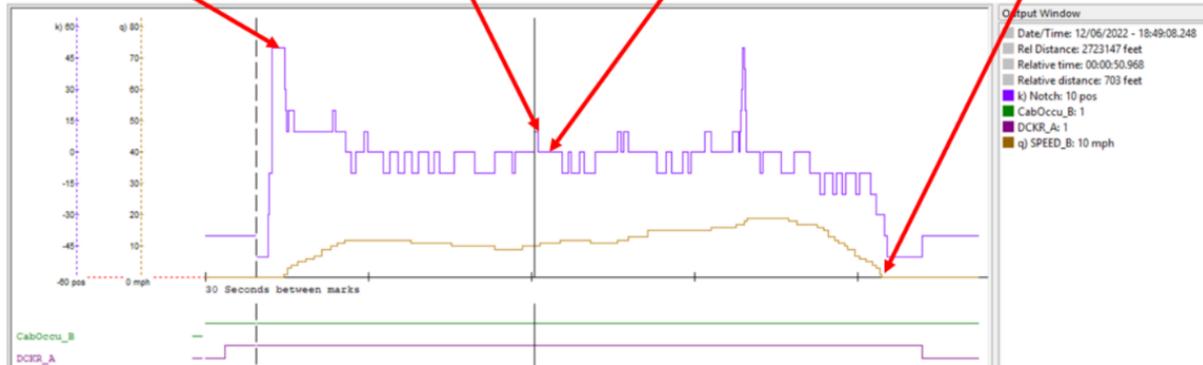
18:49:09 Master Controller was placed on Coast. Train 607 was traveling at 10 mph and continued towards Federal Triangle Station after it overran D02-08

Figure 4 – E/R Data

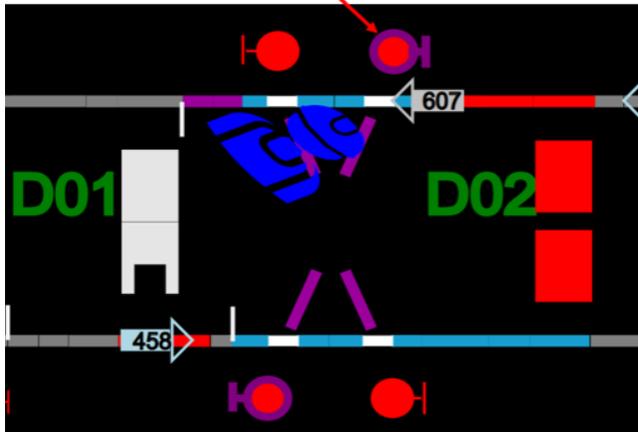
Signal D02-08 was read at the time of the incident, based on AIM Playback.

Figure 5 – Signal D02-08 Red as Train ID 607 passed

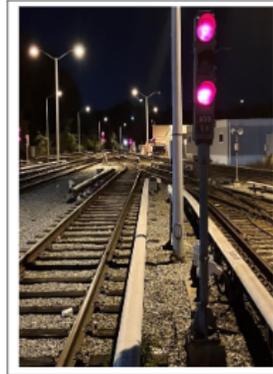
A99-118 Signal

What happened...	What should have happened...
The Yard Operator failed to contact the Interlocking Operator and inform them they were holding at A99-118 signal red.	Operators should be governed by GR 1.79 and establish clear two-way communication before moving a train.
The Yard Operator failed to stop immediately and notify the Interlocking Operator when the train passed signal A99-118 red.	Operators must stop immediately and notify the Interlocking Operator when overrunning a red signal and going over a misaligned switch in a rail yard.
The operator left the platform without permission from the Terminal Supervisor.	Operators must not depart from the platform without permission from the Terminal Supervisor along with a lunar, correct rail alignment and speed commands.
