**WMSC Commissioner Brief: W-0218 – Collision – New Carrollton Rail Yard – January 11, 2023**

FINAL REPORT OF INVESTIGATION A&I E23022

New Carrollton Yard – Collision

January 11, 2023

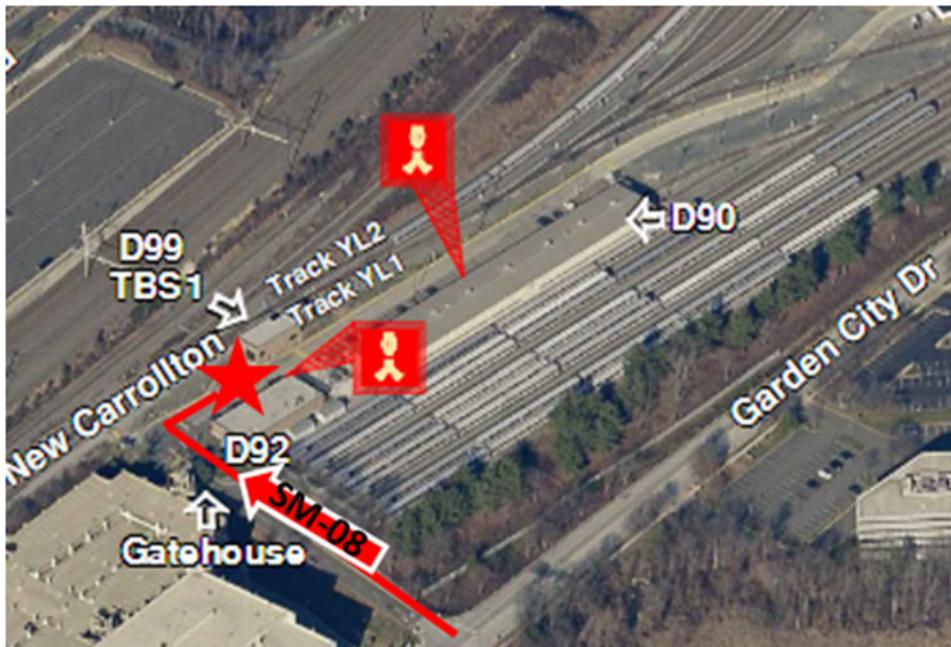
Field Sketch/Schematics

New Carrollton Rail Yard – In front of Building A

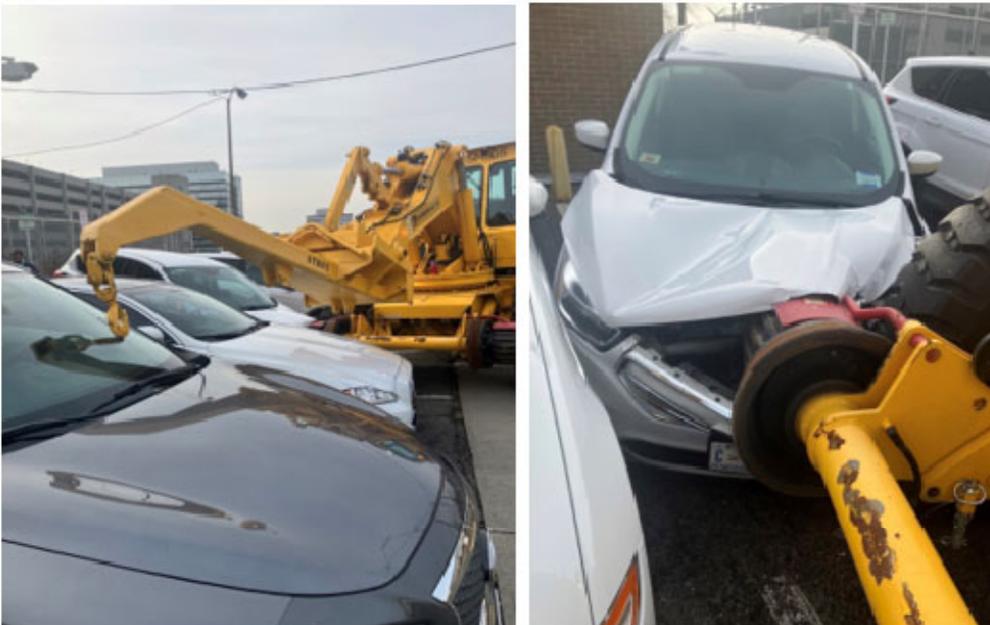
Image 1 – Images from the event involving SM-08.

The Closed-Circuit Television (CCTV) revealed that at 09:10 hours, SM-08 was offloaded onto Garden City Drive and entered New Carrollton Rail Yard. The unit did not appear to be moving at an excessive rate of speed. As the unit completed a right turn around a curve, SM-08 collided with a WMATA owned vehicle (28516) and ultimately contacted two other personally owned vehicles.

SM-08 sustained scratches and paint transfer due to the event. The unit was moved to the CTEM building where it was removed from service for post- incident inspection. WMATA vehicle 28516 sustained damage to the front and driver side resulting in the vehicle being towed to a local body shop for repairs. WMATA Employee Personal Vehicle #1 sustained damage to the driver side, was fully operational and moved by the employee. WMATA Employee Personal Vehicle #2 did not sustain any damage, was fully operational and moved by the employee.

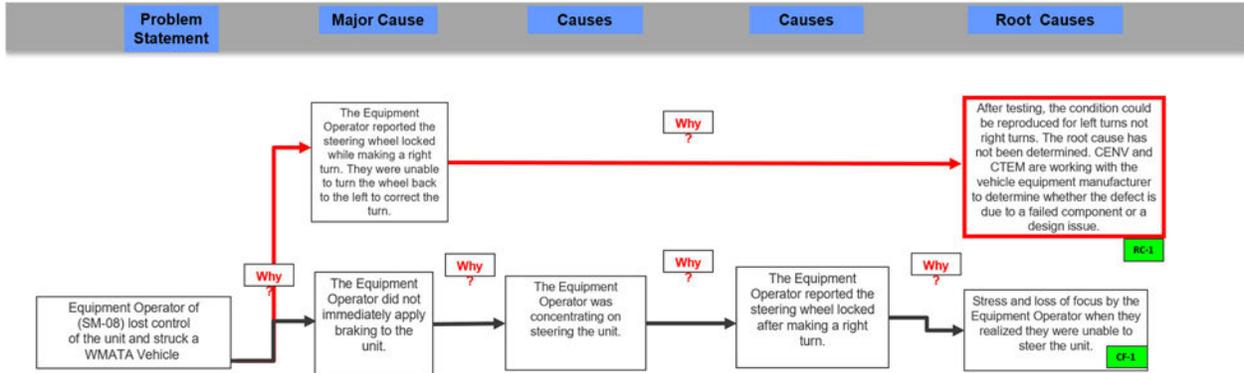
Appendix E - Root Cause Analysis

The probable cause of the Collision event on January 11, 2023, was a mechanical failure when SM-08 wheels locked in a turning position. A Contributing Factor was the delayed application of braking by the Operator. An additional contributing factor was an erroneous end-of-stroke detected by the steering relief valve limiting hydraulic flow to the steering cylinder.

Corrective Action Code	Description	Responsible Party	Estimated Completion Date
105436_SAFE CAPS_OPMS _001	Equipment Operator to attend re-training on Swing Master operations.	OPMS	Completed
105436_SAFE CAPS_CENV _001	Provide root cause and corrective action plan upon completion of testing and analysis of equipment by the Original Equipment Manufacturer.	CENV/CMNT	09/30/2023
105436_SAFE CAPS_CENV _002	Identified Swing Master units to remain out of service until the evaluation and any corrective action(s) is/are completed.	CENV/CMNT	Ongoing
