WMSC Commissioner Brief: W-0219 – Collision – Alexandria Rail Yard – January 7, 2023

Washington Metropolitan Area Transit Authority
Department of Safety (SAFE)
Office of Safety Investigations (OSI)
FINAL REPORT OF INVESTIGATION A&I E23018

Alexandria Rail Yard – Collision

January 7, 2023

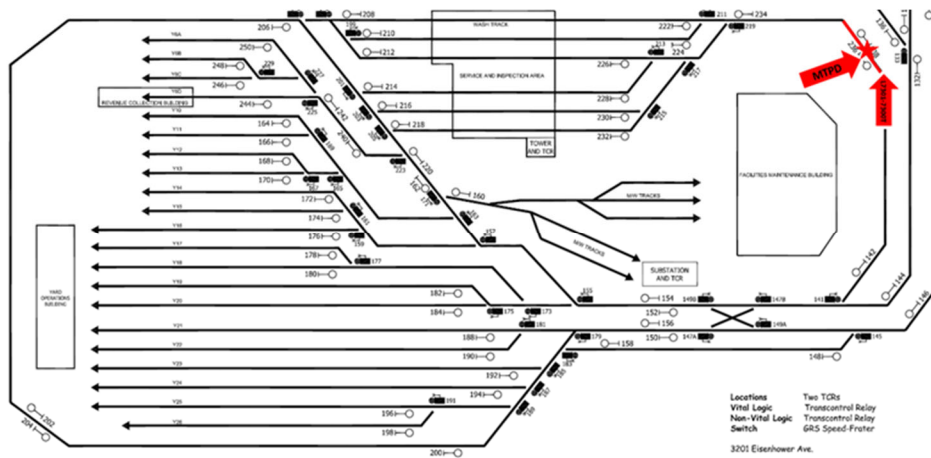
Field Sketch/Schematics

Locations are approximate. Not to scale.

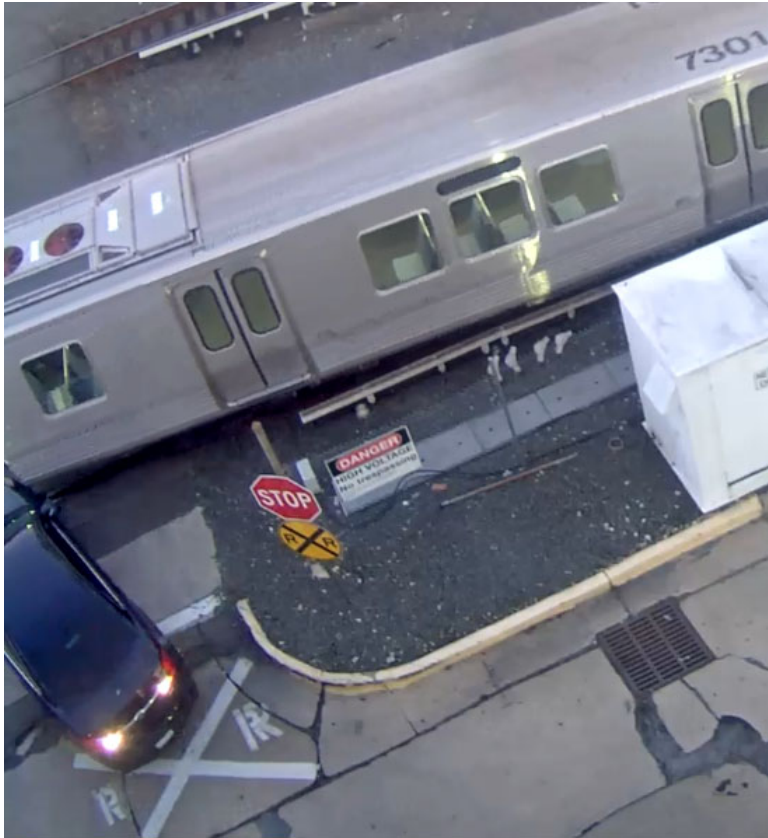
As the train entered the grade crossing, the MTPD Detective proceeded into the crossing as well. The MTPD vehicle's front passenger-side bumper collided with the front corner of rail car 7301, causing damage.

Image 1 – Collision between MTPD passenger vehicle and rail car 7301.

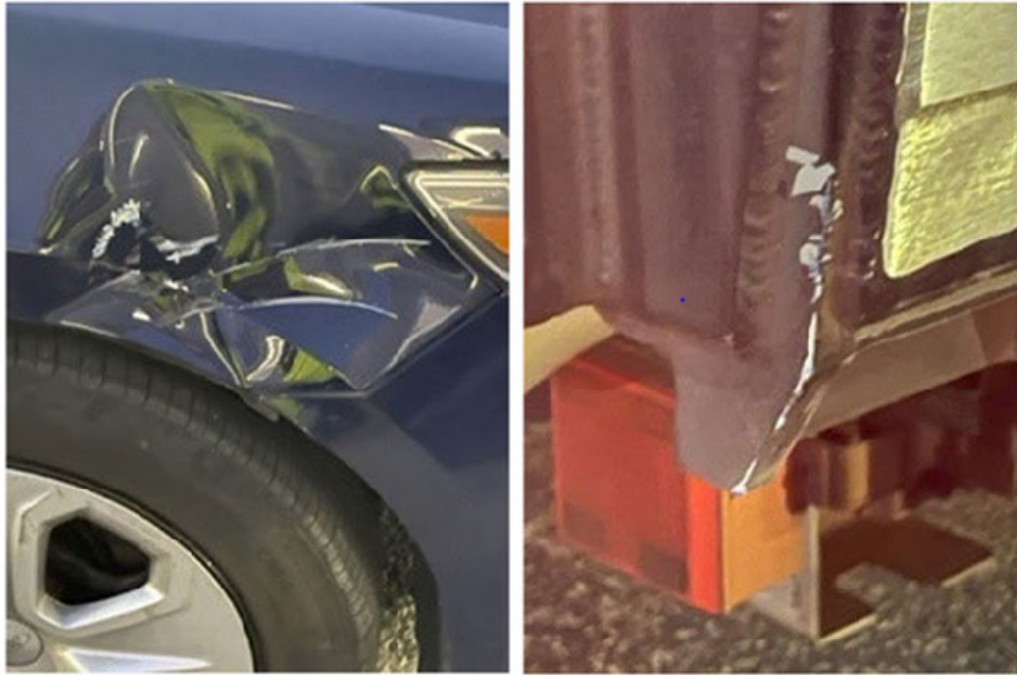
Image 2 – Vehicle damage to MTPD passenger vehicle and rail car 7301.

CMNT performed a body and under car inspection on rail car 7301 and determined no damage to the under car was reported. Body damage included a light scrape. No wheel flats were noted, the rail car was cleared to return for service.

The Office of Service Vehicle Maintenance and Equipment (SVMT) performed an inspection of MTPD vehicle SV026661 and reported that the right side front fender needed to be replaced. The material cost of the repair was \$381.33. The vehicle is in operational status.

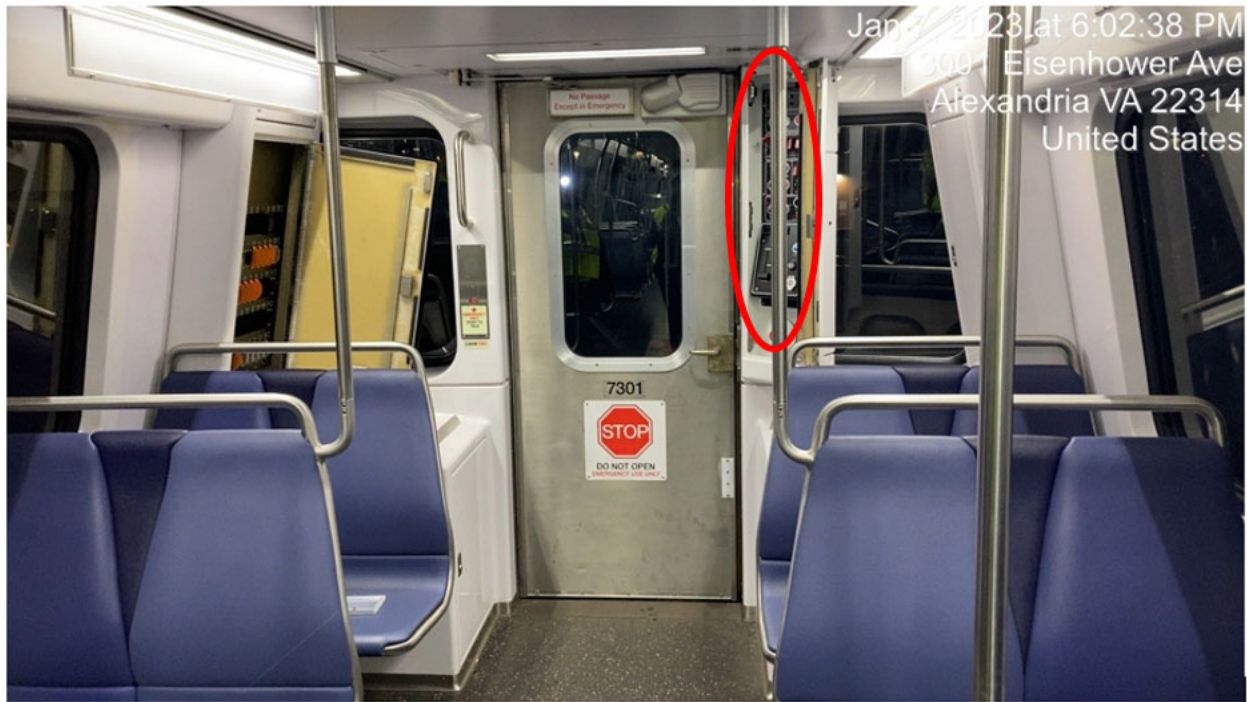
There are blind spots and reduced visibility for operators utilizing a “B” Car to move via the Hostler Panel, but that did not appear to contribute to this collision.

¹ The B Car uniquely contains the Battery, and instead of the cab, the B Car has a secured Hostler Panel (HSTP) integrated into the collision post area of the Front-end doorway. The HSTP allows an Operator to safely couple/uncouple cars and make car moves in the yard and shop.

Image 3 – Hostler Panel located on rail car 7301, facing the direction of travel. Note panel door open to the left of the image and lack of side cab window, limiting the Operator's view to the immediate front/side of the train.

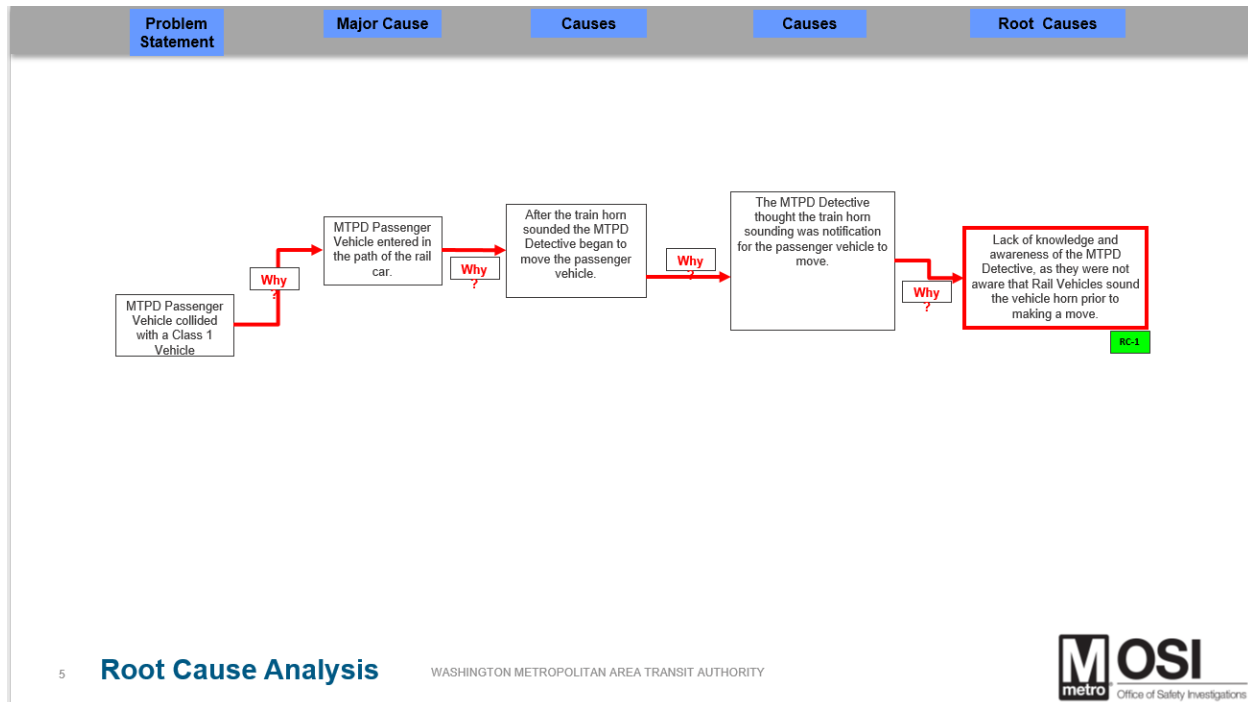
Appendix C - Root Cause Analysis

The probable cause of the collision at Alexandria Yard on January 7, 2023, was the lack of knowledge and awareness of the MTPD Detective, as they were not aware that Rail Vehicles sound the vehicle horn prior to making a move.

Corrective Action Code	Description	Responsible Party	Estimated Completion Date
105349_SAFE CAPS_MTPD_001	Mandatory In-Service Training Program for Officers will incorporate that the activation of a train horn from a non-moving train can be an indication of possible train movement. And that train movement should be expected in any direction at any time.	MTPD	Completed
105349_SAFE CAPS_SAFE_002	Work with the Office of Safety Risk Management and or Office of Operating Practices to develop signage to be placed at all rail yard crossings that will advise motor vehicle drivers to be on the lookout for train movement at all time and in any direction with an emphasis on horn activation may be an indication of possible train movement.	SAFE	9/30/2023
