WMSC Commissioner Brief: W-0222 – Evacuation for Life Safety Reasons – Gallery Place-Chinatown Station – January 19, 2023

Washington Metropolitan Area Transit Authority
Department of Safety (SAFE)
Office of Safety Investigations (OSI)
FINAL REPORT OF INVESTIGATION A&I E23039

Gallery Place Station – Evacuation for Life Safety Reasons
January 19, 2023

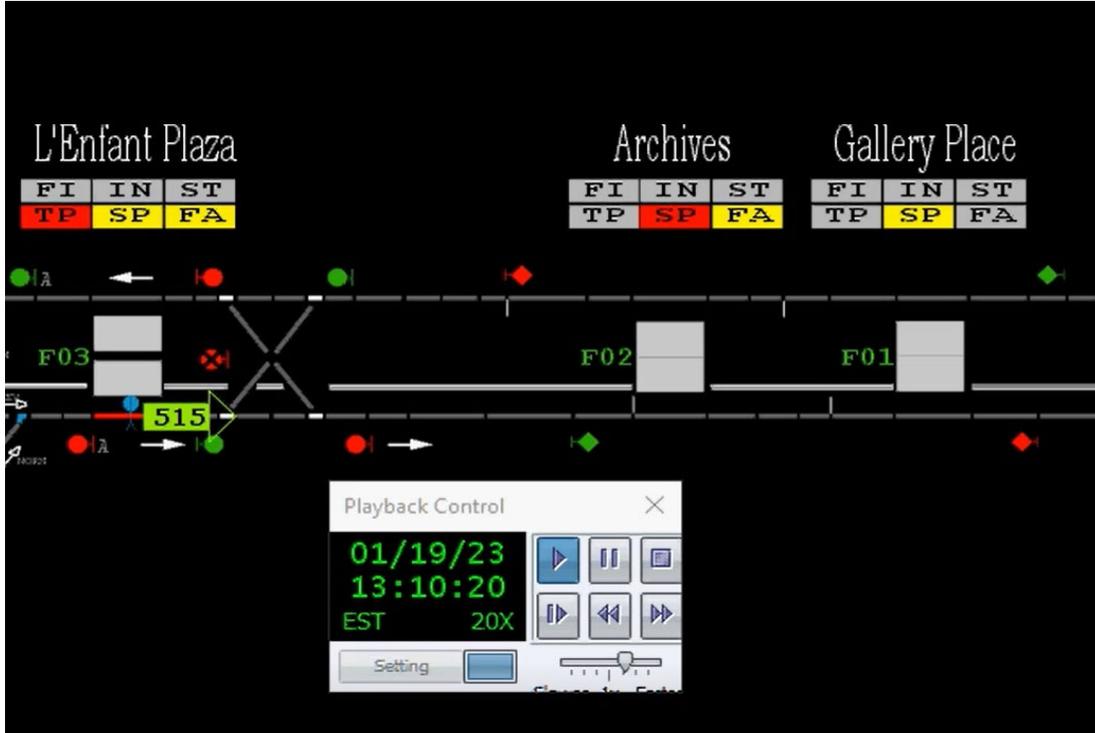
Image 1 - Train ID 515 arrived at L'Enfant Plaza Station, Track 1 at 13:10 hours. Train ID 515 was the first train to be turned back onto Track 2.

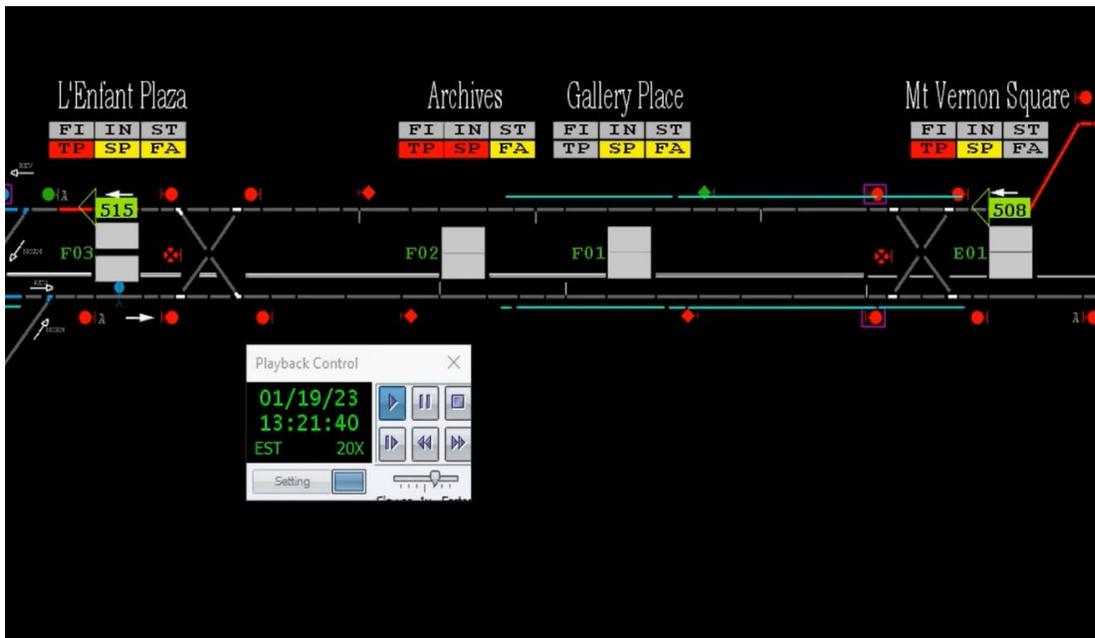
Image 2 - Train ID 515 was rerouted to L'Enfant Plaza Station, Track 2 at 13:21 hours.

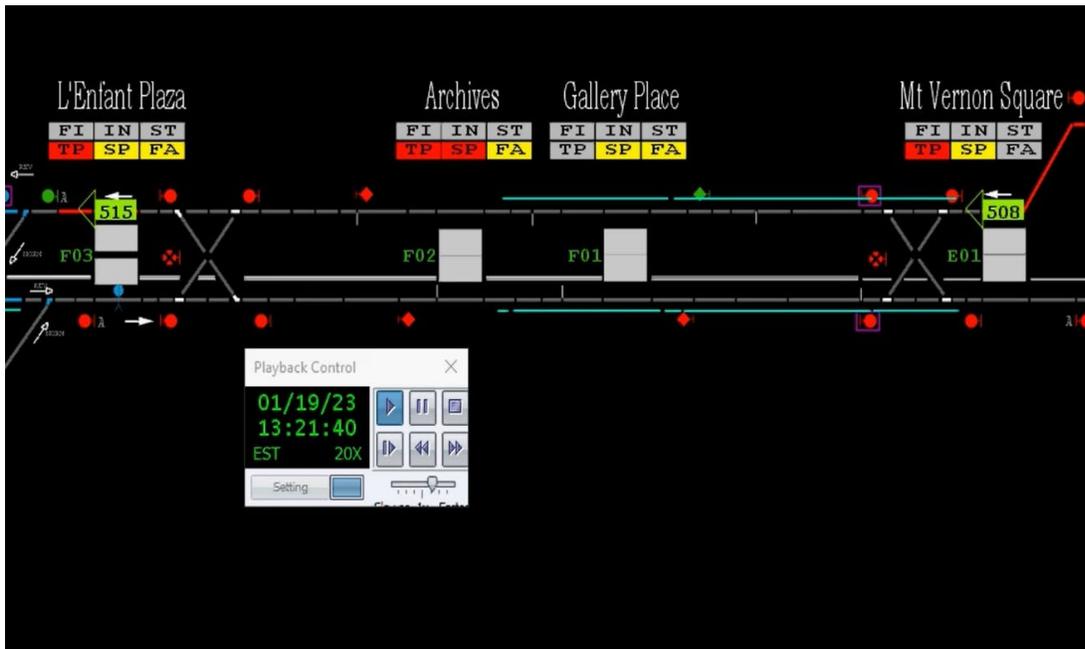
Image 3 – Third rail power was de-energized between Gallery Place and Mount Vernon Square Stations on Track 1 and Track 2 at 13:21 hours.

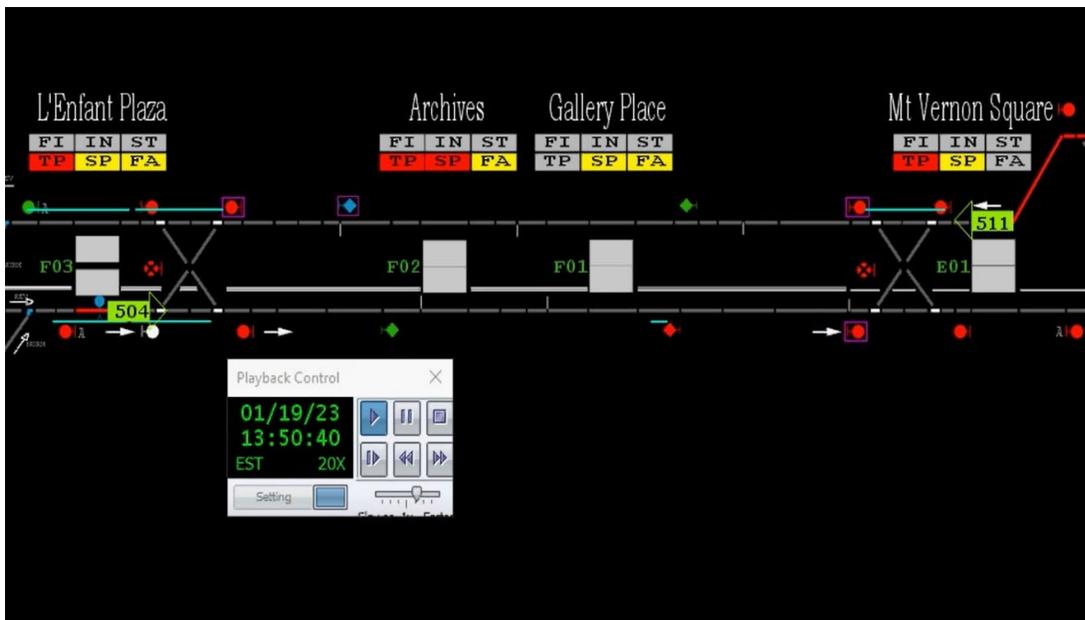
Image 4 – Third rail power was energized between Gallery Place and Mount Vernon Square Stations on Track 1 and Track 2 at 13:50 hours.

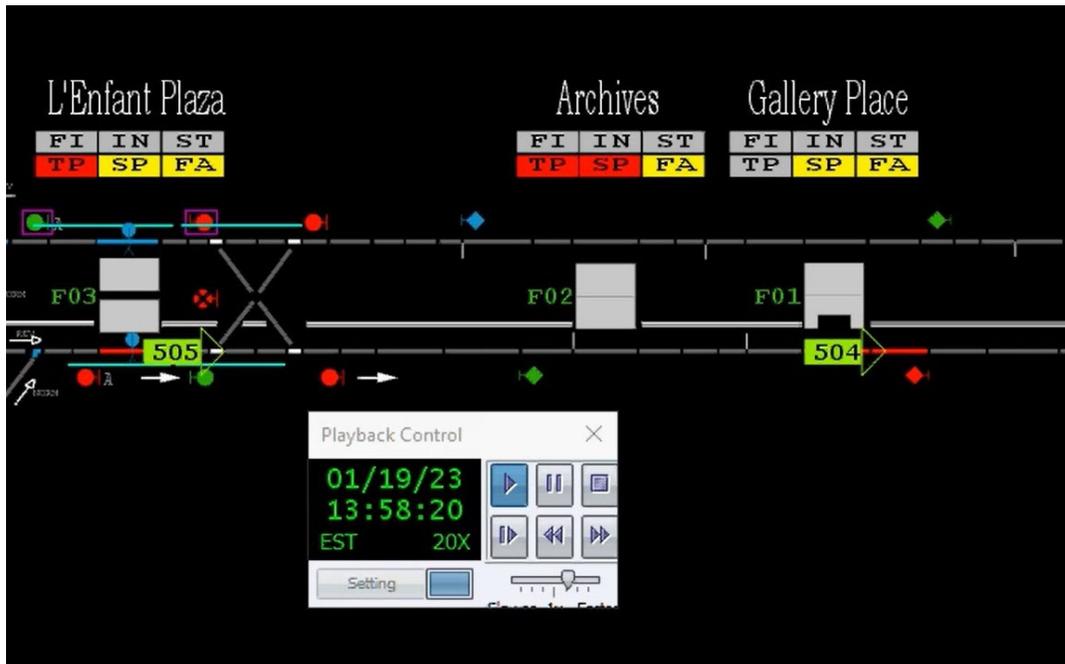
Image 5 – Train ID 504 was the first train to service Gallery Place Station, Track 1 at 13:58 hours.
