WMSC Commissioner Brief: W-0224 – Serious Injury – Medical Center Station – May 18, 2022

FINAL REPORT OF INVESTIGATION A&I E22327

Medical Center Station – Serious Injury

May 18, 2022

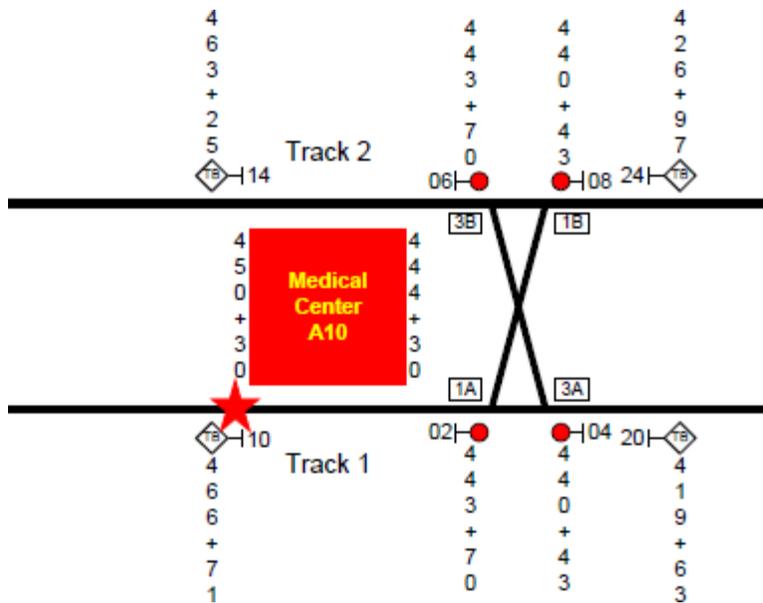
Field Sketch/Schematics

On May 18, 2022, at approximately 05:13 hours, a Traction Power Maintenance (TRPM) High Voltage Mechanic reported an injury to their Supervisor after leaving the work site. The TRPM Mechanic stated that while they were walking beyond the end gate at Medical Center Station, track 1, descending the stairs to enter the Tie Breaker Room they mis-stepped, causing injury to their right ankle. The TRPM Mechanic did not immediately report their injury and continued to work. After completing their work duties, which was to switch down power for the third rail and restore power once the work on the wayside was completed, the TRPM Mechanic left the work site and went home for self-treatment.

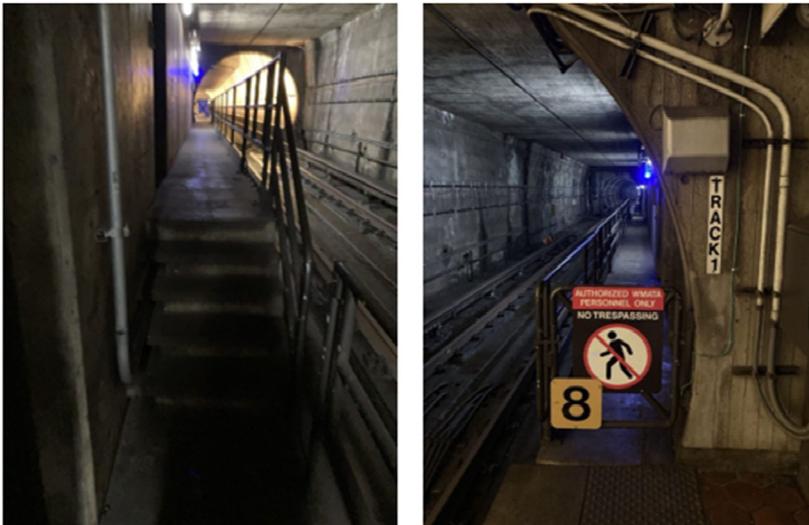
The investigation of the incident on May 18, 2022, at approximately 05:13 hours was a result of an employee who sustained an injury to his right foot. Due to the delayed reporting of the event, the investigation was not initiated until several weeks afterwards. The incident site was inspected by a Safety Investigator. The stairs were found in good condition, with a handrail and non-slip material installed. Lighting conditions were adequate at the time of the inspection. In addition, personnel are required to carry a flashlight while entering the rail right-of-way, which would aid with lighting. Following the event, additional lighting was installed in the area of the stairs as part of SMNT’s response to FTA Corrective Action Plan 15-130 (Tunnel Lighting Improvement).

Image 1 – Image of incident location.

- The TRPM Mechanic did not report the injury immediately to their RWIC or Supervisor while on duty.
- The TRPM Mechanic left the work site and self-transported to their residence before the end of their shift.
- Lighting and stair conditions were found to be adequate and in good condition.

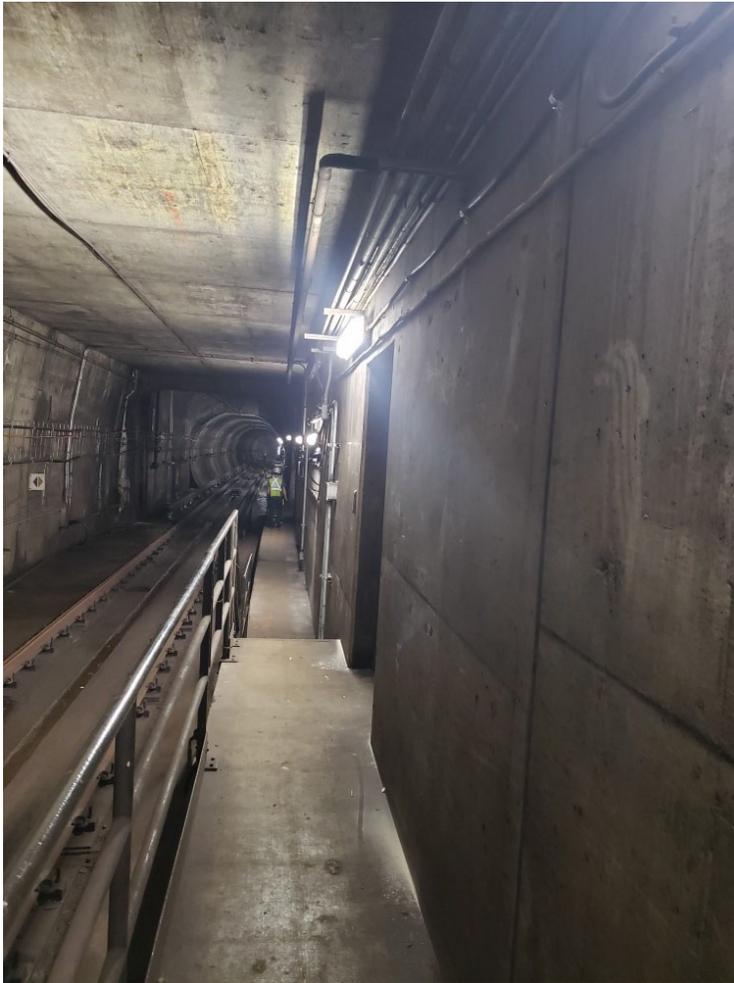
Figure 3 - New Lighting Installation at Medical Center Track 1

Due to other corrective action plans, Metrorail improved lighting in the area of the stairs after this event. Metrorail is nearing completion of this system-wide lighting improvement.

Corrective Action Code	Description	Responsible Party	Estimated Completion Date
100416_SAFE CAPS_SMNT_ 001	Complete tunnel lighting installation project in compliance with FTA Corrective Action Plan 15-130. Status as of 3/13/2023 is 98% complete.	SMNT SRC	4/30/2023
100416_SAFE CAPS_SMNT_ 002	Install additional lighting at event site to bolster visibility at the stairs.	SMNT SRC	Completed

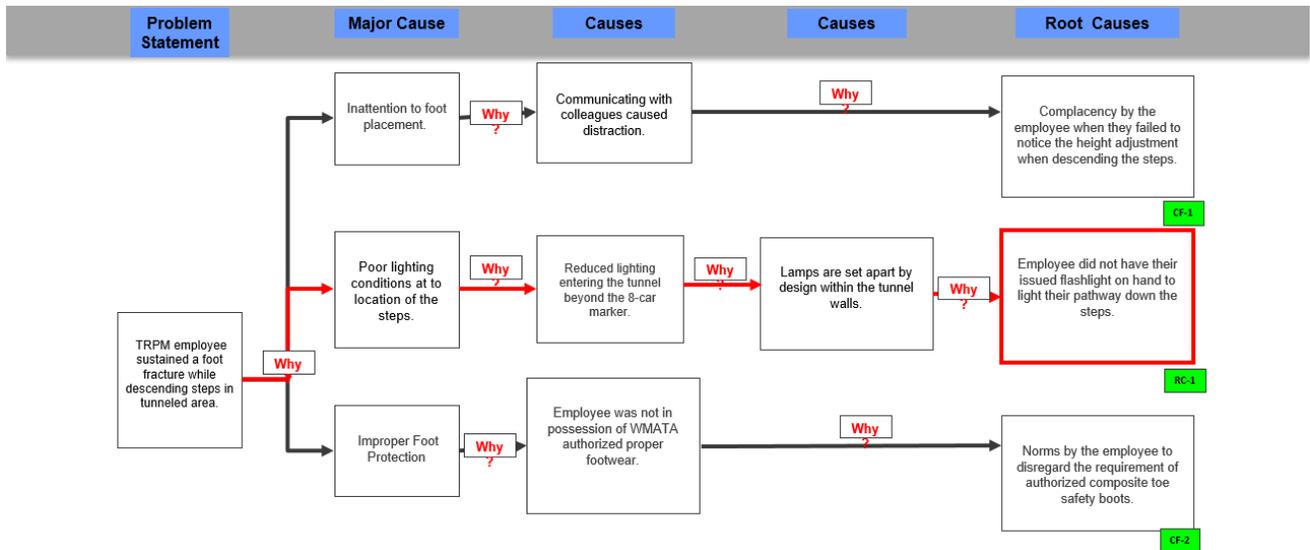
Appendix D – Root Cause Analysis

The probable cause of the Serious Injury event at the Medical Center Station on May 18, 2022, was a human factors error by the TRPM Mechanic when they did not properly secure their footing while descending the stairway.
