WMSC Commissioner Brief: W-0226 – Serious Injury – Braddock Road Station – June 26, 2022

FINAL REPORT OF INVESTIGATION A&I E22399

Date of Event:	June 26, 2022
Type of Event:	Serious Injury
Incident Time:	00:36 hours
Location:	CSX Property adjacent to Chain Marker C2 530+00 Braddock Road, Track 2
Time and how received by SAFE:	02:12 Hours
WMSC Notification Time:	02:32 Hours
Responding Safety Officers:	WMATA: Yes WMSC: None Other: None
Rail Vehicle:	N/A
Injuries:	Complaint of Injury
Damage:	No
Emergency Responders:	Alexandria Fire Department, Metro Transit Police Department (MTPD), Office of Rail Transportation (RTRA) Track and Structures (TRST), Office of Emergency Preparedness (OEP)
SMS I/A Number	20220626#101206MX

Braddock Road Station – Serious Injury

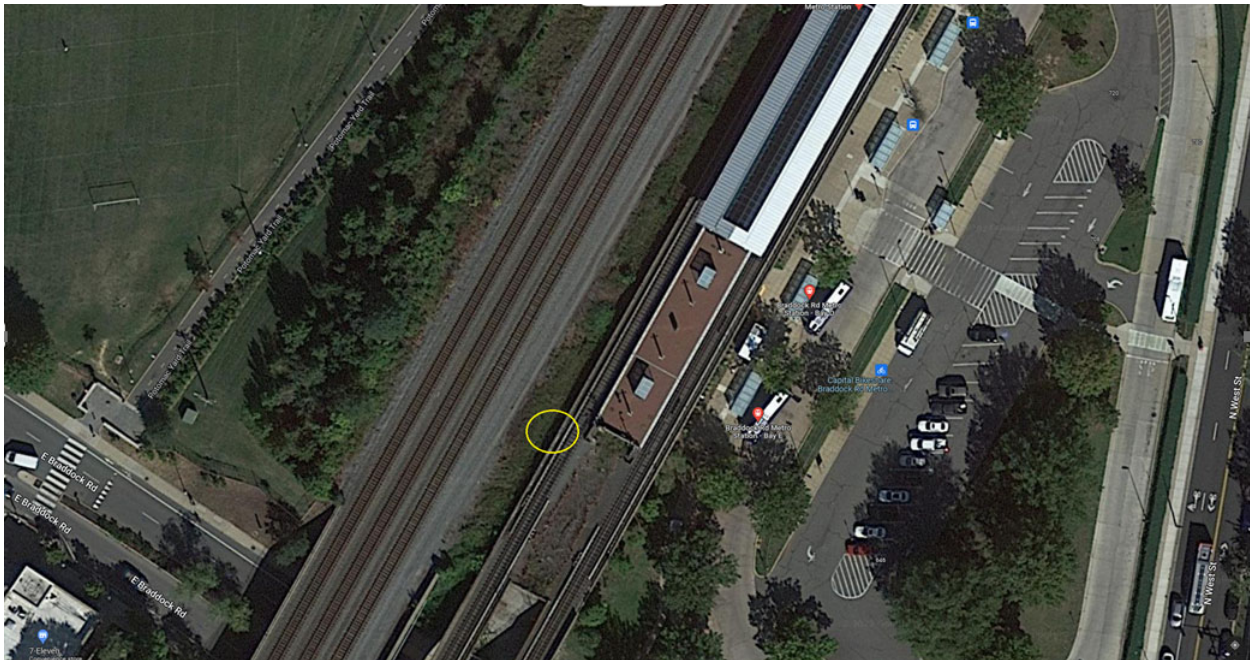
Figure 1: Approximate Location of the Fall on CSX Property

At approximately 01:21 hours, MTPD advised the missing individual was located on the CSX roadway, having fallen approximately “eight feet” from the dividing wall separating the WMATA roadway from the CSX roadway. At approximately 01:25 hours, MTPD advised that officers on scene were unable to lift the customer back over onto WMATA property and that the customer was complaining of back pain. MTPD also advised Alexandria Fire Department was en route to the scene for the extrication. At approximately 01:27 hours, MTPD advised the customer had climbed over the wall near Chain Marker (CM) C2 530+00.

**Approximate location of event. Not to scale.*
