**WMSC Commissioner Brief: W-0227 – Evacuation for Life Safety Reasons – Rosslyn Station – February 8, 2023**

Washington Metropolitan Area Transit Authority  
Department of Safety (SAFE)  
Office of Safety Investigations (OSI)  
**FINAL REPORT OF INVESTIGATION A&I E23088**

## Rosslyn Station – Evacuation for Life Safety Reason

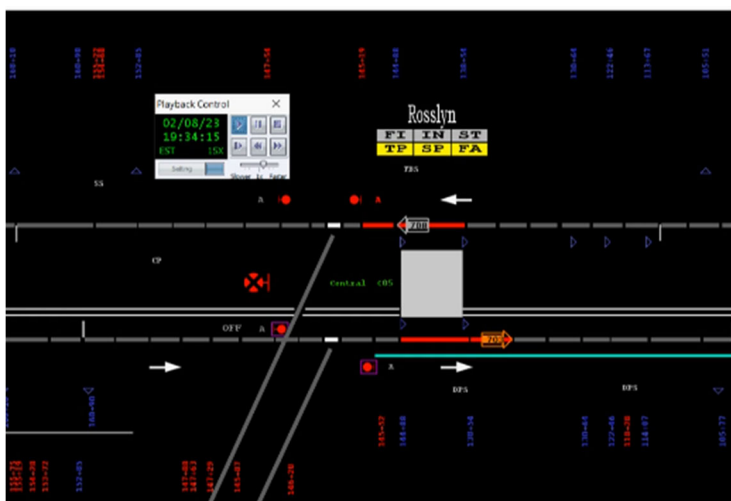
Figure 1: This image shows when third rail power was initially de-energized.

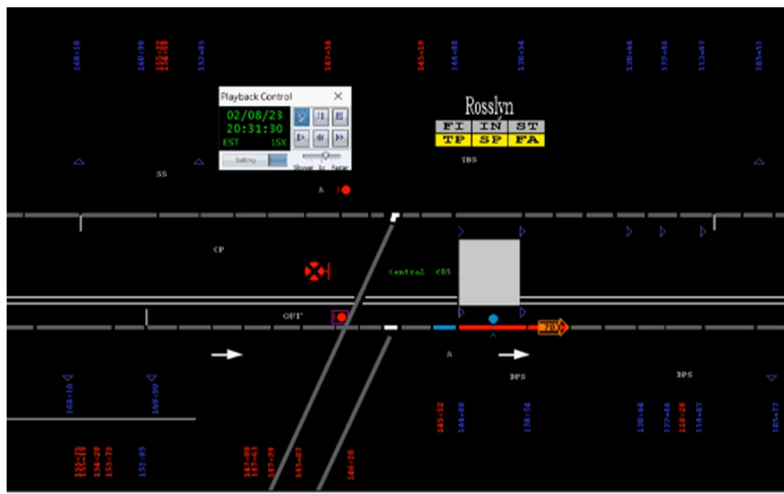
Figure 2: This image shows when the third rail power was restored.

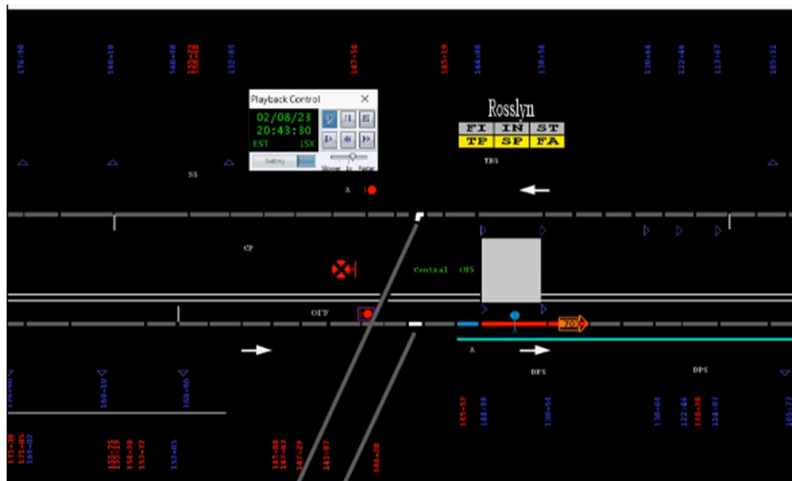
Figure 3: This image shows when third rail power was de-energized so the CMNT Road Mechanic could complete a train inspection.

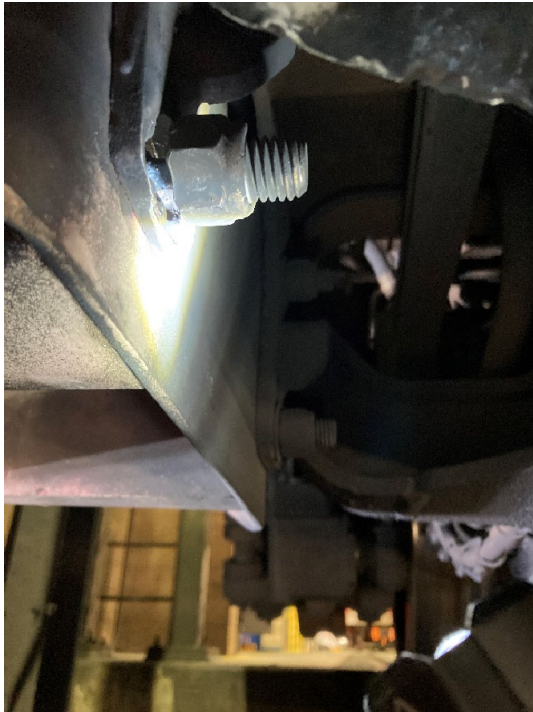
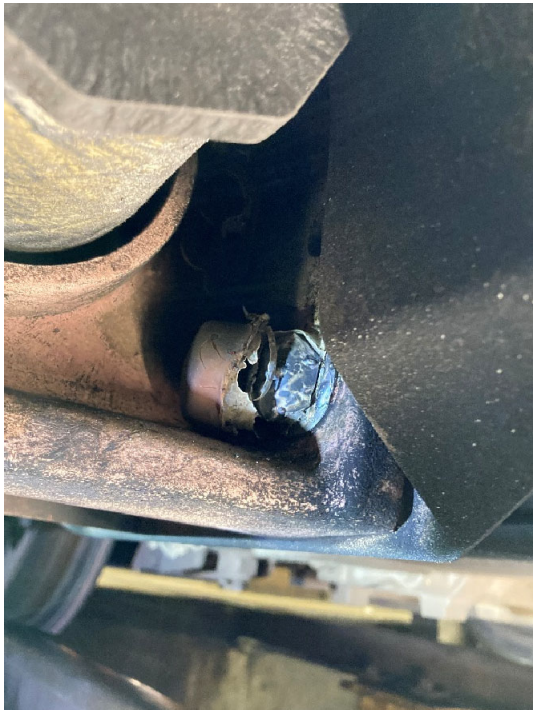
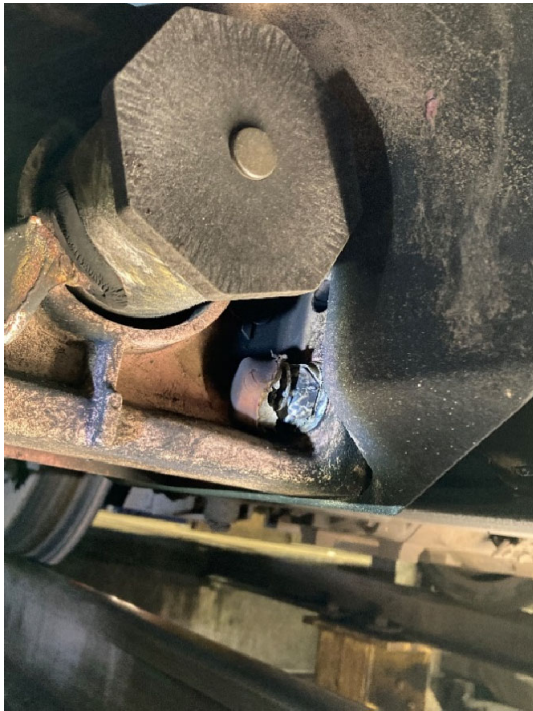
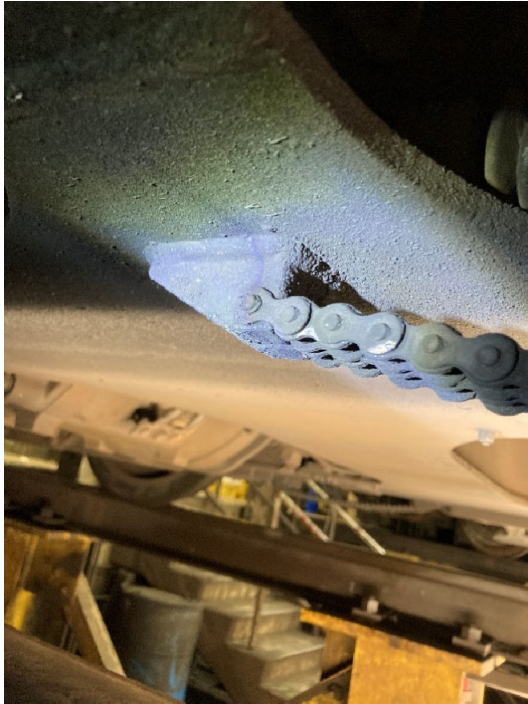
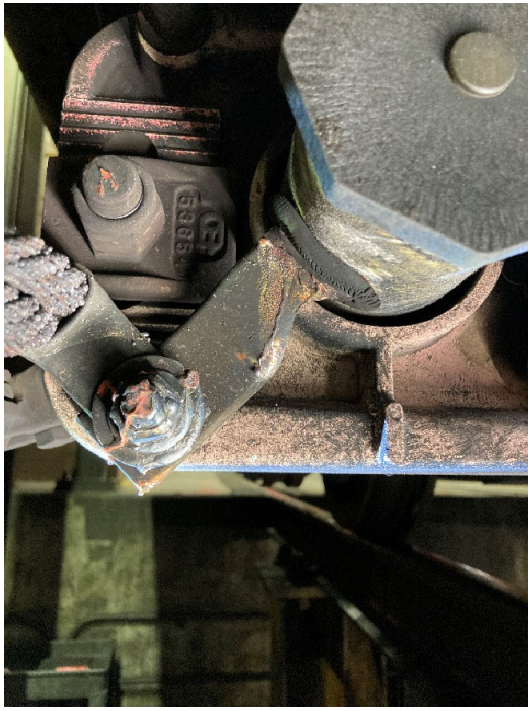
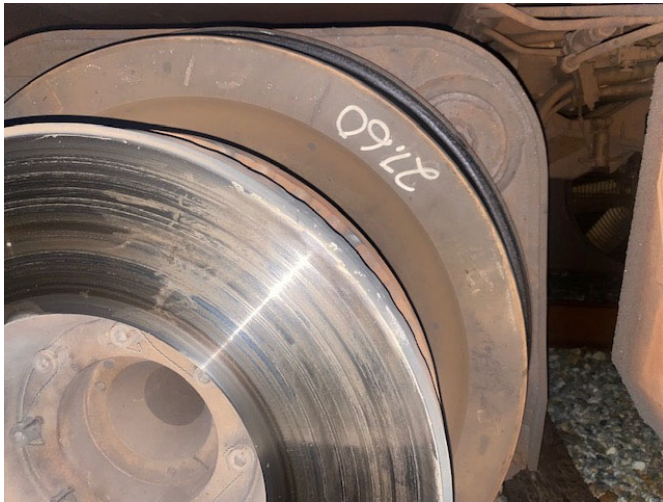
"IIT observed evidence of flashing on the #2(Front/Left) collector shoe fuse bus bar, the #2 shoe fuse shunt, the #4 Brake Disc, the HP-4 on brake disc #4, and shielding around the Front Truck Digitrol on car 3255. No other apparent damage was observed during the ground walk around.

IIT suspects this incident stemmed from foreign object damage, resulting in Flashing of 700V various points on the Collector assembly and the truck, including the #4 Brake Disk.

40	IN THE SHOP INSPECTED ALL TRUCKS, COLLECTOR SHOES, FUSES, HIGH VOLTAGE CABLS, TRACTION MOTORS, BRAKE RESISTOR GRIDS, INDUCTANCES, PROPULSION PACKAGE, OK. HOWEVER, FOUND # 2 COLLECTOR SHOE BUSBAR, MOUNTE BOLT, BRAKE PNEUMATIC UNIT GUARD, FLASHED. ALSO, FOUND RH CALIPER ASSEMBLY OVERHEAT. THE TRUCK NEEDS R/R FOR EVALUATION. 000-300-D10 PROPULSION; OTHER UNDERCAR Component: EQUIPMENT; 2K/3K/6K/7K Work Accom: CHECKED Reason: INCIDENT//ACCIDENT Status: CLOSE Position: Warranty?: N

- Perform a complete undercar inspection on entire consist for possible foreign object damage.
- Download Propulsion fault logs from cars 3254-55
- Fully inspect Primary Cable on Car 3255.
- Replace Front Truck due to evidence of flashing on 3255.
- Perform collector shoe height checks cars 3254-55.
