**WMSC Commissioner Brief: W-0228 – Evacuation for Life Safety Reasons – Van Ness-UDC Station – February 26, 2023**

**FINAL REPORT OF INVESTIGATION A&I E23135**

# Van Ness – UDC Station – Evacuation for Life Safety Reasons

February 26, 2023

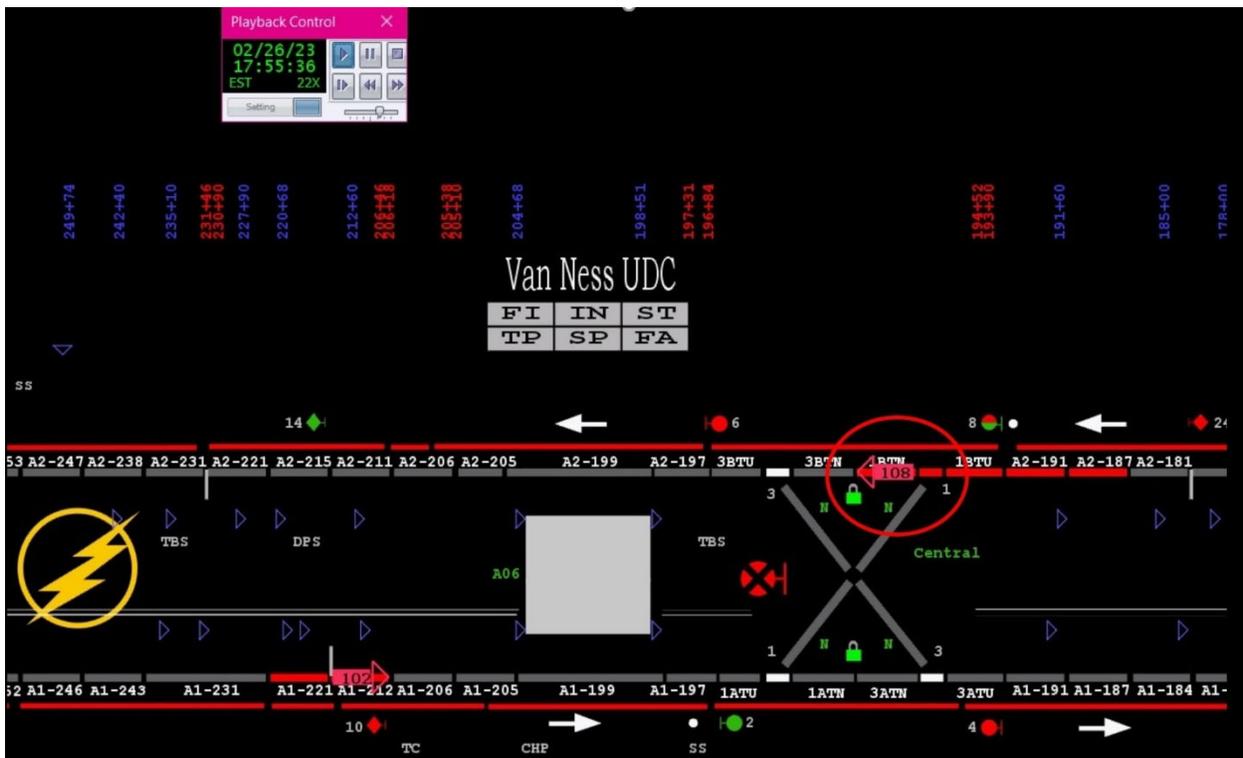
Image 1 - Train ID 108 approaching Van Ness – UDC Station, Track 2 at 17:55 hours. Third rail power is energized on the platform and interlocking.

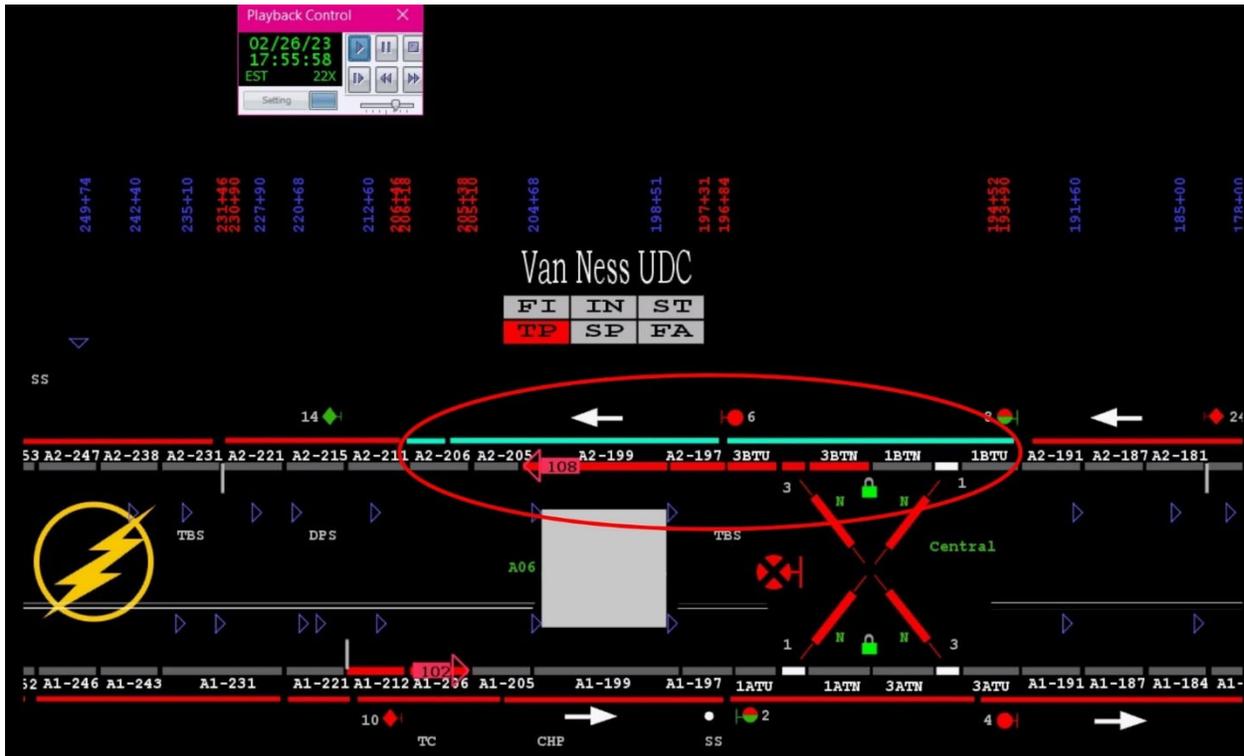
Image 2 - AIMS Display showing third rail power deenergized in the interlocking and on the platform on Track 2.
