Inspection Form

Washington Metrorail Safety Commission

Inspection Date	YYYY/MM/DD	Report Number	20230308-WMSC-DLB-1			
Inspection Date	2023/03/08	Report Number				
Rail Agency Name	Washington Metropolitan Area Transit Authority	Rail Agency Department	Name			
Rail Agency Department	Safety	Contact Information				
Inspection Location	Potomac Yard	•

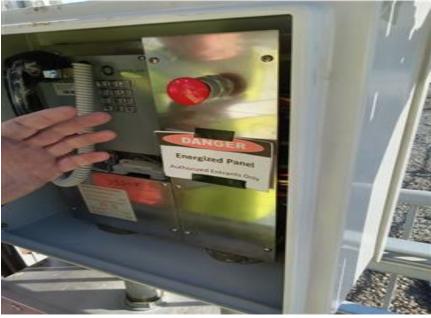
$Potomac_Yard_ETS__mn__Push_Button_Static_Picture_030823.jpeg$

#	1	Ins	pection Subj	ect	ETS Push	Buttons	Operation		Activity Code			SAFE-PI-QAI			
Job Briefing Employee Name/Title	N/A			Accompani	ied Inspecto	or?	Yes	Out Brief Conducted	I Vac I Time			1 05:00 PM 1		side nift	
Related Reports	No			Related CA	PS / Finding	gs		No	•						
Related Rules,	Ref		Rule	or SOP			Standard		Other /	Γitle		Cl	Checklist Reference		
SOPs, Standards, or Other	No		N/A				N/A		N/A		N	N/A			
Inspection Location	Main Track	Yard	Station	occ	RTA Fa	acility	WMSC Office	Track Type	At-g	rade	Tunne	el E	levated	N/A	
		Х												Х	
Line(s) & Track	Potomac Yai	rd			Chain Ma	rker and/	or Station(s)		From	l			То		
Number								N/A				N/A			
Vehicles	Head Car		N	umber of C	ars	Equipm	ent	N/A							
	N/			N/A											
				d the WMSC of a safety issue involving recently installed exes at the Potomac Yard. Metrorail has identified a					Number of Defects				1		
	manufacturing issue with the red push button for the new ETS's located at Potomac Yard.							Recommended Finding?				Yes

The issue is described best by the fact that the red push button does not function									Remedial Action Required? Yes					
Description	The issue is described best by the fact that the red push button does not function properly to deenergize third rail power. Metrorail described that the push buttons may not depress when pressed. Metrorail determined that turning the button slightly allows the button to be depressed and deenergizes third rail power as intended. All ETS push buttons at Potomac Yard will be replaced with proper functioning buttons before the station opens, but the safety concern remains since the same ETS design exist on the newly opened Silver Line Phase 2 extension. The number of similar push button units are above seven hundred installed and in used on the Silver Line Phase 2 extension. Metrorail's Safe and Power Departments shared the following plan with the WMSC via email as to the following sequential mitigation plan: - Immediate Mitigation TODAY. In the event that the red push button does not depress, the button must be turned - like a dial - until it is able to be fully pushed in. Once the push button has been turned to the proper position and fully depressed, it will work normally and de-energize third rail power. Metrorail will draft a Safety Bulletin for review and circulation by Safety today, to alert personnel to the issue Short-Term Mitigation Traction Power Maintenance (TRPM) will place placards inside each affected ETS box. The placards will detail the issue and the proper method to fully depress the push button. A picture (with the appropriate markings) or diagram will also be included as a visual reference. TRPM will install markings on the push button and interior faceplate to visually communicate the exact alignment for the push button to work properly. A second Safety Bulletin will be circulated once completed Long-Term Mitigation / Permanent Solution For each affected ETS box, TRPM will replace the red push button with a suitable replacement that will depress upon initial push. Due to the official communication of this safety issue from Metrorail, the WMSC will provide oversight as the issue is resolve					Recommended Reinspection?
