WMSC Commissioner Brief: W-0232 – Evacuation for Life Safety Reasons, Improper Train Movement – Green Line – February 9, 2023

Prepared for Washington Metrorail Safety Commission meeting on August 8, 2023

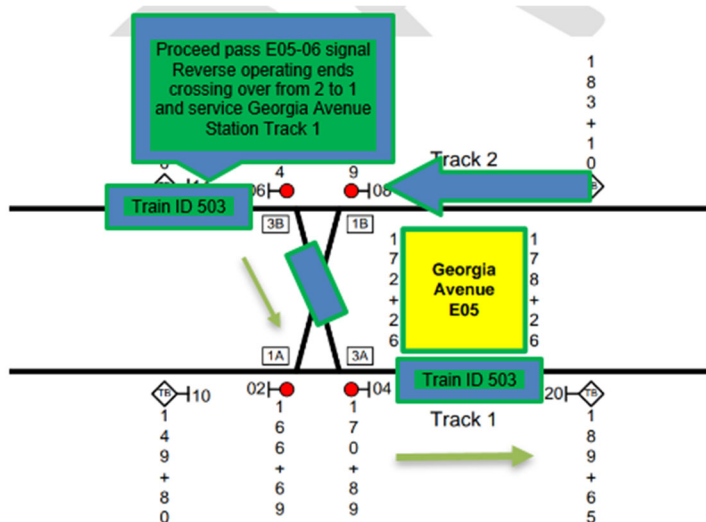
Intended Move for Improper Rail Vehicle Movement Event

The Radio RTC then instructed Train ID 503 to stop, reverse operating ends, and travel back towards the interlocking. They were then to clear the E05-06 Signal, cross over from Track 2 to Track 1 and proceed back towards Greenbelt on track 1. The Train Operator repeated and complied with these instructions without further incident and remained in service until the end of their shift. The next day, they were notified of the violation as the event was not immediately identified and reported.

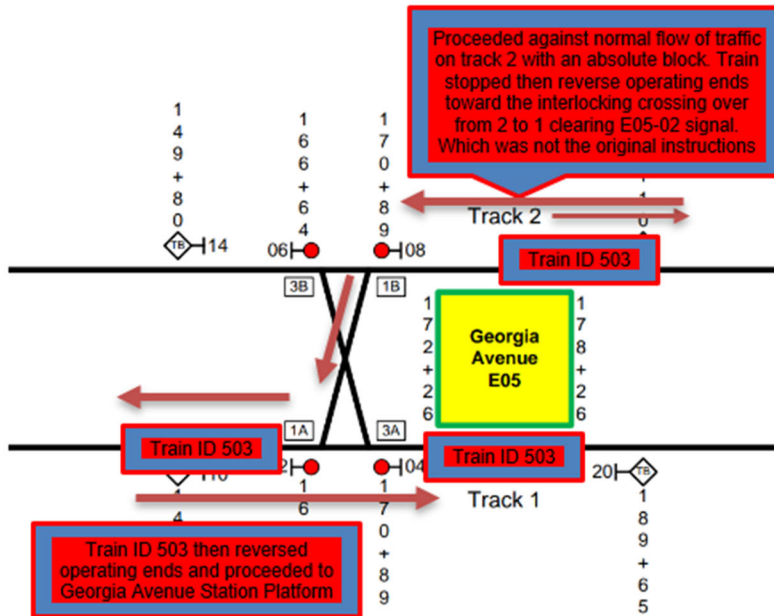
Actual Move for Improper Rail Vehicle Movement Event

During the turnback of trains away from the station, the Train Operator of Train ID 503 made an improper rail vehicle movement at Georgia Avenue on Track 2. The Radio RTC initially gave Train ID 503 incomplete instructions to clear the interlocking E05-06 signal, key down, reverse ends and operate back towards Greenbelt Station. The Train Operator then reversed operating ends on the platform and asked the Radio RTC to verify the instructions. The Radio RTC then provided instructions to 503 to “key up on their downtown end and clear the Zero Six signal.” The Train Operator replied, “Roger,” and then entered Stop and Proceed Mode and operated against the normal traffic flow on track 2, moving in the direction of Greenbelt Station. Train ID 503 had no passengers aboard during the improper rail vehicle movement, and Train ID 504 was servicing Fort Totten Station on track 2.

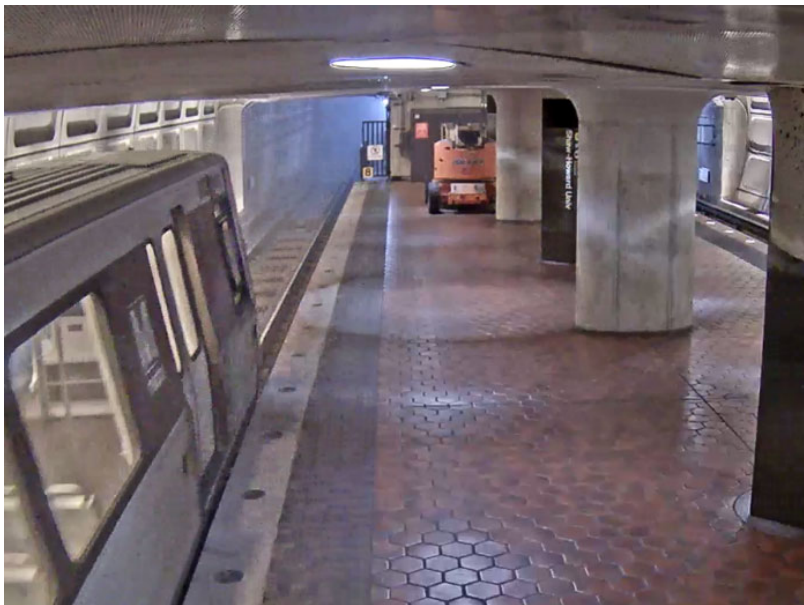
Figure 1 - Smoke emitting from the tunnel on track 1 side, following the train as it enters the station .

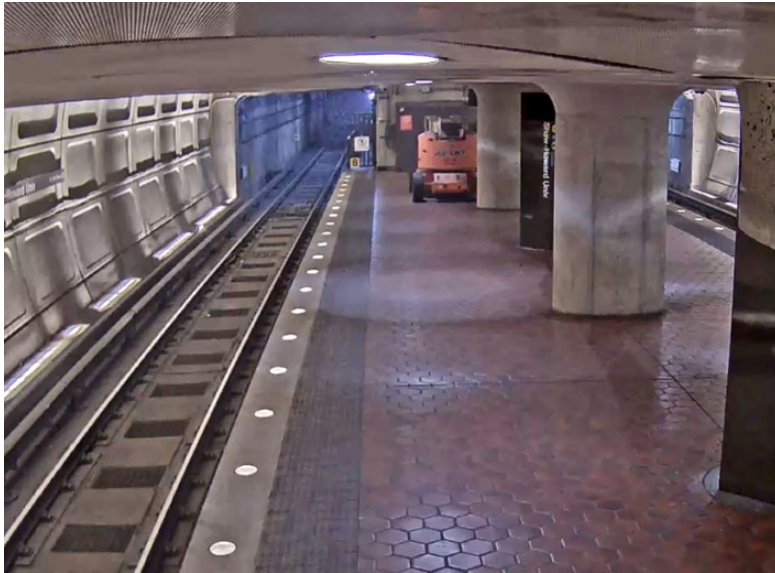
Figure 2 - Smoke dissipated to a light haze at 22:34:43 hours.

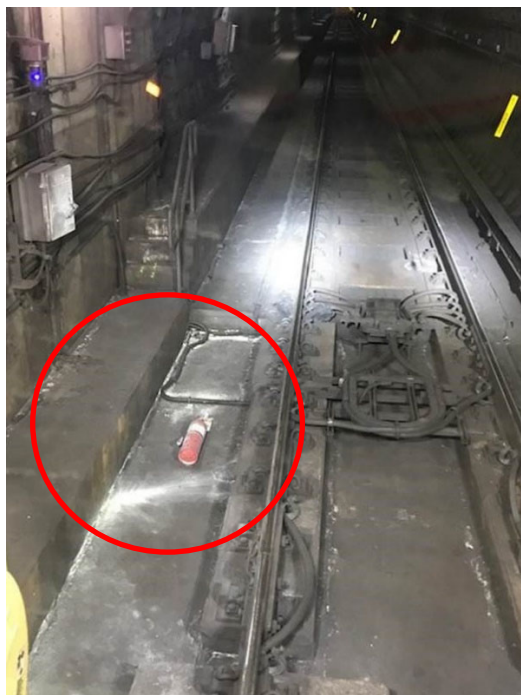
The probable cause of the Evacuation for Life Safety Reasons event at Shaw Howard Station was a discharged fire extinguisher outside of the platform limits, resulting in the appearance of a smoke condition in the station. The originating source of the fire extinguisher is also unknown. No missing fire extinguishers were identified from the incident consist.

During night work operations, personnel discovered a spent fire extinguisher in the tunnel area at Chain Marker (CM) E1 045+50 on the roadway near the platform limits prior to entering Shaw Howard University Station. The fire extinguisher was not damaged, as though it was struck by a train.

Figure 9 - Fire Extinguisher near CM E01 045+50

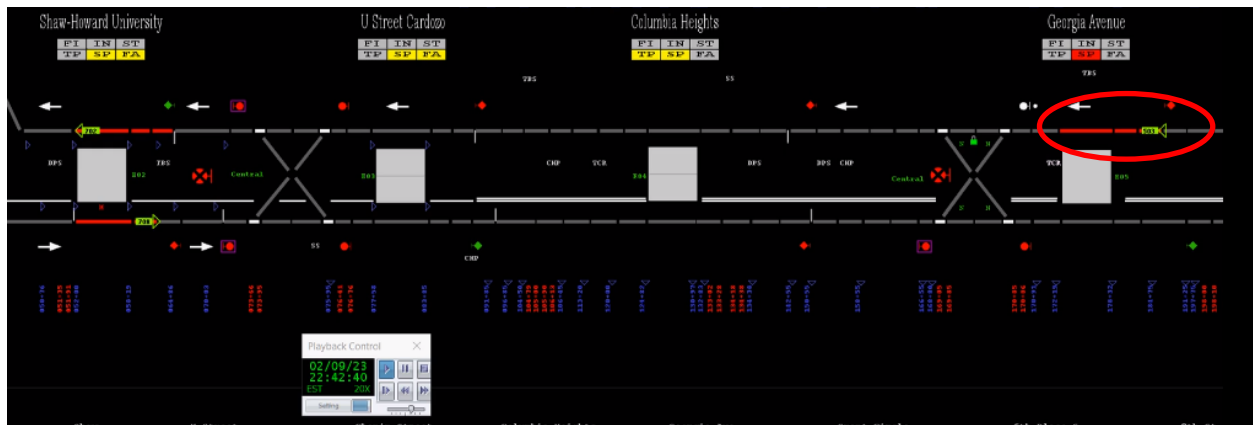
CMOR IIT data indicated that the Train Operator of Train ID 503 activated Stop and Proceed Mode on car 3054 at 22:39 hours and traveled 379 feet with a maximum speed of 15 MPH against the normal traffic flow.

Figure 10 - Train ID 503 AIMs indicating traveling in the wrong direction.

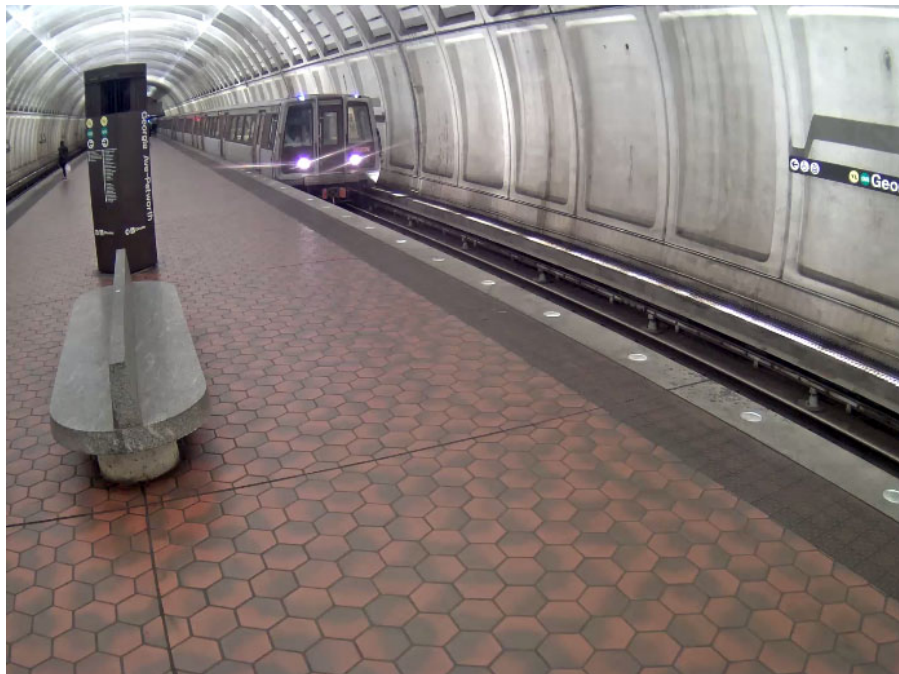
Figure 12 - Train Operator of ID 503 keyed up on the incorrect end of their consist, facing against the normal flow of traffic.

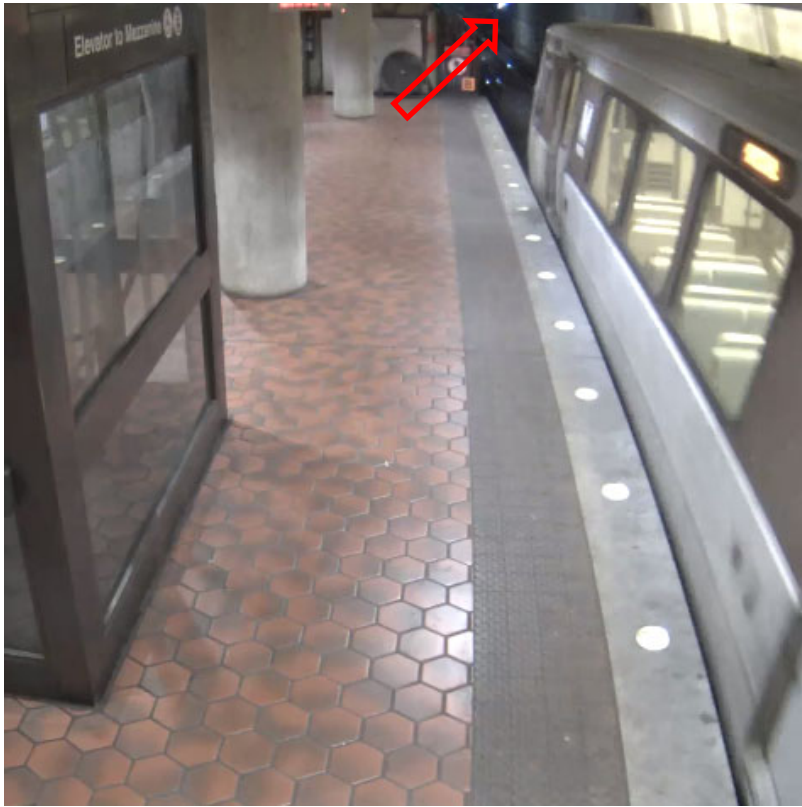
Figure 13 - Train ID 503 departing Georgia Avenue Station against traffic flow.

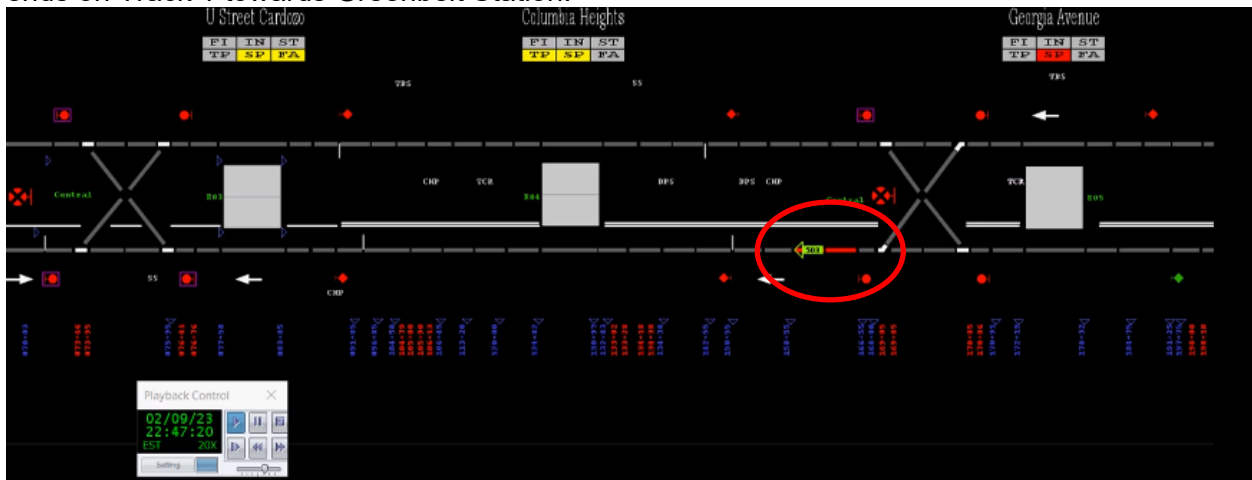
Figure 14 - Train ID 503 crossing over from track 2 to 1 at 22:47 hours.
