#### WMSC Commissioner Brief: W-0235 – Evacuation for Life Safety Reasons at Clarendon Station – March 7, 2023

# FINAL REPORT OF INVESTIGATION A&I E23155

Date of Event:	March 7, 2023
Type of Event:	Evacuation for Life Safety Reasons – Smoke
Incident Time:	08:08 hours
Location:	Clarendon Station, track 1
Time and how received by SAFE:	09:21 hours
	Mission Assurance Coordinator (MAC)
WMSC Notification Time:	09:21 hours
Responding Safety Officers:	WMATA: None
	WMSC: None
	Other: None
Rail Vehicle:	None
Injuries:	None
Damage:	None
Emergency Responders:	Arlington County Fire Department (ACFD),
	Metro Transit Police (MTPD)
SMS I/A Incident Number:	20230308#106705

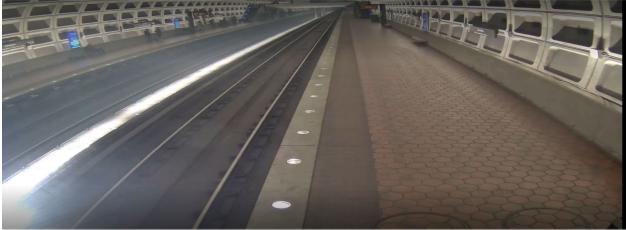
Figure 1 Light Haze of smoke observed -Platform level.

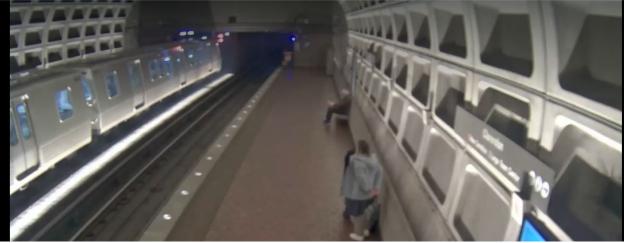
Figure 2 Inbound Train on the Platform -smoke emitting from the tunnel

The probable cause for the evacuation for life safety reasons event was light, odorless smoke from an unknown source that was drawn into the station by a train entering. There were no significant findings related to the response and recovery from this event.

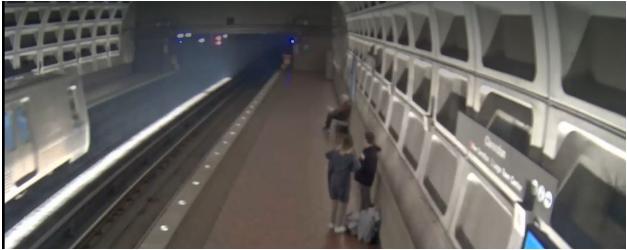
Figure 3 Train exiting station-smokes continues to enter the station.
