WMSM Commissioner Brief: W-0237 – Evacuation for Life Safety Reasons at Dulles Rail Yard – March 21, 2023

Washington Metropolitan Area Transit Authority
Department of Safety (SAFE)
Office of Safety Investigations (OSI)
FINAL REPORT OF INVESTIGATION A&I E23192

Dulles Rail Yard – Evacuation for Life Safety Reasons

March 21, 2023

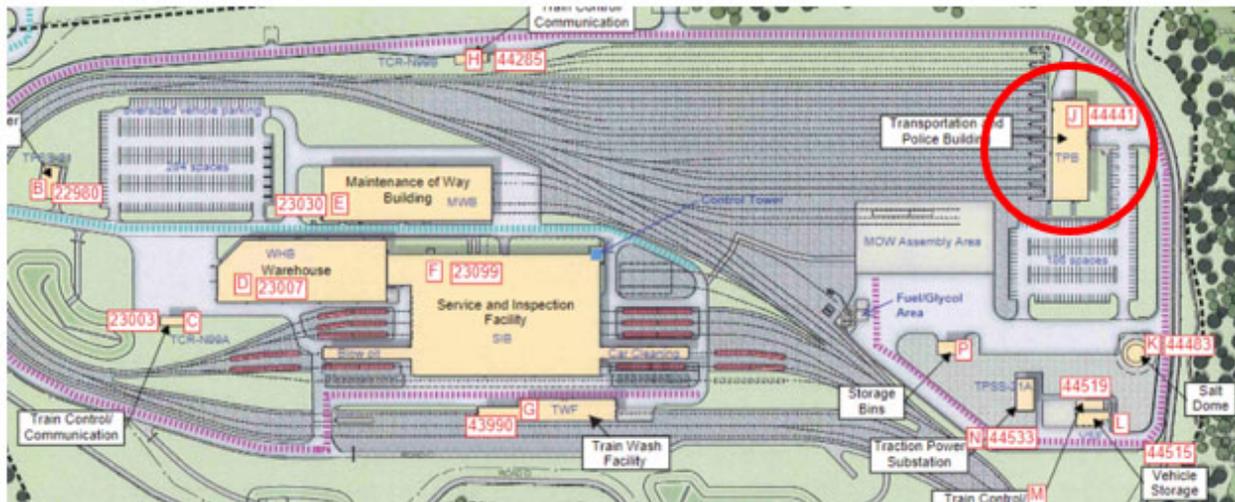
Field Sketch/Schematics

The above depiction is not to scale.

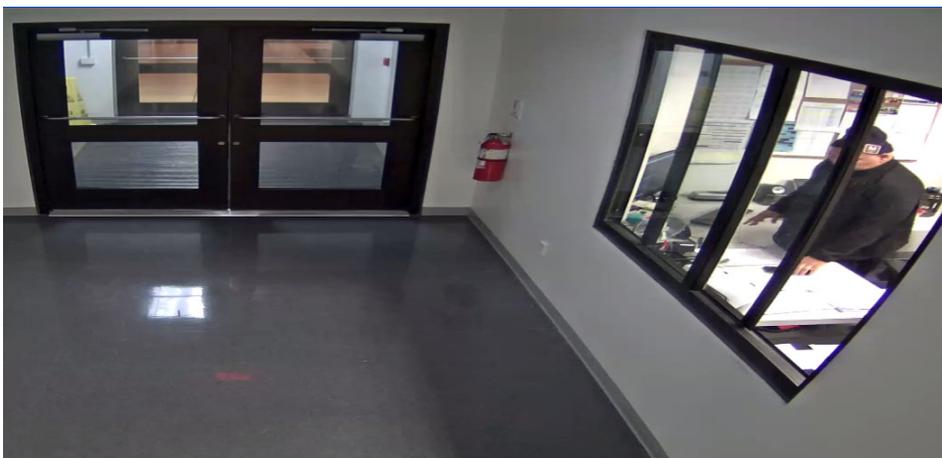
Image 1 – The Depot Clerk located in the office at Dulles Yard – Building J.

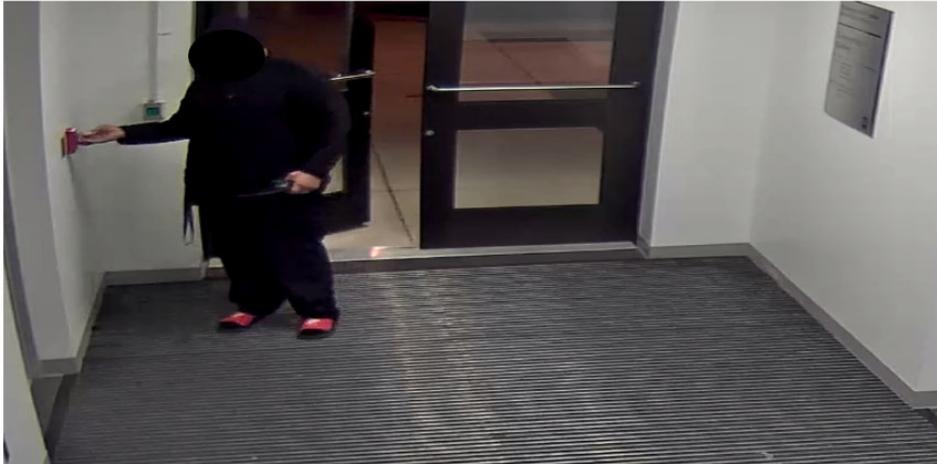
Closed-Circuit Television (CCTV) revealed that at 02:00 hours, the Depot Clerk exited the building and appeared to have a conversation with others that were outside of the building. At 02:02 hours, the Depot Clerk re-entered the building and activated the fire alarm pull station.

Image 2 – The Depot Clerk activating the fire alarm pull station.

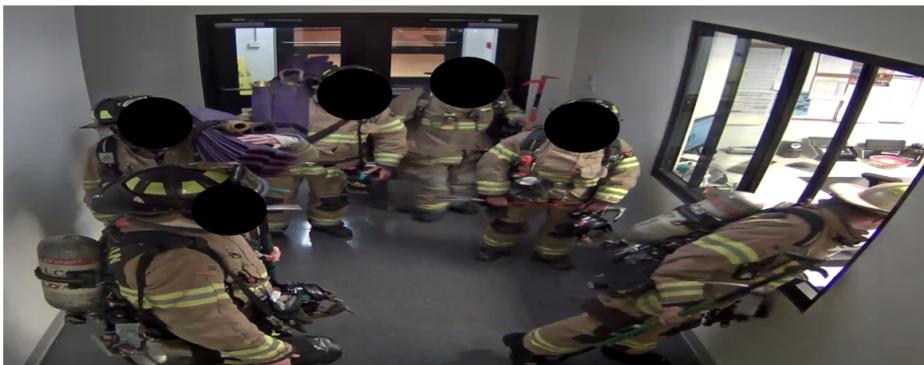
At 02:08 hours, MOC dispatched the Office of Radio Communications (COMR). At 02:10 hours, Power personnel reported to MOC that they were on scene. At 02:12 hours, LC-CFRS arrived, silenced the alarm, canvassed the area and reported no sign of smoke or fire in Building J, then reset the fire alarm.

Image 3 – LC-CFRS canvassing the Depot Clerk's Office for signs of smoke.
