WMSC Commissioner Brief: W-0239 – Evacuation for Life Safety Reasons at Union Station – March 21, 2023

FINAL REPORT OF INVESTIGATION A&I E23193

Union Station – Evacuation for Life Safety Reasons

March 21, 2023

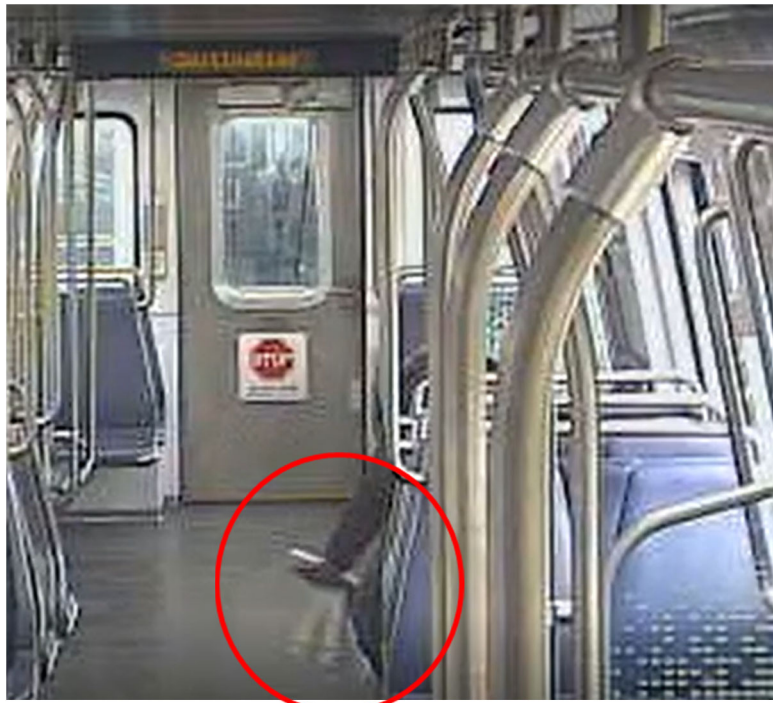
A review of onboard camera systems showed a customer traveling several stations showing signs of erratic behavior near doors 11 and 12 on the rear of railcar 7221. A set of newspapers were positioned next to the customer on the floor of the railcar.

Figure 1 - Customer grabbing newspaper on the railcar floor

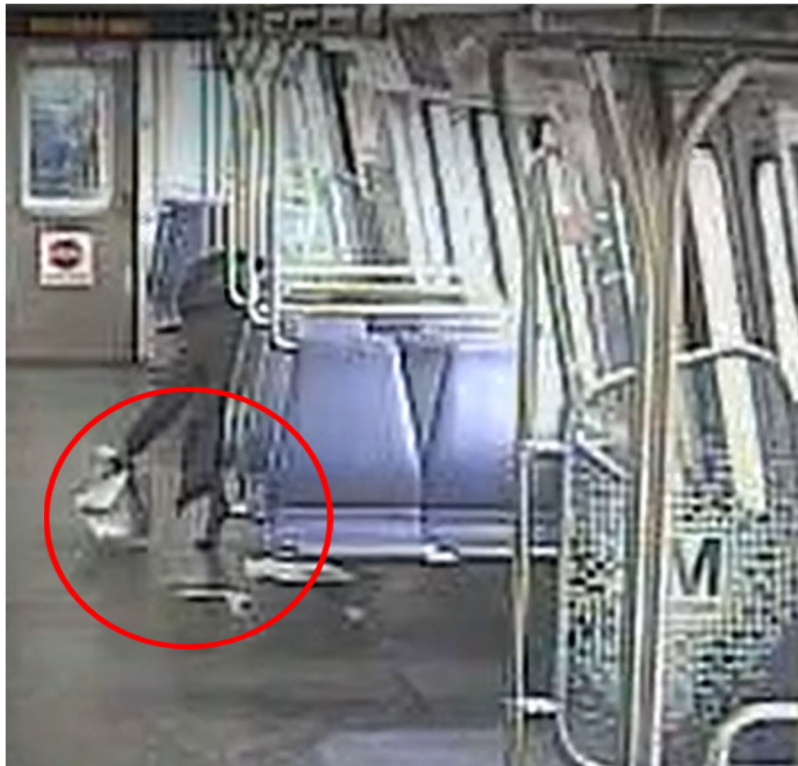
Figure 2 - Several newspapers moved under the customer's seat.

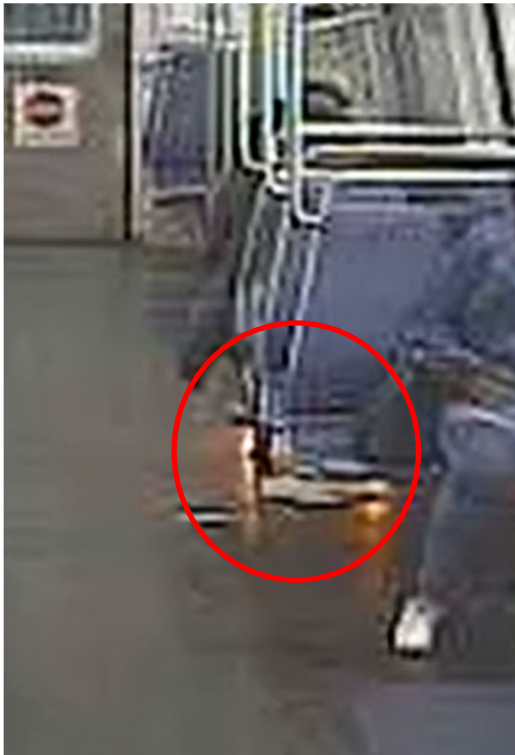
Figure 3 - The fire grows under the customer's seat - at approximately 15:22 hours.

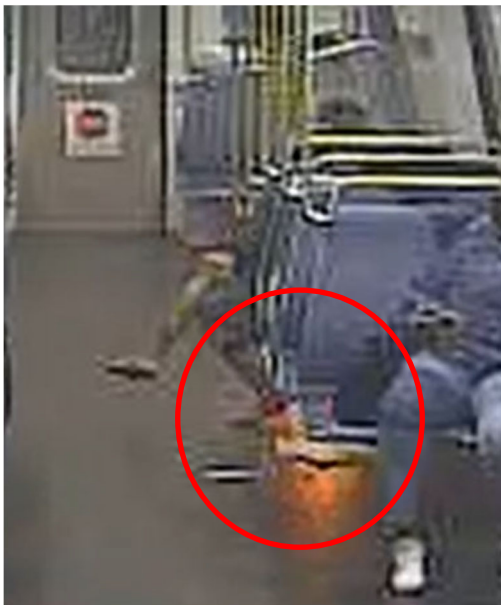
At approximately 15:23 hours, a customer appears to notice the smoke condition. The customer that ignited the fire remained seated with legs crossed. The customer did not have shoes or socks on their feet.

Figure 4 - Customer with fire under the seat and legs crossed.

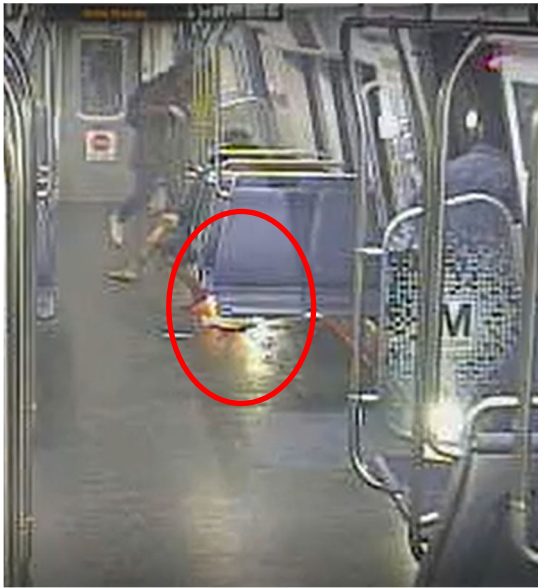
Figure 5 - Doors opened, and passengers exited the train as the fire continued at approximately 15:24 hours.

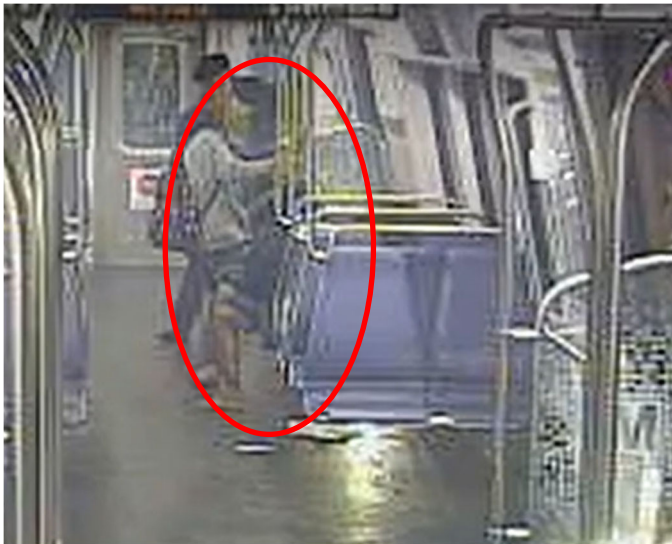
Figure 6 - Customers boarded car 7221 and extinguished the fire with their feet at approximately 15:26 hours.

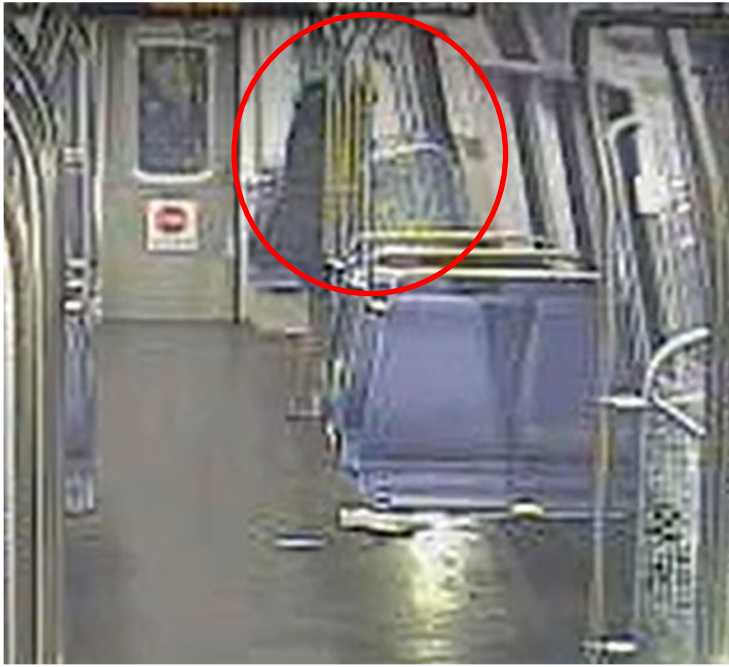
Figure 7 - Customer disembarking the train without incident with MTPD at approximately 15:27 hours.

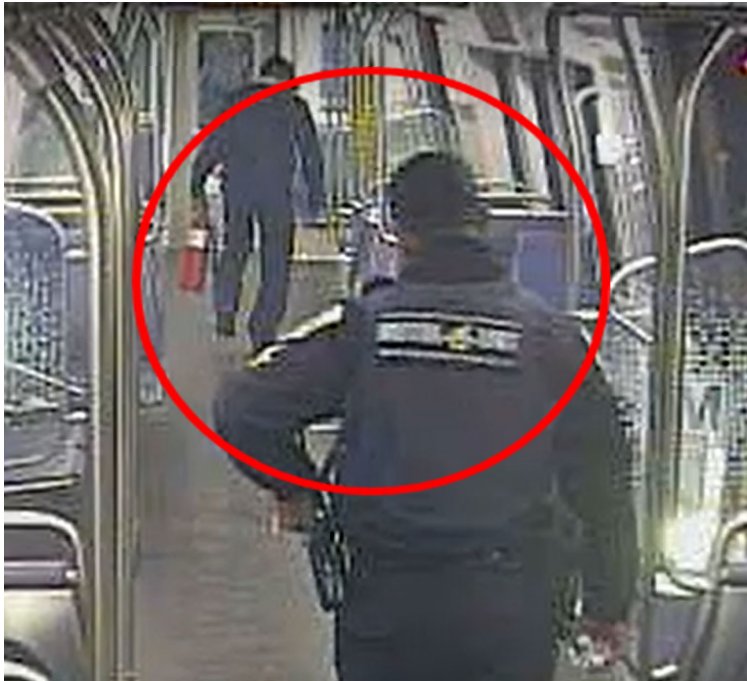
Figure 8 - MPD and Station Manager (with fire extinguisher) aboard railcar 7221.

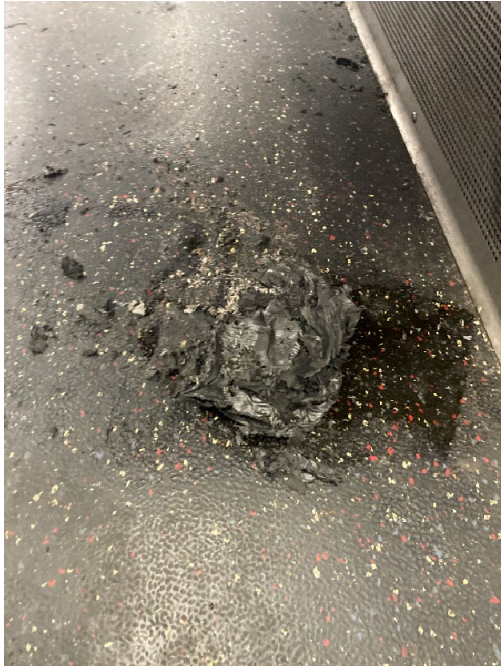
The probable cause of this event was a customer intentionally igniting a fuel source resulting in fire and smoke condition aboard car 7221. There were no Contributing Factors identified related to vehicles, personnel or infrastructure of the Washington Metropolitan Area Transit Authority (WMATA).

Figure 11 – Charred trash on the floor of railcar 7221.

- Railcar 7221 was offloaded and isolated from customers.
- The Train was removed from service and taken to the railyard to be inspected for damage.

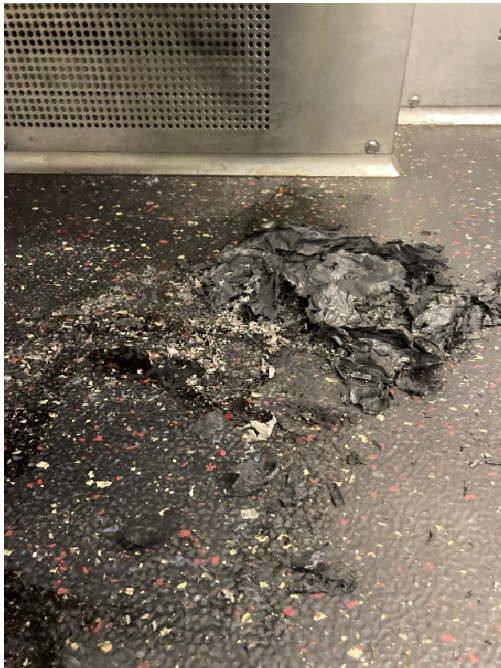
Figure 12 – More burned paper remnants. No damage to the floor of railcar 7221.

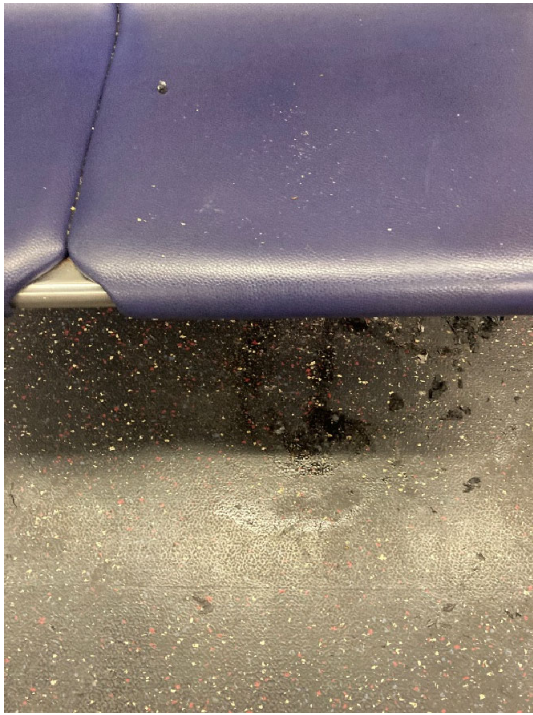
Figure 13 - No damage to the floor underneath the seat of railcar 7221.

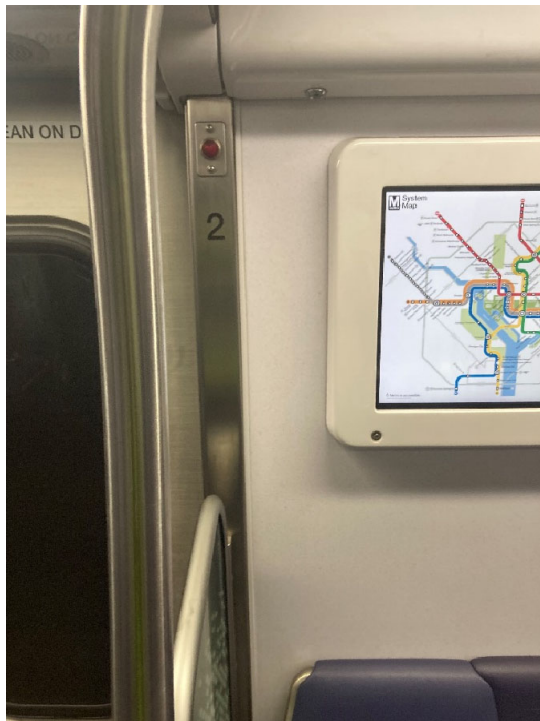
Figure 14 - Railcar door #2 is the nearest exit where the trash was ignited.
