WMSC Commissioner Brief: W-0245 – Evacuation for Life Safety Reasons at Crystal City Station – March 16, 2023

FINAL REPORT OF INVESTIGATION A&I E23179

Crystal City Station – Evacuation for Life Safety Reasons

March 16, 2023

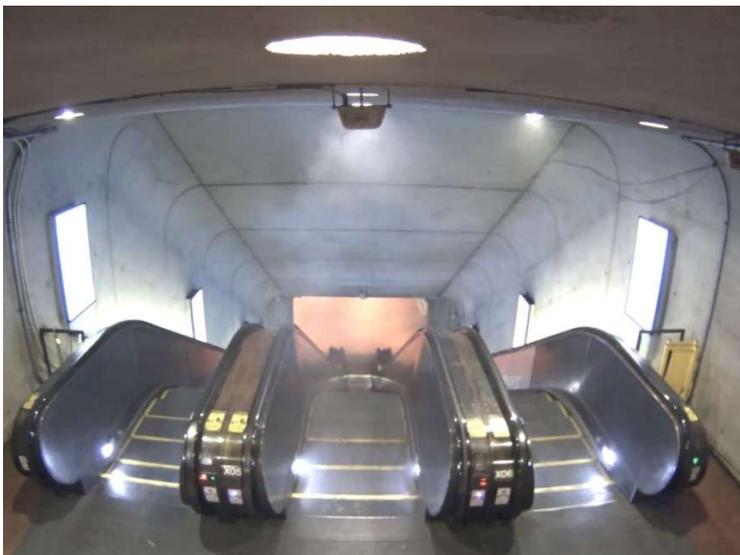
Figure 1 - Smoke emitting from Escalator X05 at 20:49 hours.

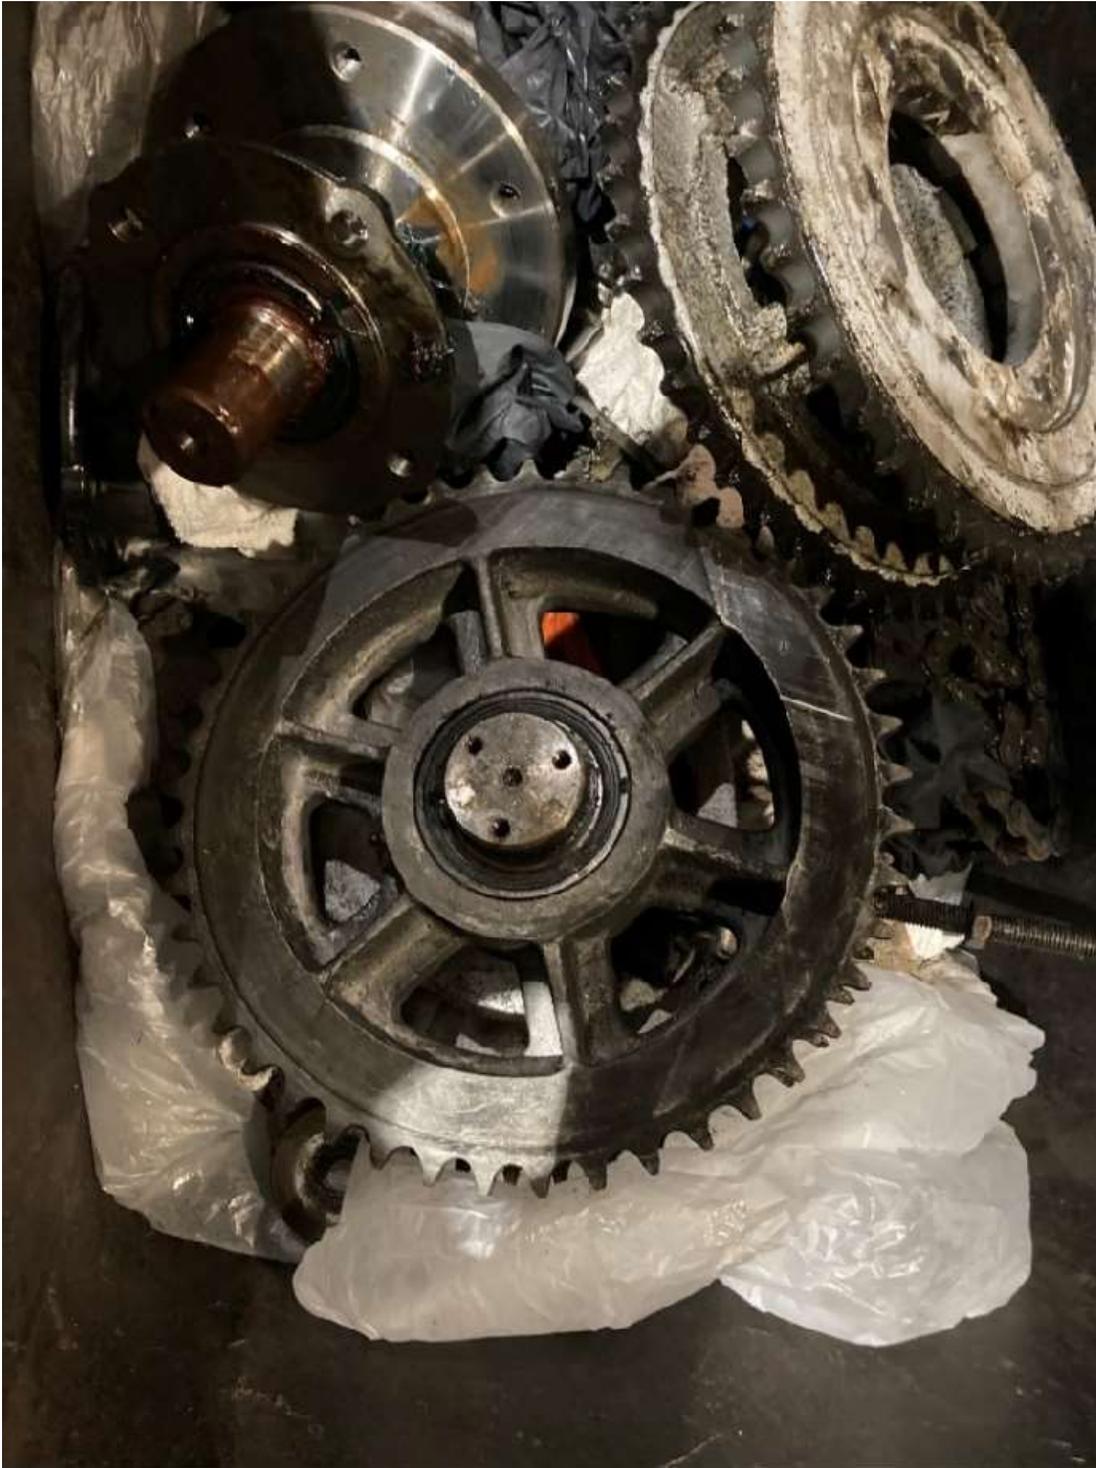
The following day Friday, March 17, 2023, ELES personnel conducted a follow-up investigation at Crystal City. The ELES Mechanic reported that they removed five steps of Escalator X05 to gain access to the area where the fire was located. They reported that the initial investigation showed signs that the escalator drive system had shifted to the left side, causing slight contact with the main drive sprocket and step tracks on the right side. They stated there was visible fire damage to the stub shaft bearing grease line, main drive chain, and numerous step and axle rollers the right side. Accumulated dirt and grease were also visible through the escalator but not considered excessive in this instance.

Image 1 - Drive sprocket (top right), idler sprocket (bottom) and drive sprocket stub shaft and bearing (top left). The idler shows signs of rubbing, it should have a white paint like the drive sprocket but has been worn off.

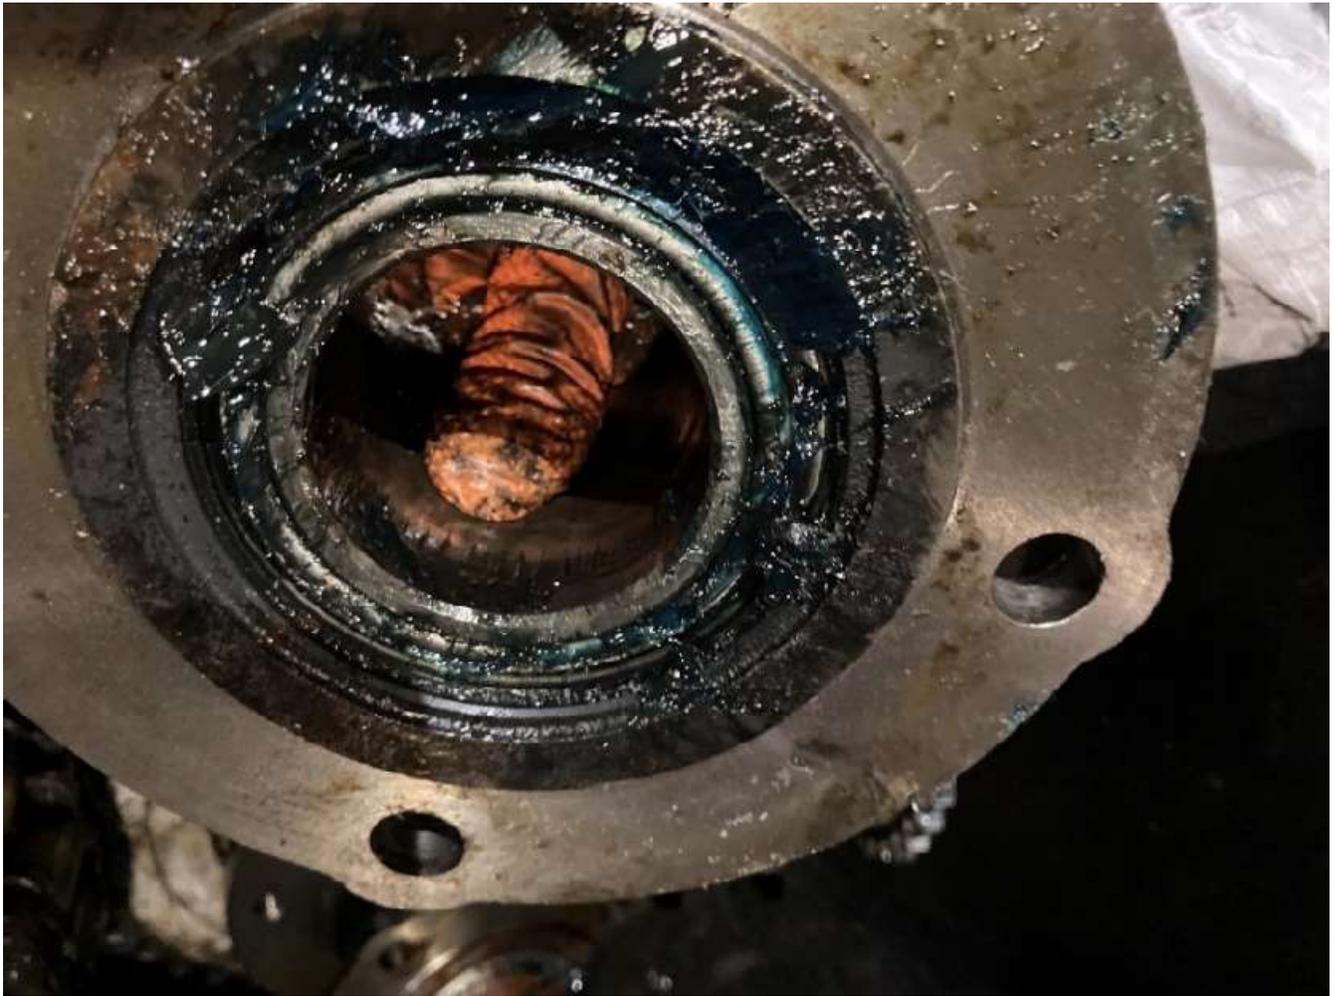
All removed drive components were reportedly visually inspected to determine any cause of the fire. ELES found the bearings were well-greased and showed no signs of wear. The maintenance history was also investigated for Escalator X05, and the components had all been replaced on September 10, 2022, due to wear on the previous parts. Routine maintenance was completed as scheduled on a 45-day cycle. The escalator was last serviced on March 2, 2023. ELES Mechanics stated there is no reported maintenance history on this unit that would have contributed to the cause of the fire. This escalator unit is at the end of its useful life and scheduled for replacement within the next few years.

Image 2 - Stub shaft bearing showing it has been well greased.

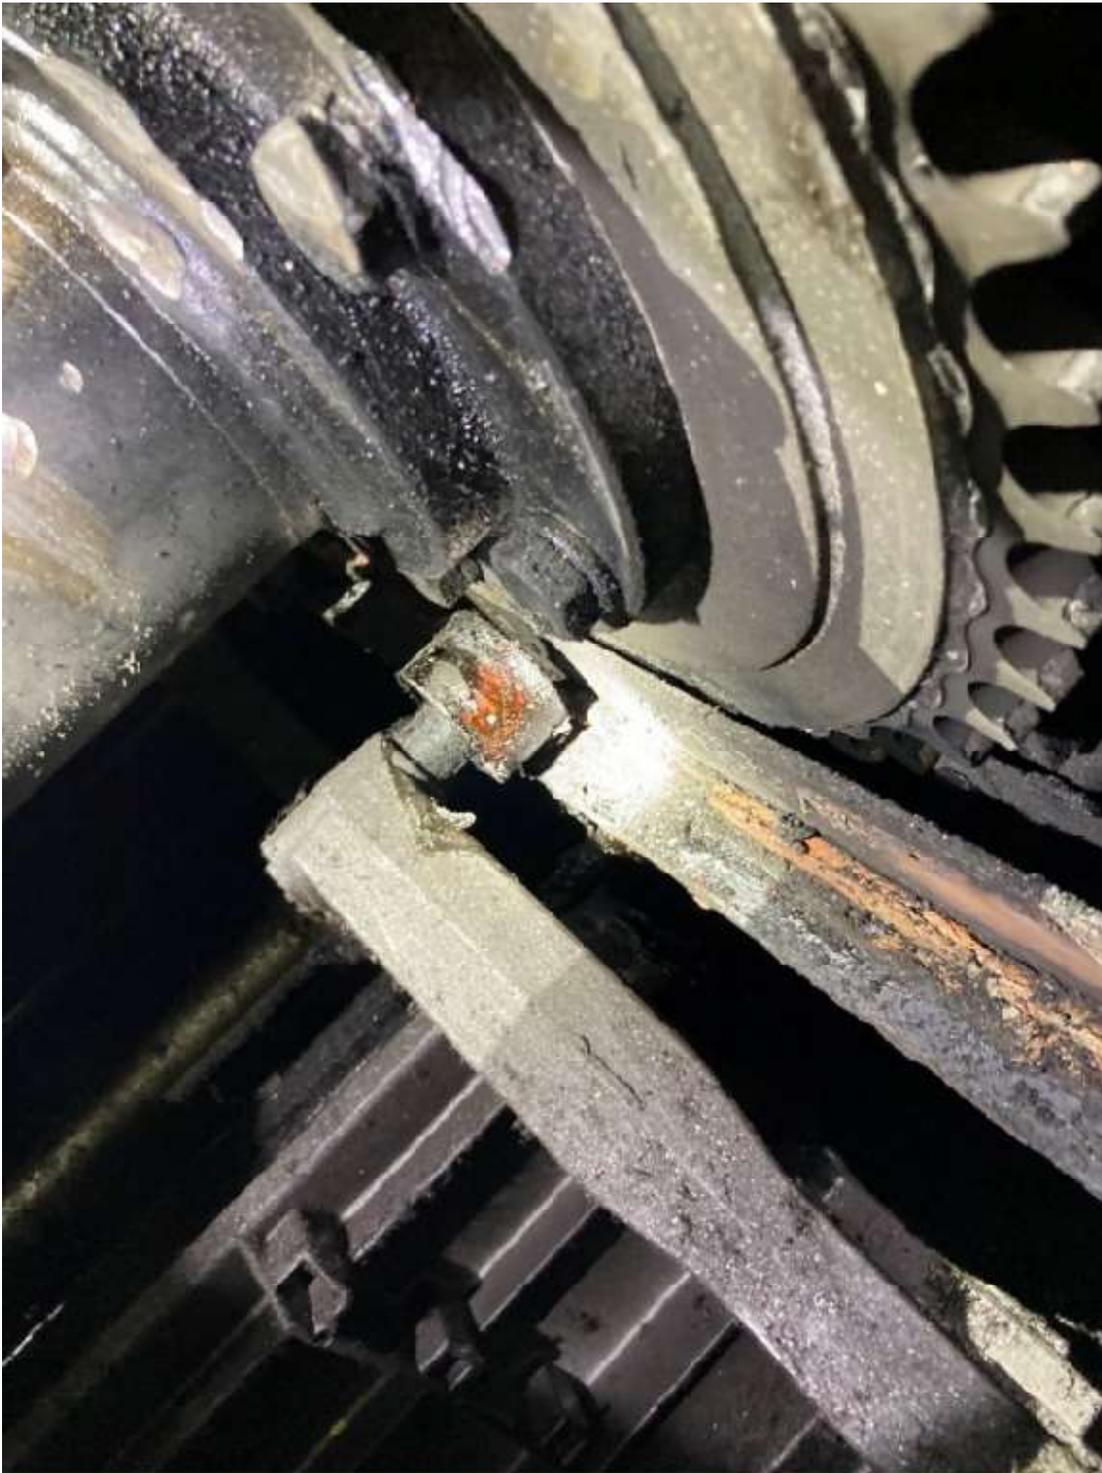
Image 3 - Melted escalator step roller. Polyurethane wheel has melted away. Drive sprocket has signs or wear from rubbing on step track.

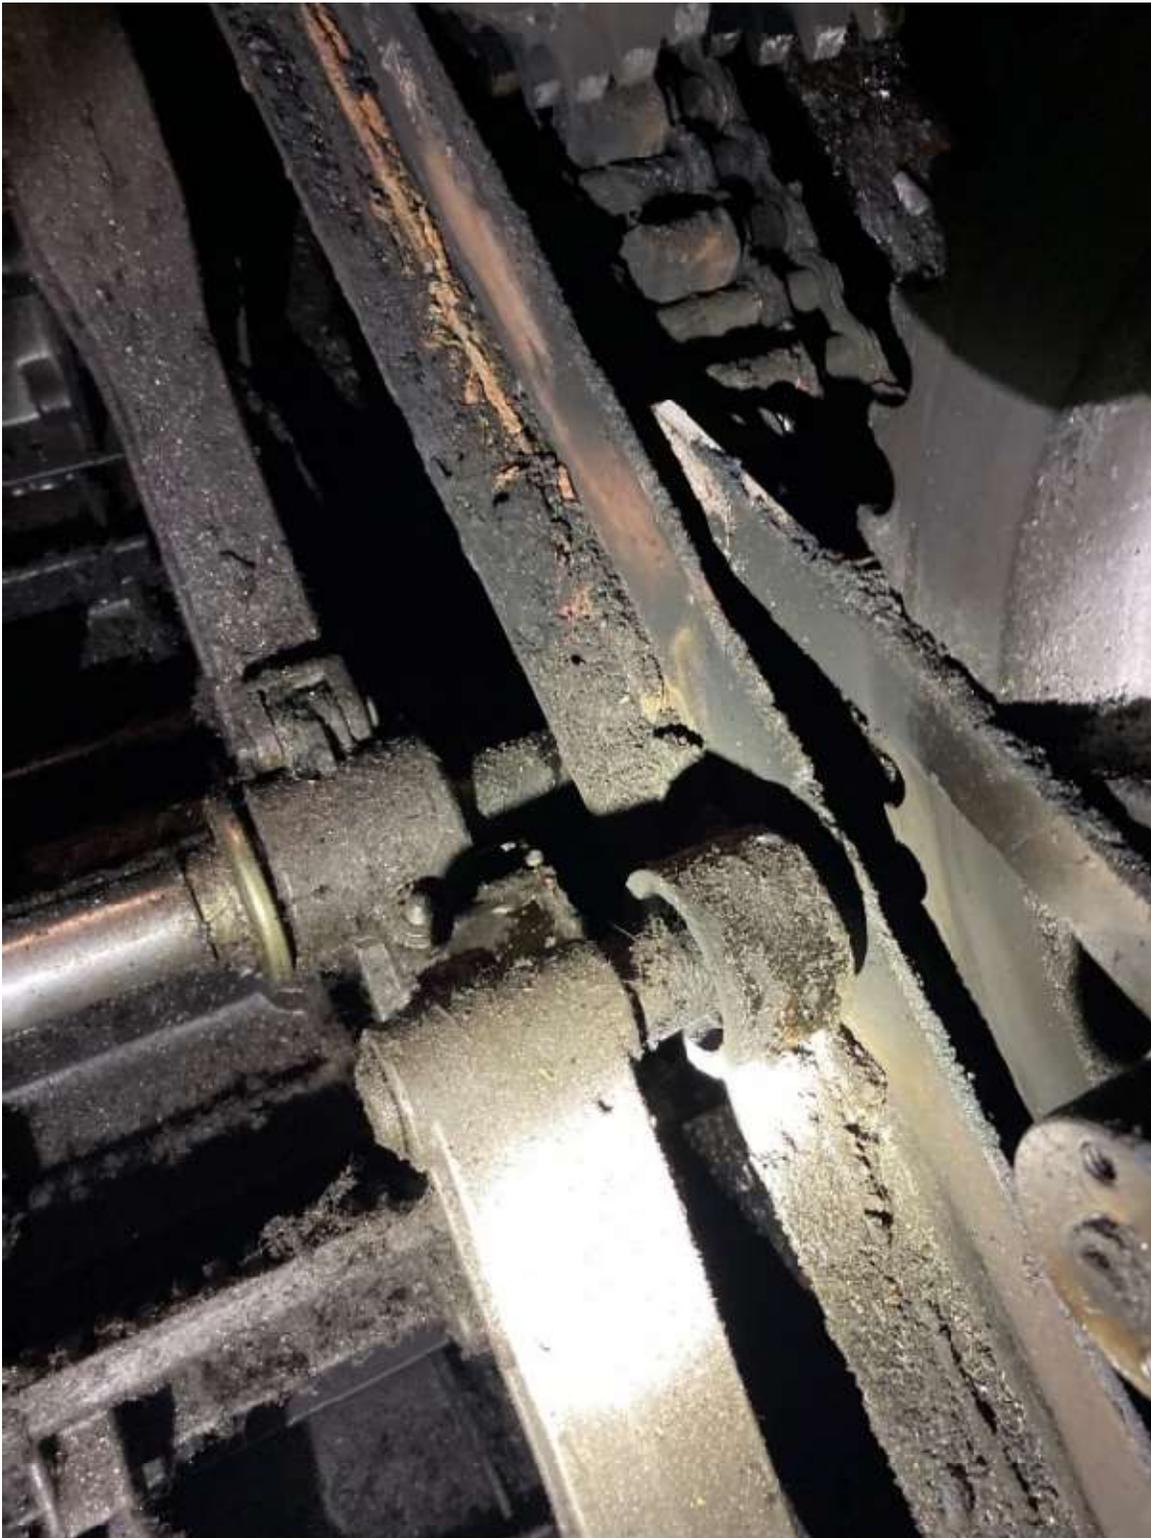
Image 4 - Damaged step roller, broken drive chain safety switch actuator arm and damaged escalator drive chains. Polyurethane has melted off both step roller, switch arm and drive chains on right side.

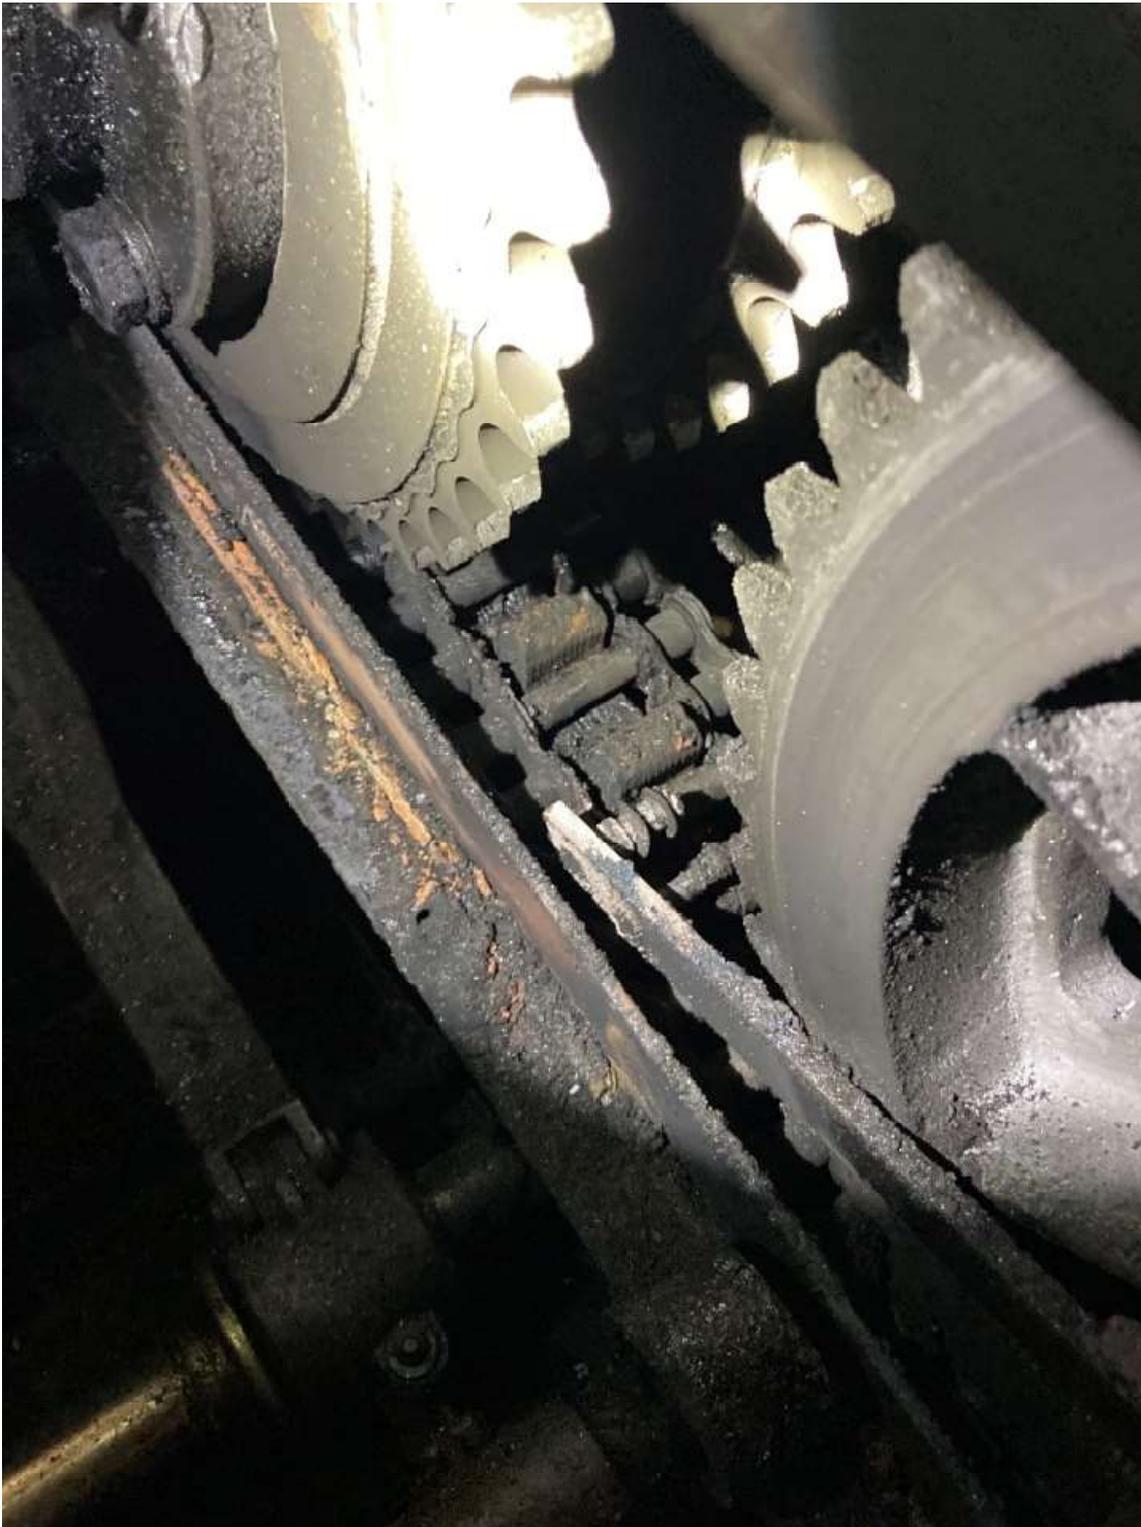
Image 5 - Closer picture of the damage to the escalator drive chains and broken chain actuator arm. Drive and idler sprockets show signs of wear from rubbing on step track.

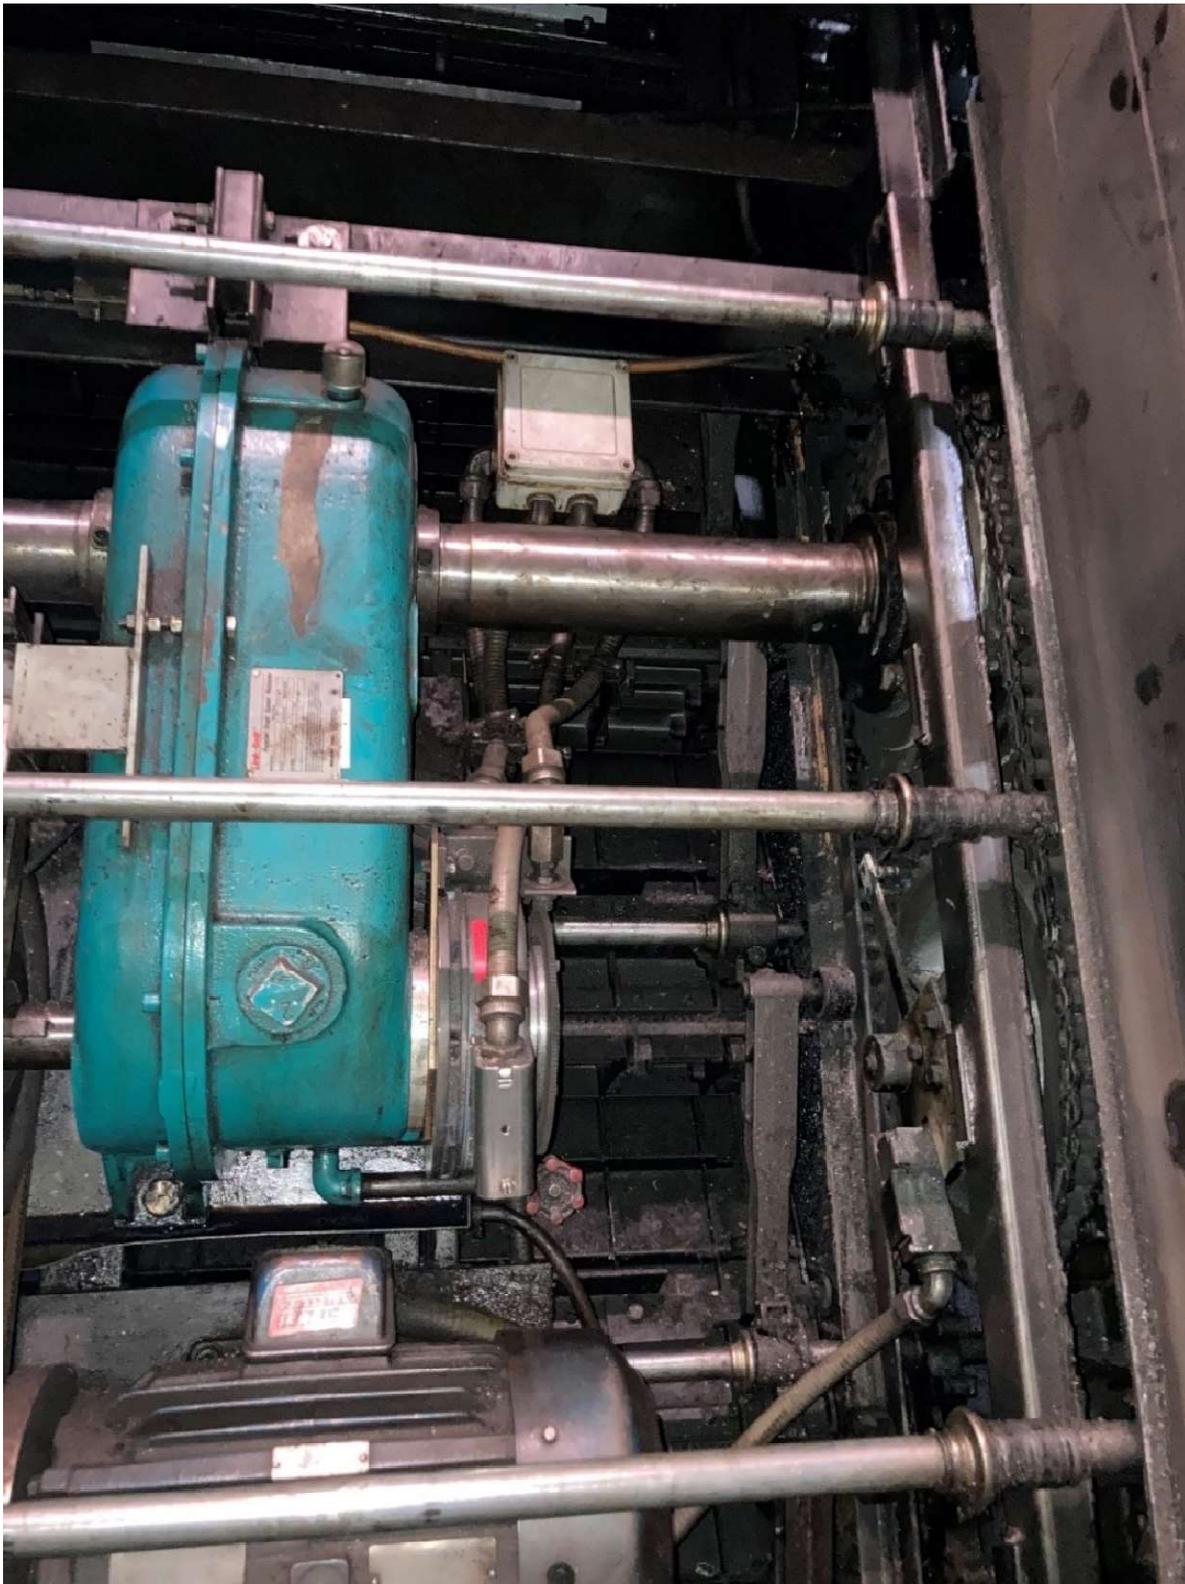
Image 7 - Damaged right side drive area.

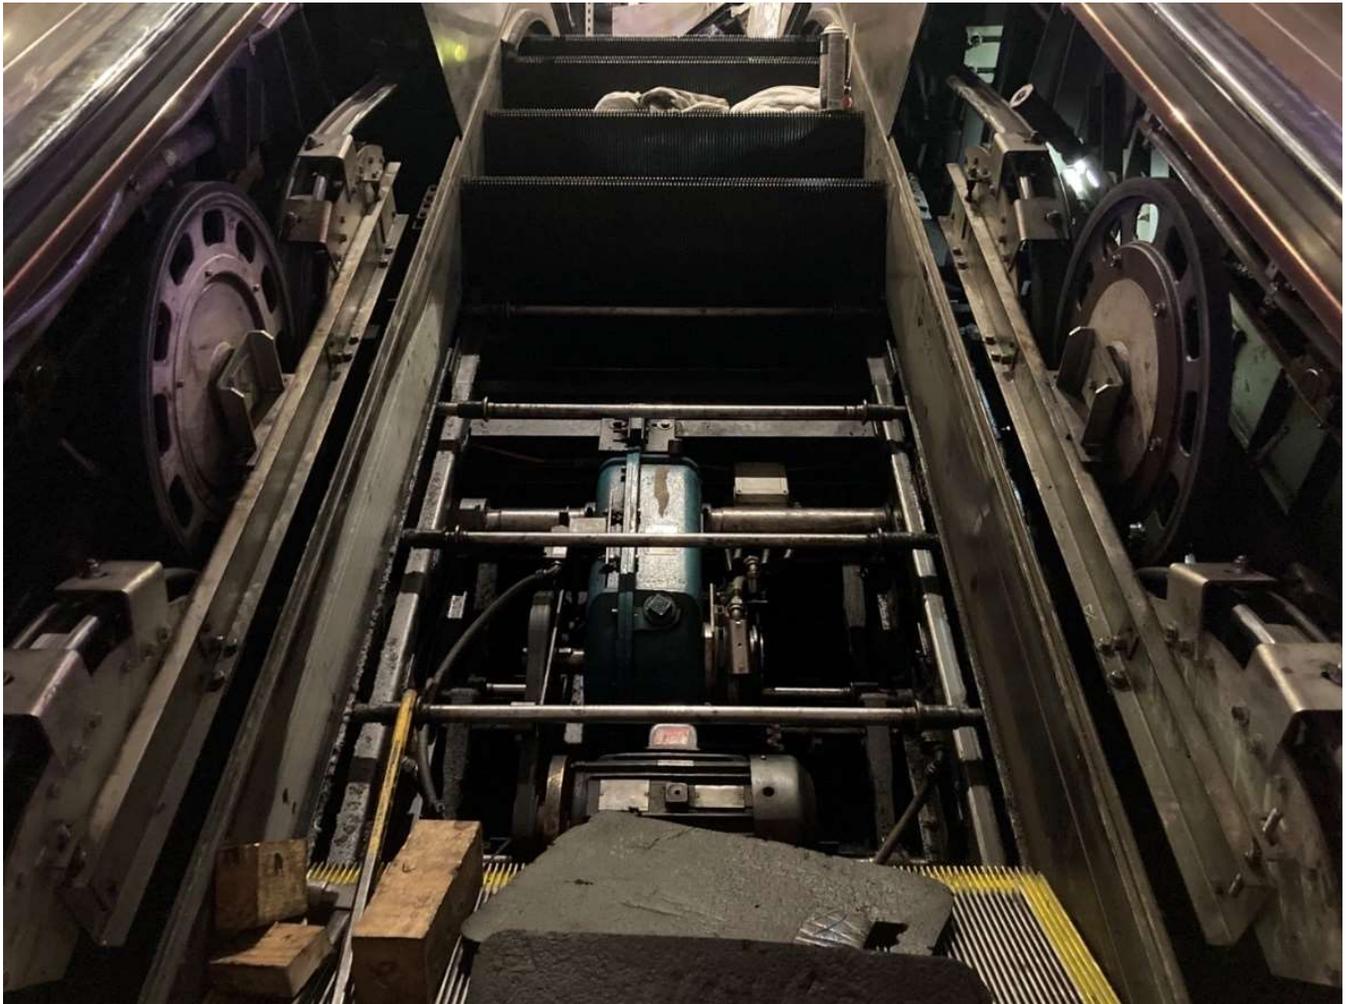
Image 8 - Escalator drive area for Drive #1. This escalator has 2 drives. Drive #2 is located further down the escalator. Drive #2 was unaffected.

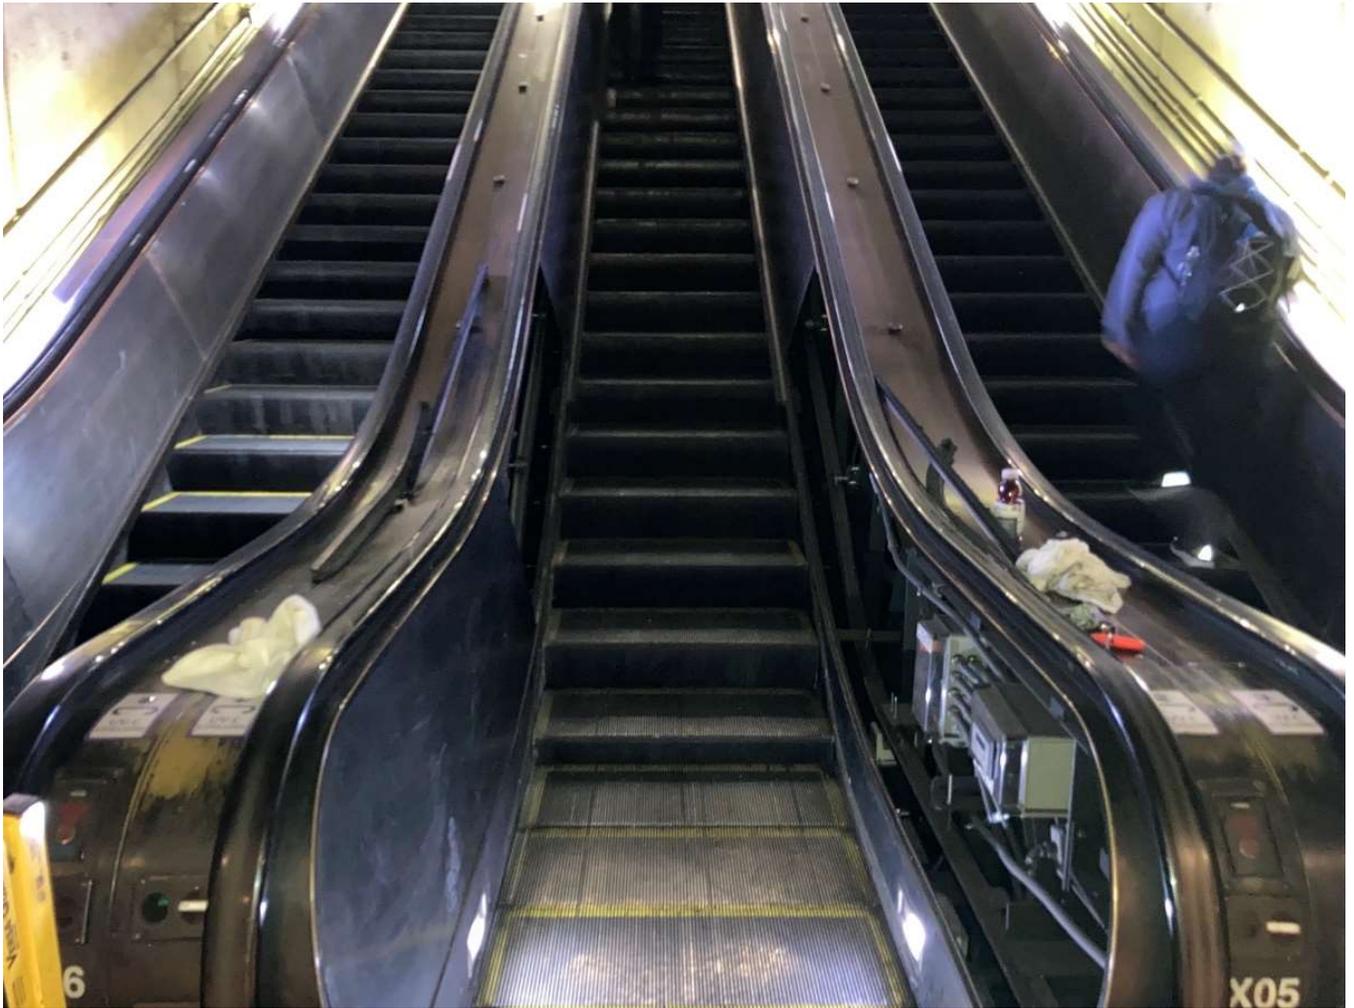
Image 9 – Affected Escalator X05 before repairs began.

The escalator was removed from service, repaired and returned to service on March 20, 2023.

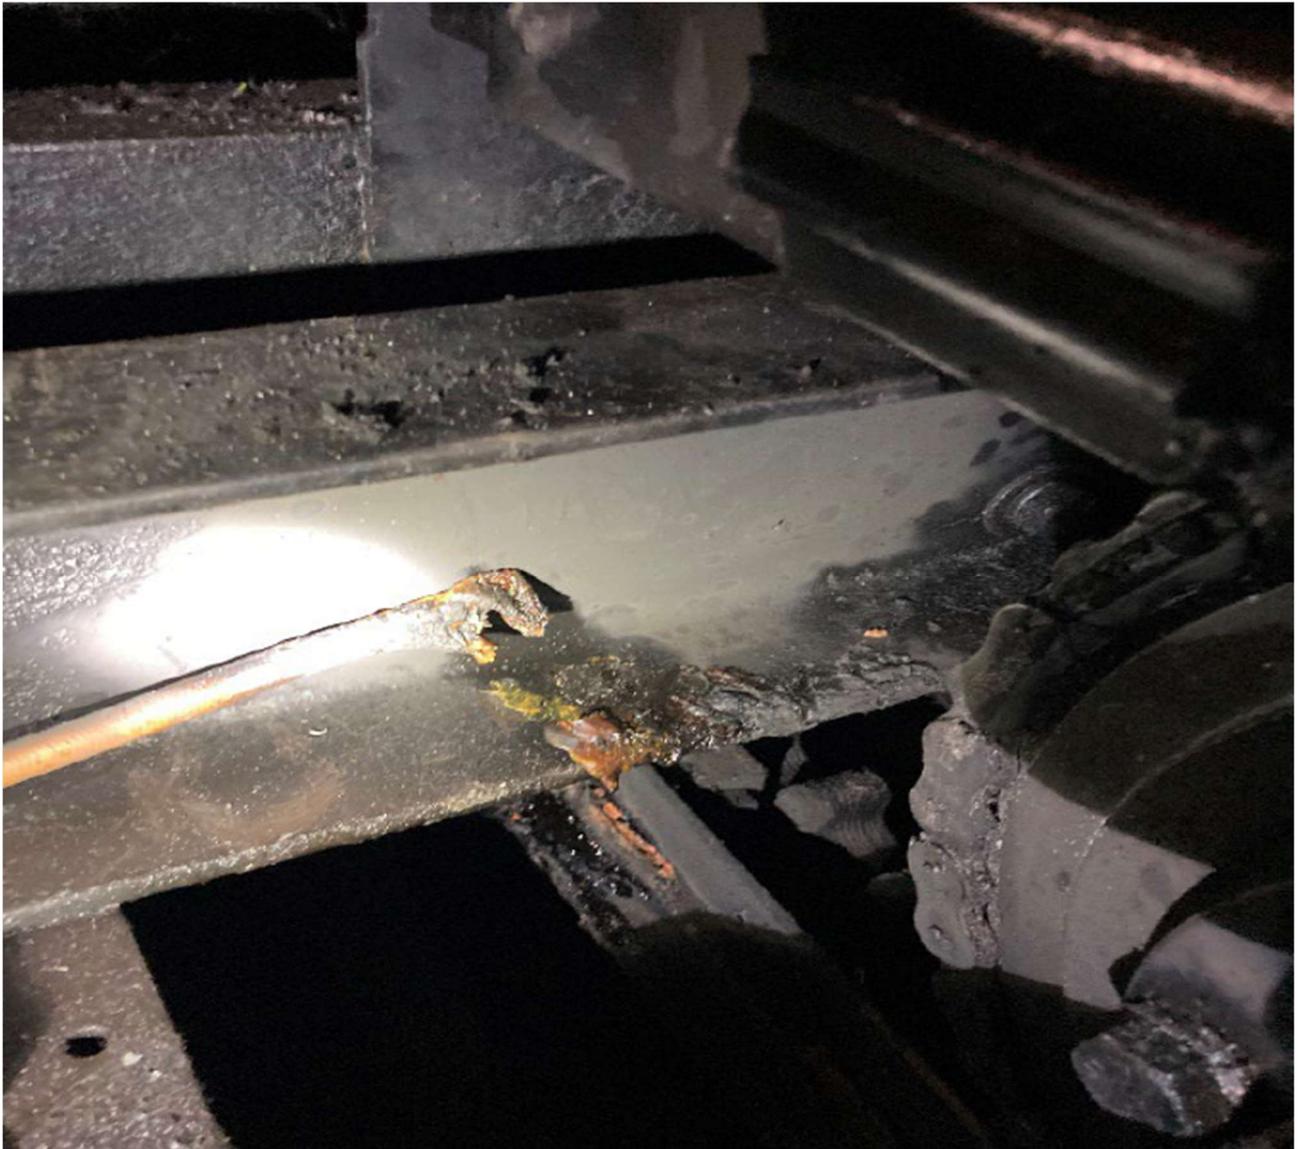
Image 10 - Melted grease line for the stub shaft bearing.
