WMSC Commissioner Brief: W-0247 Evacuation for Life Safety Reasons - Greenbelt Rail Yard - April 18, 2023

FINAL REPORT OF INVESTIGATION A&I E23266

Greenbelt Yard Building, Service & Inspection Shop – Evacuation for Life Safety Reason

April 18, 2023

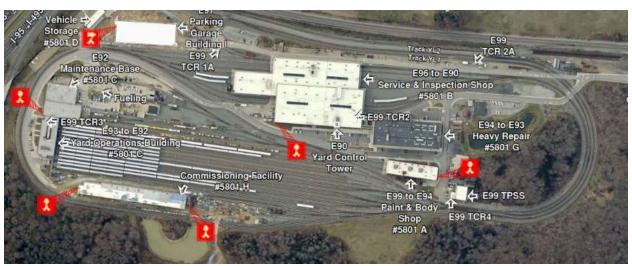
Figure 1 - Building - B (S&I Shop) location of leaking gas meter. The above depiction is not to scale.

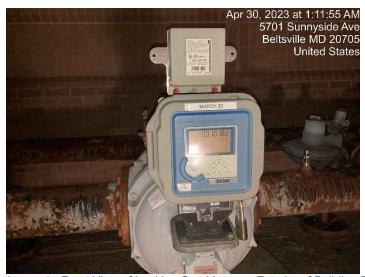
Image 1 - Front View of Leaking Gas Meter on Exterior of Building B (S&I Shop)

Washington Gas responded on April 19, 2023, and determined the source of the leak to be a defective regulator and replaced the manifold feeding the S&I shop.

The probable cause of the Evacuation for Life Safety Reasons (Gas Leak) event was determined to be a gas leak from the gas regulator located on the external portion of Building B.

Washington Gas responded the following day and identified a defective regulator on the gas meter as the cause of the leak. Maintenance and the inspection of the meter are the responsibility of Washington Gas. Washington Gas replaced the manifold feeding the Service and Inspection Shop.

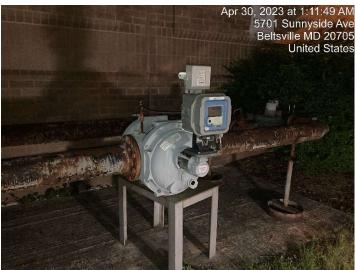
Image 2 - Side View of Leaking Gas Meter on Exterior of Building B (S&I Shop)

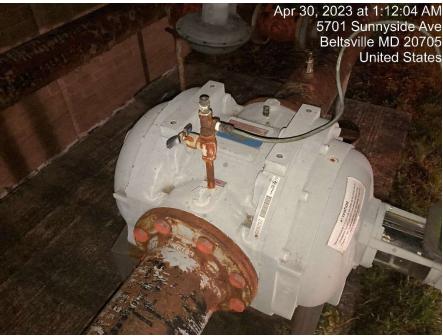
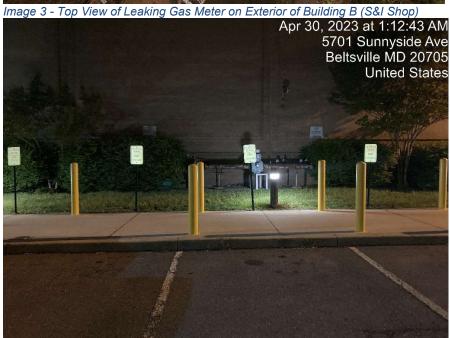
Image 4 - Front View of Leaking Gas Meter on Exterior of Building B (S&I Shop)
