WMSC Commissioner Brief: W-0248 Serious Injury – Congress Heights Station – April 23, 2023

FINAL REPORT OF INVESTIGATION A&I E23284

Date of Event:	April 23, 2023
Type of Event:	Serious Injury
Incident Time:	12:48 hours
Location:	Congress Heights Station, track 1
Time and How received by SAFE:	12:54 hours – SAFE/MAC
WMSC Notification Time:	13:45 hours
Responding Safety Officers:	WMATA: None WMSC: None Other: None
Rail Vehicle:	Train ID 506 L7252-7253.7421-7420.7240-7241.7385-7384T
Injuries:	Shoulder and Knee Injuries
Damage:	None
Emergency Responders:	Metro Transit Police Department (MTPD), District of Columbia Fire and Emergency Medical Services Department (DCFEMS)
SMS I/A Incident Number:	20230423#107911MX

Congress Height Station – Serious Injury

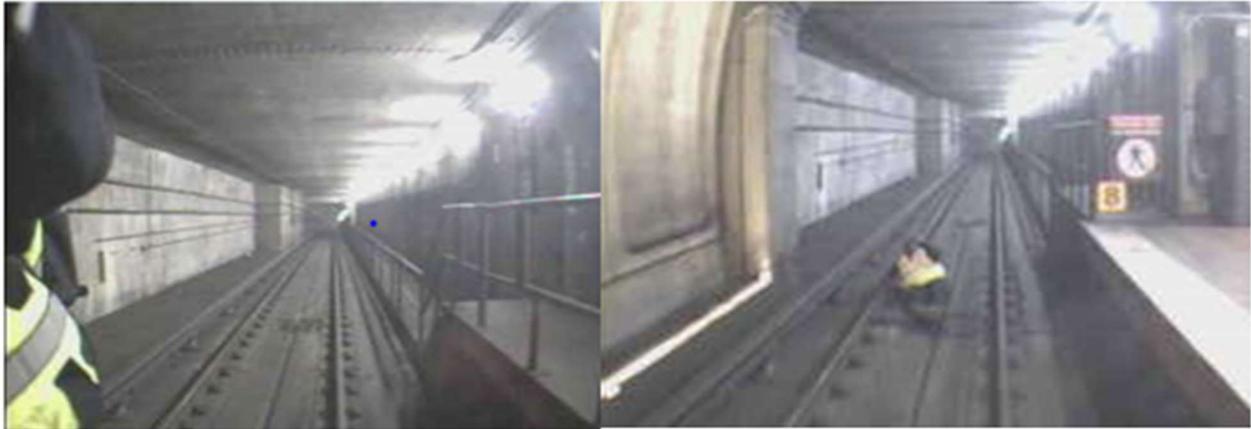
A review of the interior train video and Closed-Circuit Television (CCTV) revealed that when Train ID 506 berthed on the platform, Rail Supervisor #1 deliberately exited from the trailing car's, rear bulkhead door, then fell to the roadway. The train departed the station, Rail Supervisor #1 was laying between the running rails. After the event, Rail Supervisor #1 reported that they were attempting to secure an exterior inter-car barrier when they fell. No damage or malfunctioning inter-car barrier were found.

Image 1 – Rail Supervisor #1 exiting car 7384 through the bulkhead door at 12:48 and lying injured as the train departed Congress Heights Station on track 1.

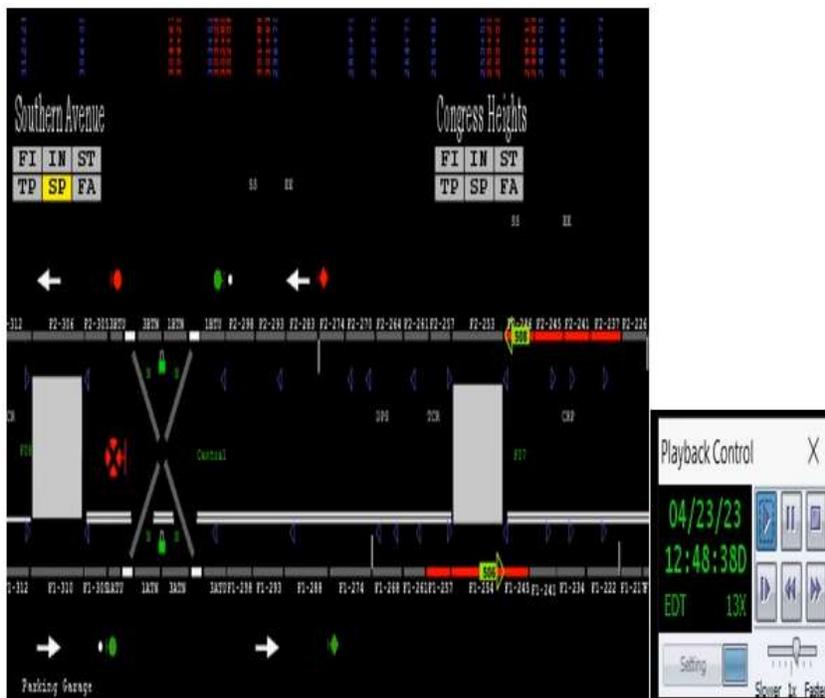
Figure 1 - Train ID 506 arriving at Congress Heights Station

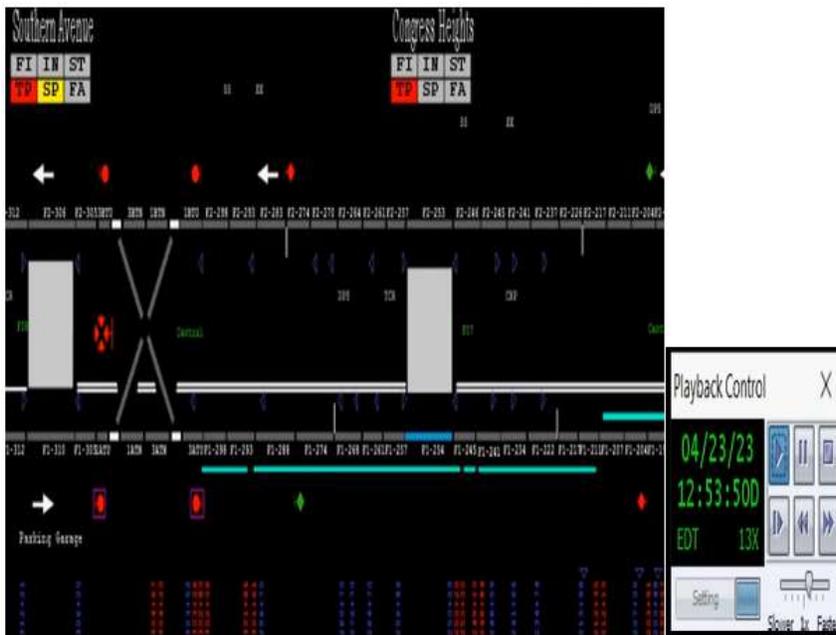
Figure 2 - Third rail de-energized on track 1 at Congress Heights Station

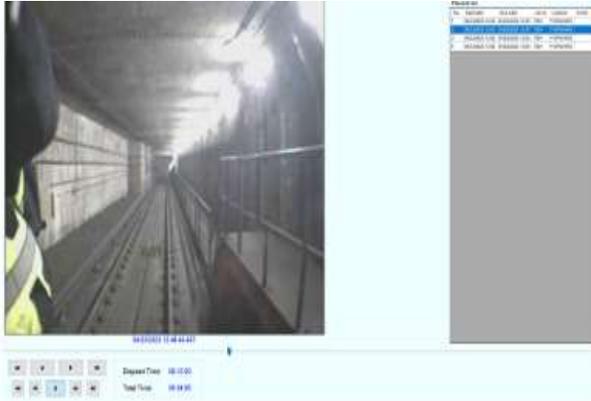
The Worker is seen coming out at the rear of Car 7384 on 04/23/23 Time 12:48:44.457

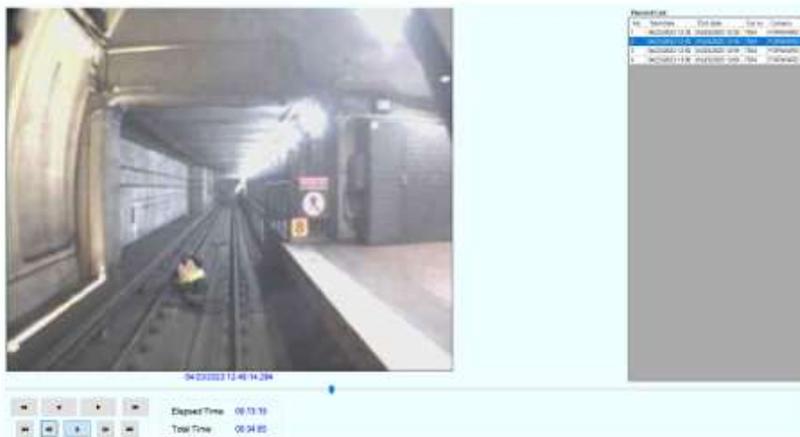
The Worker fell from the Rear of Car 7384 as they began to move from Congress Heights Station Platform on Track-1 on 04/23/23 Time 12:49:14.284.

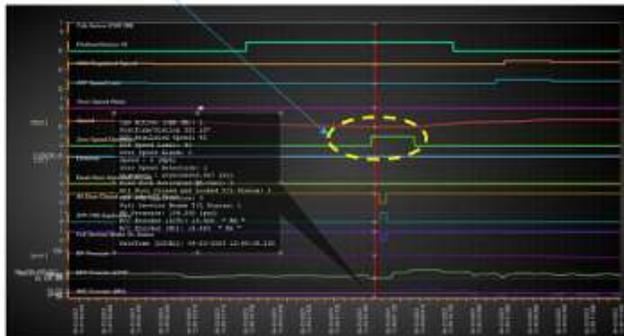
12:48:38.230 ER Data Graph confirming lead Car 7252 stopped at Congress Heights on Track-1 TWC (187)
