WMSC Commissioner Brief: W-0250 – Collision – Gallery Place-Chinatown Station – May 12, 2023

Washington Metropolitan Area Transit Authority
Department of Safety (SAFE)
Office of Safety Investigations (OSI)
FINAL REPORT OF INVESTIGATION A&I E23325

Gallery Place Station – Collision

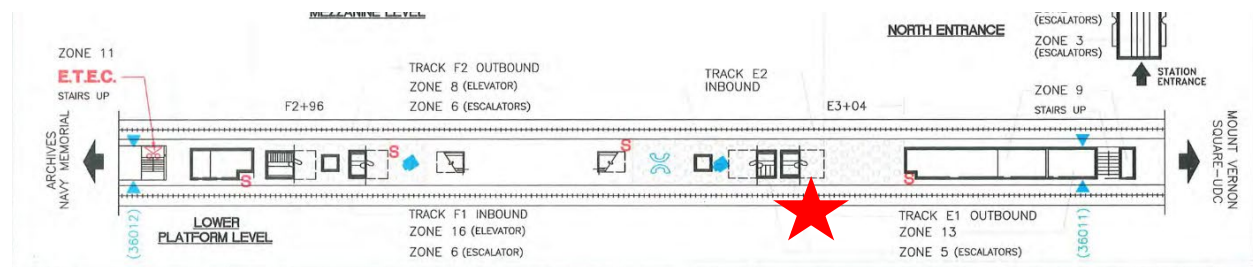
Figure 1: This image shows the approximate location where the person was struck by the train. The above depiction is not to scale.

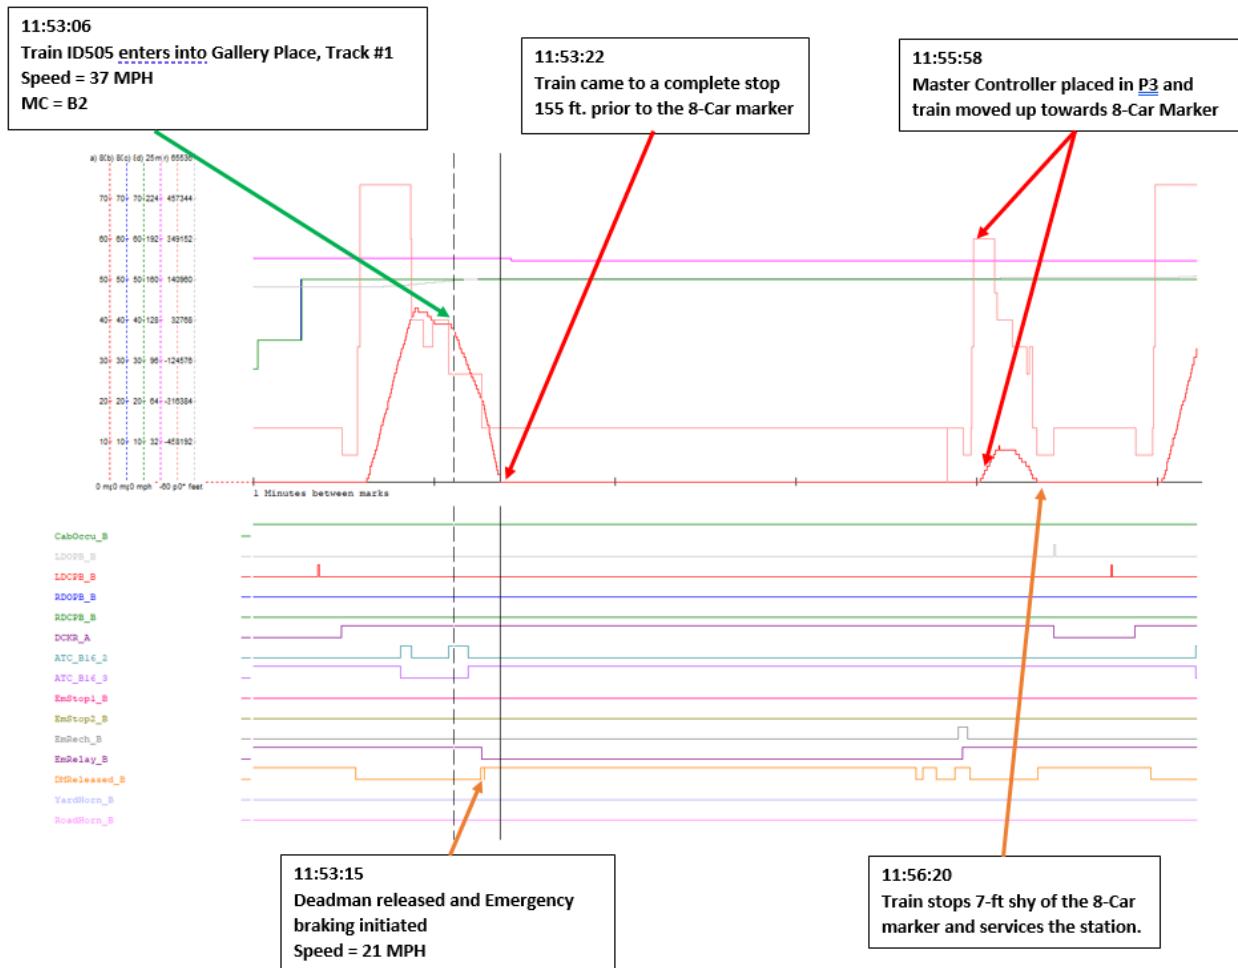
Figure 2 - Graphical Representation of Train Data from Car 3103

“Based on VMS data, Train ID 505, with Lead Car 3103 entered into Gallery Place station, traveling at 37 MPH. The Deadman emergency Brake function was initiated 358 feet into Gallery Place Station. The train came to a complete stop 155 feet from the 8-Car marker. A few minutes later, the Master Controller was moved to a P3 power position, and the train moved towards the 8-Car marker, stopping 7 feet shy of the 8-Car marker and servicing the station.

Based on VMS data, there was no fault with the train that contributed to the cause of this incident. The train performed as commanded.”

Time	Description of Events
11:53:06 hours	Train ID 505, with Lead car 3103, entered into Gallery Place, Track #1, at a speed of 37 MPH, with the Master Controller in the B2 Braking position.

11:53:15 hours	A control safety device released in B2 Braking position, initiating emergency braking and dumping the brake pipe, train speed was 21 MPH, 242 feet from the 8-Car Marker.

11:53:21 hours	The train came to a complete stop 155 feet from the 8-Car marker.
11:55:53 hours	The brake pipe pushbutton was activated, and the brake pipe was recharged.

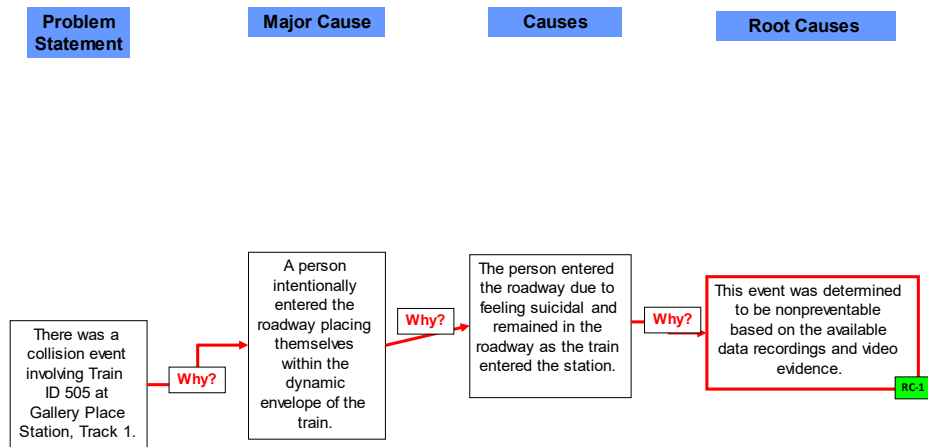
Appendix C – Why-Tree Analysis

The probable cause for this collision was the intentional action of the person to enter onto the rail right-of-way.

There are no Recommended Corrective Actions associated with this event. The personnel involved performed within operating rules and procedures and equipment performed as designed.
