WMSC Commissioner Brief: W-0256 Derailments – Blue Line (near Arlington Cemetery, Largo Town Center, and Rosslyn stations) – October 12, 2021

Prepared for Washington Metrorail Safety Commission meeting on January 23, 2024

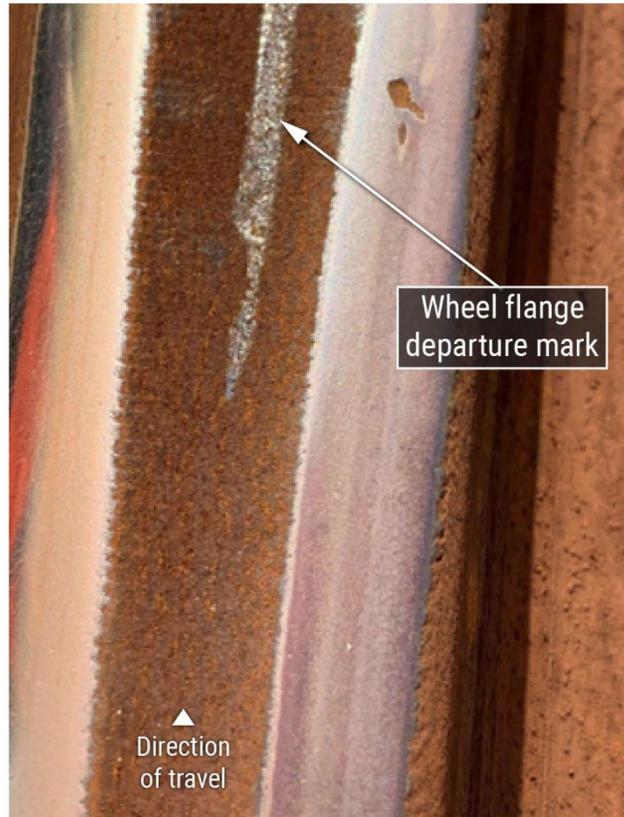
The NTSB also identified wheel flange departure marks on the tread portion of the track (the tread portion carries the wheel tread) on switches 1B and 3B at crossover G05 west of Largo Town Center Station at chain marker 621+98 on main track 2. (See figure 7.) In addition, the NTSB identified wheel marks on the ground, broken ground pads, and damaged automatic train control equipment between switch 1B and switch 3B. The damage was consistent with one or more derailed

Figure 7. Wheel flange departure mark on the tread portion of a frog point at the 1B switch.

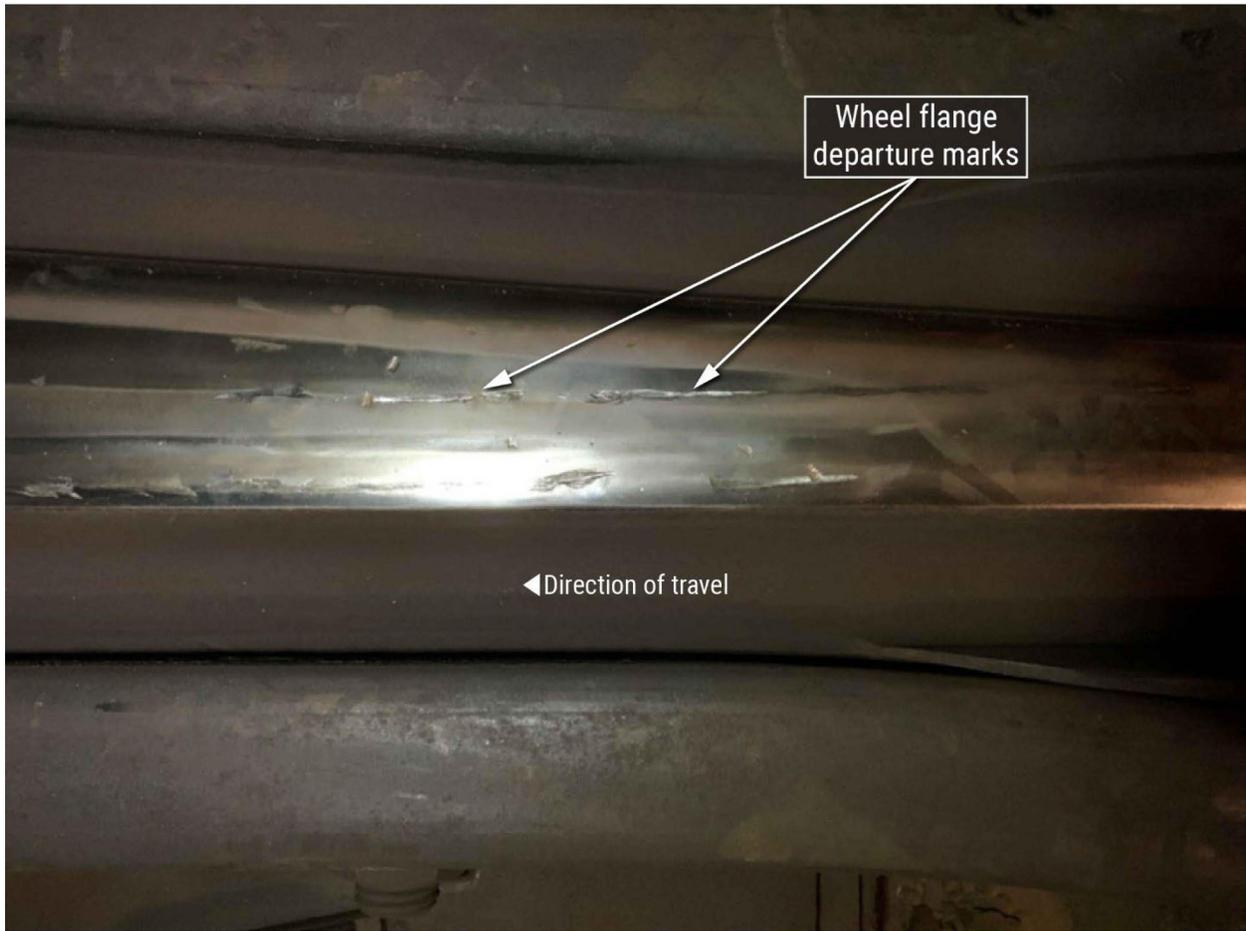
The NTSB identified wheel flange departure marks in the turnout at the frog of the switch in the C05 turnout at chain marker 146+70, about 166 feet south of Rosslyn Station. (See figure 9 and figure 10.) Investigators also found wheel departure marks on other track components nearby. This turnout was the final point of derailment.

Figure 9. Wheel flange departure marks on the tread portion of the frog point at the C05 turnout.

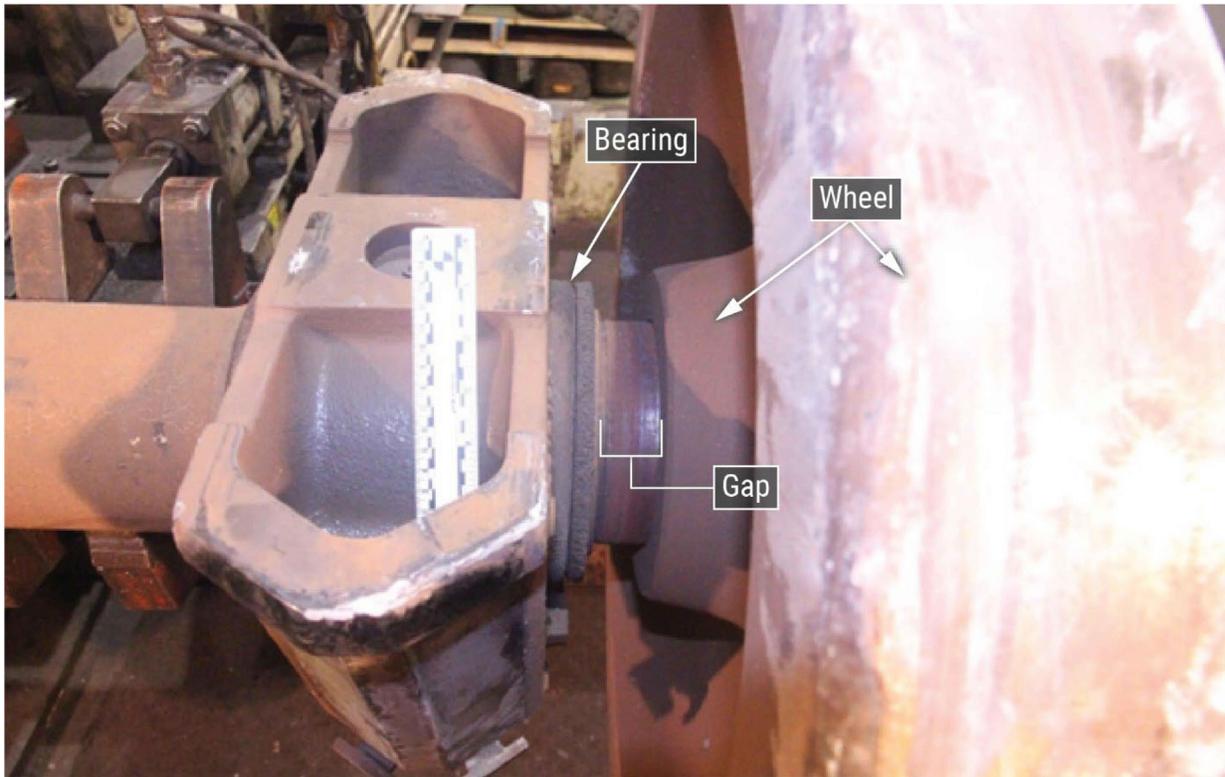
²⁰ The measurement recorded in the inspection discrepancy sheet was "55 3/8 inches" and should be taken as approximate; the wheels were loose on the axle and no longer perpendicular, meaning that the exact point and circumstances of the measurement could introduce variation.

Figure 12. Gap between the right-side wheel and bearing on wheelset #4.

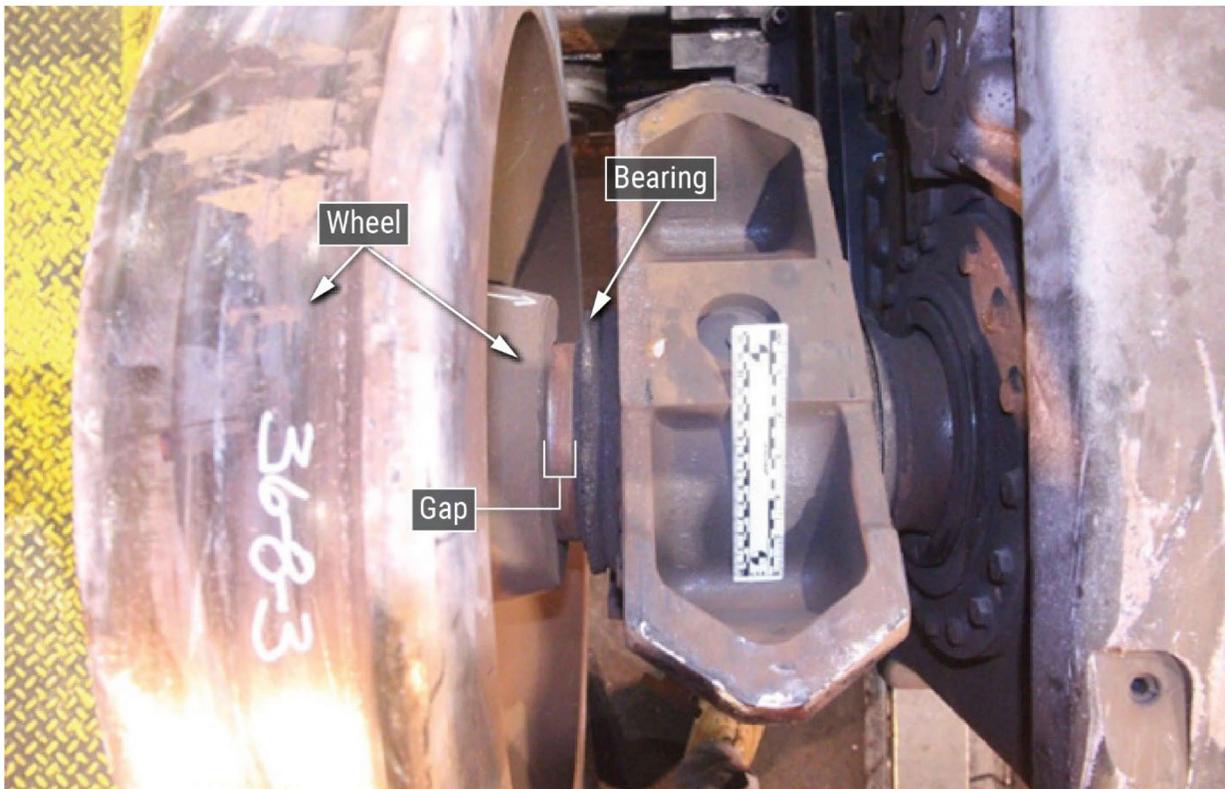
Figure 13. Gap between the left-side wheel and bearing on wheelset #4.

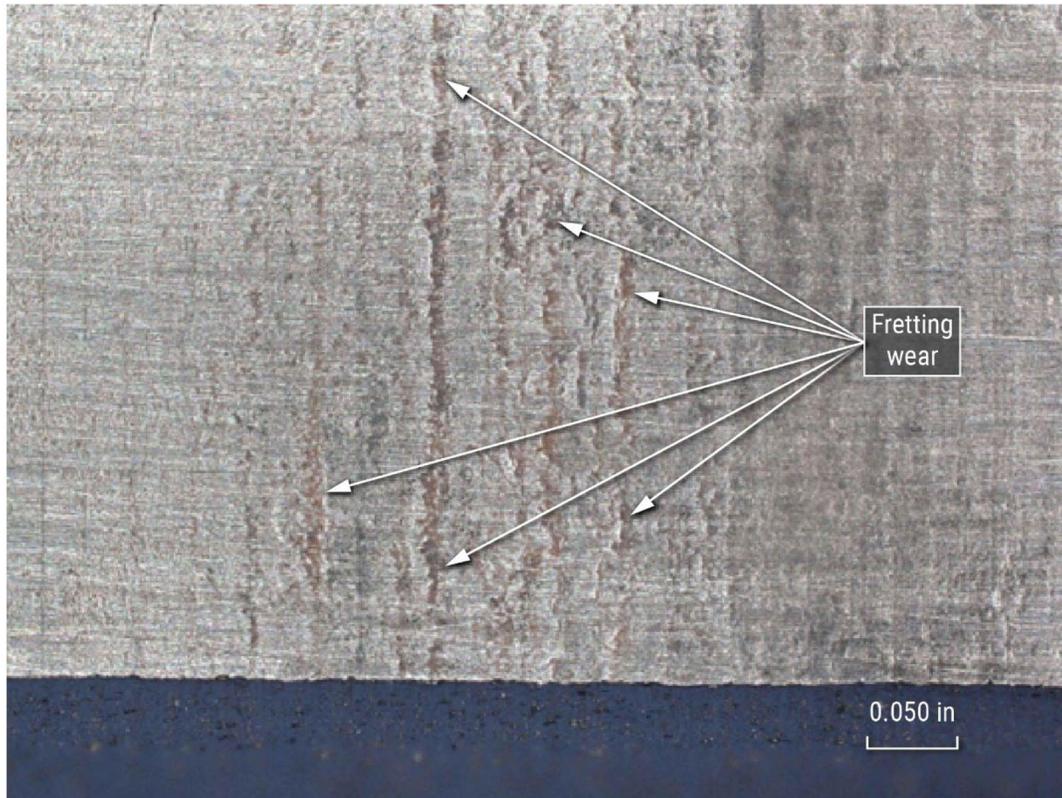
After cleaning the axle to remove obscuring surface oxidation and to allow further examination, the NTSB Materials Laboratory identified circumferential bands consistent with fretting wear on the axle wheel seat surface. Fretting wear results from small oscillations between two bodies in contact. Fretting wear tends to roughen surface finishes, leading to oxidation and reducing the strength of the connection between components. In axles, fretting wear can be a sign of ratcheting extrusion, in which an axle under simultaneous bending and lateral stresses will experience movement between the wheel bore surface and the axle wheel seat (Nishimura, Sakatmoto, and Kawashima 2001).

The most severe observed region of fretting damage, located on the right-side axle wheel seat surface, exhibited parallel wavy and linear features oriented perpendicular to the axle's long axis. The features exhibited a reddish-brown color consistent with oxidation (rust). (See figure 14.)

Figure 14. Close-up of the most severe fretting wear on the right-side axle wheel seat.
