The Washington Metrorail Safety Commission

Safety Audit - of the Washington Metropolitan Area Transit Authority Audit of Metrorail Power Systems

Final Report:
February 7, 2024

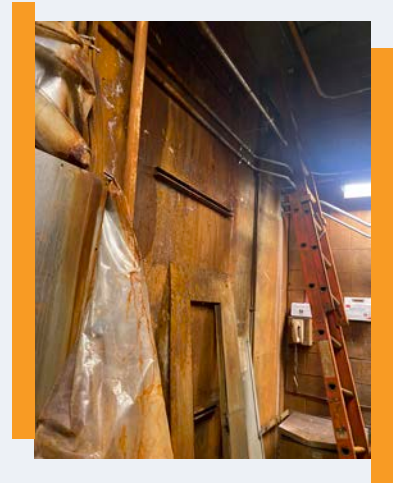
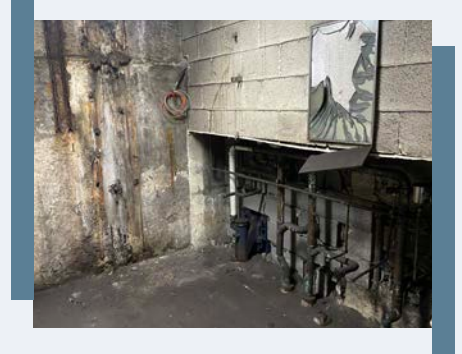
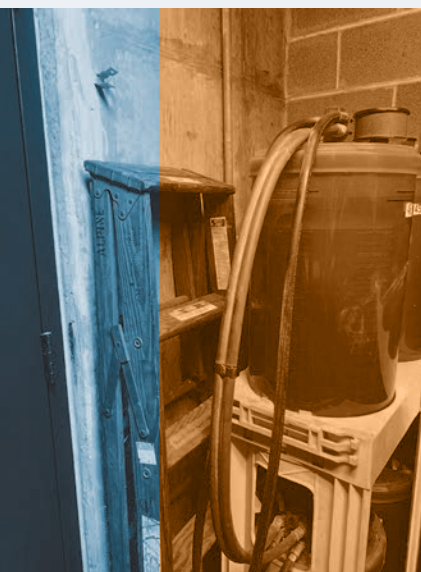
Locations where significant water intrusion was evident by extensive corrosion included the Traction Power Substation at Benning Road. Other power rooms had varying evidence of water leaks onto or around equipment, such as the Gallery Place (F01) battery room floor, and other rooms with evidence of leaks onto equipment. Significant signs of water intrusion were also found in the Alternating Current (AC) Room at Metro Center Station where much of the room was rust-colored. Power rooms, tie-breaker facilities, and traction power substations house vital electrical equipment responsible for supplying power to sections of third rail and surrounding facilities. Water intrusion could result in injury or death by electrocution or safety critical systems failure, including systems designed to ensure safe train movement.

At Metro Center AC Room 1, the WMSC Audit team observed a heavy leak from a pipe onto the roadway outside the room, and extensive corrosion, sediment and apparent water damage inside the room. The walls, floors and other parts of the room were coated in a rust color. Room logbooks showed the water intrusion issue noted repeatedly for many years, but onsite observations and logbooks showed that the water intrusion has not been effectively mitigated. This demonstrates deficiencies in Metrorail's corrective maintenance program. In response to a subsequent request, Metrorail provided records showing that repeated work orders were created and closed starting in January 2021 for Metro Center AC Room 1 and in March 2021 for AC Room 2 for water intrusion inspection. The observations demonstrate that this problem persists. After the WMSC raised this concern to Metrorail, WMATA personnel performed an inspection that determined water was leaking from the pipe outside the room at a rate of 1 gallon per minute. Repairs on that pipe, which were separate from the evidence of long-term water intrusion that remains in the room, were completed on July 23, 2023.

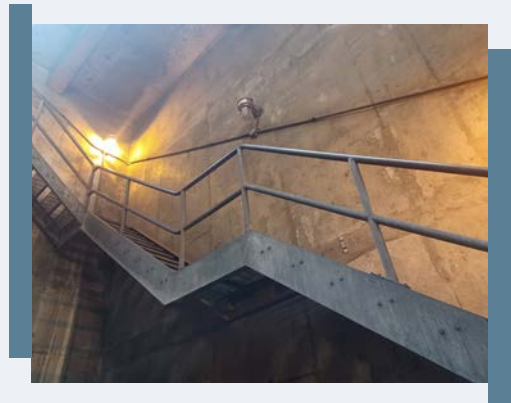
- ▶ At Benning Road Traction Power Substation 2, safety issues related to the emergency exit at the east end of the room that leads to a ladder to the street level were identified.
 - ◆ The emergency exit door did not open with a moderate amount of force, and only opened when kicked open by an employee (see Finding 1). The door's auto close mechanism then did not function. The bottom of the door appeared corroded from repeated water intrusion.
 - As an interim mitigation, WMATA installed aluminum and sprayed the hinges to ensure functionality. A work order to replace the door was created on July 22, 2023, and it was completed on September 11, 2023.

Lights in the stairwell were out, the protective covers for bulbs were sitting on the stairs, and one of the light sockets appeared to have been struck and damaged, posing a hazard

- A Low Voltage Power crew repaired all lighting issues identified.
- ◆ The bottom of the emergency exit stairs is corroding, apparently due to regular water pooling.

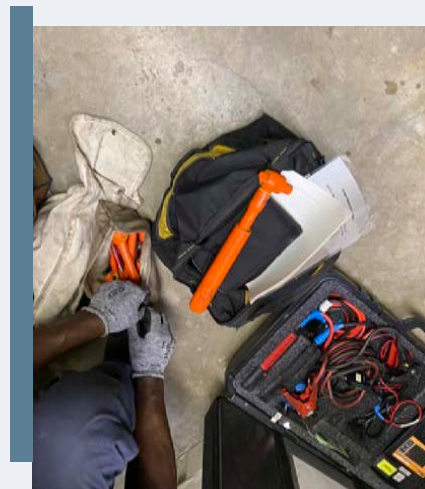
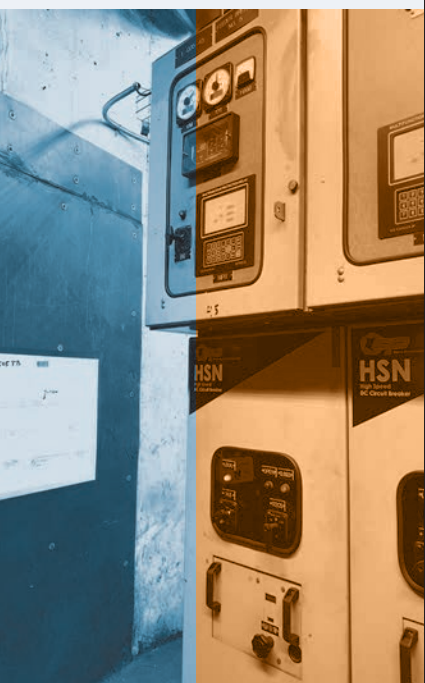
WMSC personnel observed the use of a torque wrench with a sticker showing the tool was past due for calibration.

After the WMSC presented this safety concern, WMATA identified that the use of tools out of calibration by the battery maintenance crew is a systemic issue, and began to correct that issue. The Office of Power leadership stated that the battery personnel's torque

wrenches were not included in the calibrated tools process when Metrorail shifted responsibility for and organization of its calibration. These torque wrenches were not entered at that time in Maximo, Metrorail's maintenance management system, as requiring calibration.

Metrorail submitted documentation to the WMSC that detailed the corrective actions taken to address this finding.
