Inspection Form

Washington Metrorail Safety Commission

Increation Date	YYYY/MM/DD	Donast Number	20230929-WMSC-DLB-9					
Inspection Date	2023/09/29	Report Number						
Rail Agency Name	Washington Metropolitan Area Transit Authority	Rail Agency Department	Name					
Rail Agency Department	Roadway Worker Protection (RWP)	Contact Information						
Inspection Location	Carmen Turner Facility (CTF) 3500 Pennsy Drive Landover Md. 20785

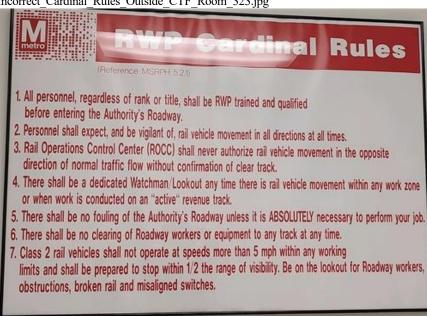
This a second reporting and it involves the following safety concern: 1. Signage posted outside of Metrorail training room 323 located on the third floor at the Carmen Turner Training Facility (CTF) â¿¿ see attached photo. The posted signage conveys outdated Roadway Worker Protection (RWP) cardinal rule information. In particular cardinal rule number seven states that "Class 2 rail vehicles shall not operate at speeds more than 5 mph within any working limits and shall be prepared to stop within â½ the range of visibility. Be on the lookout for Roadway workers, obstructions, broken rail and misaligned switches." The Metrorail Operating Rulebook (MOR) does not use this cardinal rule, in fact it has been removed from usage. The MOR guidance states cardinal rule number seven as follows, "Roadway Maintenance Machines shall operate at Restricted Speed within any working limits." METHOD: The information for this report was provided to the WMSC via anonymous Metrorail personnel through directed contact. CONCLUSION/FINDING: It was found that Metrorail is still in possession of and using outdated signage from the MSRPH for training purposes that allows for practical drift from established Metrorail procedures and rules. The safety concern introduced by the presence of the outdated signage is ambiguous information. This confusion will introduce misinterpretation and improper setup of roadway worker protection resulting in safety incidents. It is recommended that the situation continue to be monitored by the WMSC. It is also recommended that the outdated RWP guidance be removed from the training environment and, if necessary, Metrorail create and post new signage reflecting									•	Number o	of Defects				0

Roadway Worker Protection (RWP) cardinal rule information. In particular cardinal rule number seven states that "Class 2 rail vehicles shall not operate at speeds more than 5 mph within any working limits and shall be prepared to stop within Â'x the range of visibility. Be on the lookout for Roadway workers, obstructions, broken rail and misaligned switches." The Metrorail Operating Rulebook (MOR) does not use this cardinal rule, in fact it has been removed from usage. The MOR guidance states cardinal rule number seven as follows, "Roadway Maintenance Machines shall operate at Restricted Speed within any working limits." METHOD: The information for this report was provided to the WMSC via anonymous Metrorail personnel through directed contact. CONCLUSION/FINDING: It was found that Metrorail is still in possession of and using outdated signage from the MSRPH for training purposes that allows for practical drift from established Metrorail procedures and rules. The safety concern introduced by the presence of the outdated signage is ambiguous information. This confusion will introduce misinterpretation and improper setup of roadway worker protection resulting in safety incidents. It is recommended that the situation continue to be monitored by the WMSC. It is also recommended that the outdated RWP guidance be removed from the training environment and, if necessary, Metrorail create and post new signage reflecting										Remedial Action Required?					No	0

Incorrect Cardinal Rules Outside CTF Room 323.jpg

Also, follow- up unannounced inspections should be implemented. As a follow-up to this anonymous safety concern report, the WMSC Inspector reached out to Metrorail RTRA management who upon being notified of the situation promptly removed the outdated cardinal rules sign. Therefore, the situation was mitigated. Remedial Action		Roadway Worker Protection (RWP) cardinal rule information. In particular cardinal rule number seven states that "Class 2 rail vehicles shall not operate at speeds more than 5 mph within any working limits and shall be prepared to stop within ½ the range of visibility. Be on the lookout for Roadway workers, obstructions, broken rail and misaligned switches." The Metrorail Operating Rulebook (MOR) does not use this cardinal rule, in fact it has been removed from usage. The MOR guidance states cardinal rule number seven as follows, "Roadway Maintenance Machines shall operate at Restricted Speed within any working limits." METHOD: The information for this report was provided to the WMSC via anonymous Metrorail personnel through directed contact. CONCLUSION/FINDING: It was found that Metrorail is still in possession of and using outdated signage from the MSRPH for training purposes that allows for practical drift from established Metrorail procedures and rules. The safety concern introduced by the presence of the outdated signage is ambiguous information. This confusion will introduce misinterpretation and improper setup of roadway worker protection resulting in safety incidents. It is recommended that the situation continue to be monitored by the WMSC. It is also recommended that the outdated RWP guidance be removed from the training environment and, if necessary, Metrorail create and post new signage reflecting the MOR cardinal rules. This action will serve to eliminate a re-occurrence in the future. Also, follow- up unannounced inspections should be implemented. As a follow-up to this anonymous safety concern report, the WMSC Inspector reached out to Metrorail RTRA management who upon being notified of the situation promptly removed the outdated								Ye:	s
