WMSC Commissioner Brief: W-0257 Red Signal Overrun – Ballston Station – April 15, 2023

Prepared for Washington Metrorail Safety Commission meeting on March 5, 2024

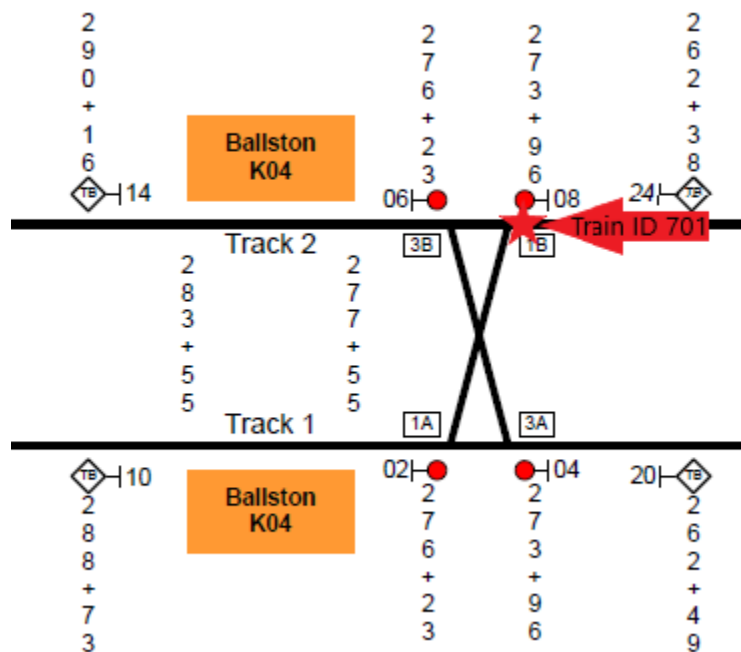
Field Sketch/Schematics

Ballston Station, Track 2, Red Signal K04-08
CM K2 273+96

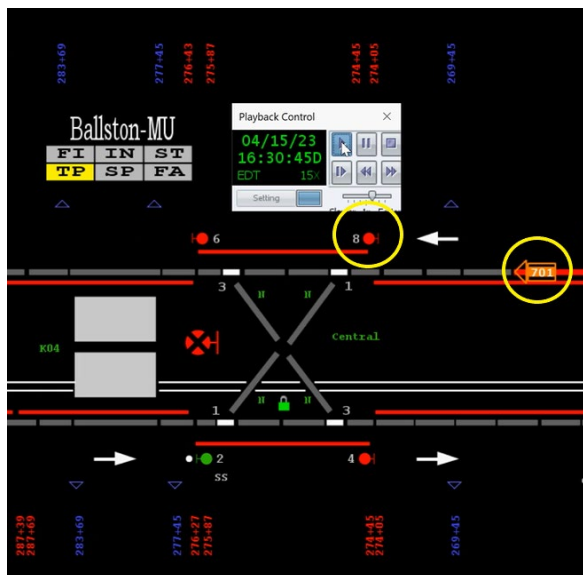
Based on the AIMS playback, it was observed that at 4:30 PM, signal K04-08 was changed to red.

Figure 2 – Train ID 701 moving towards red signal K04-08 with ATP cutout (Train ID White font) at 16:30 hours.

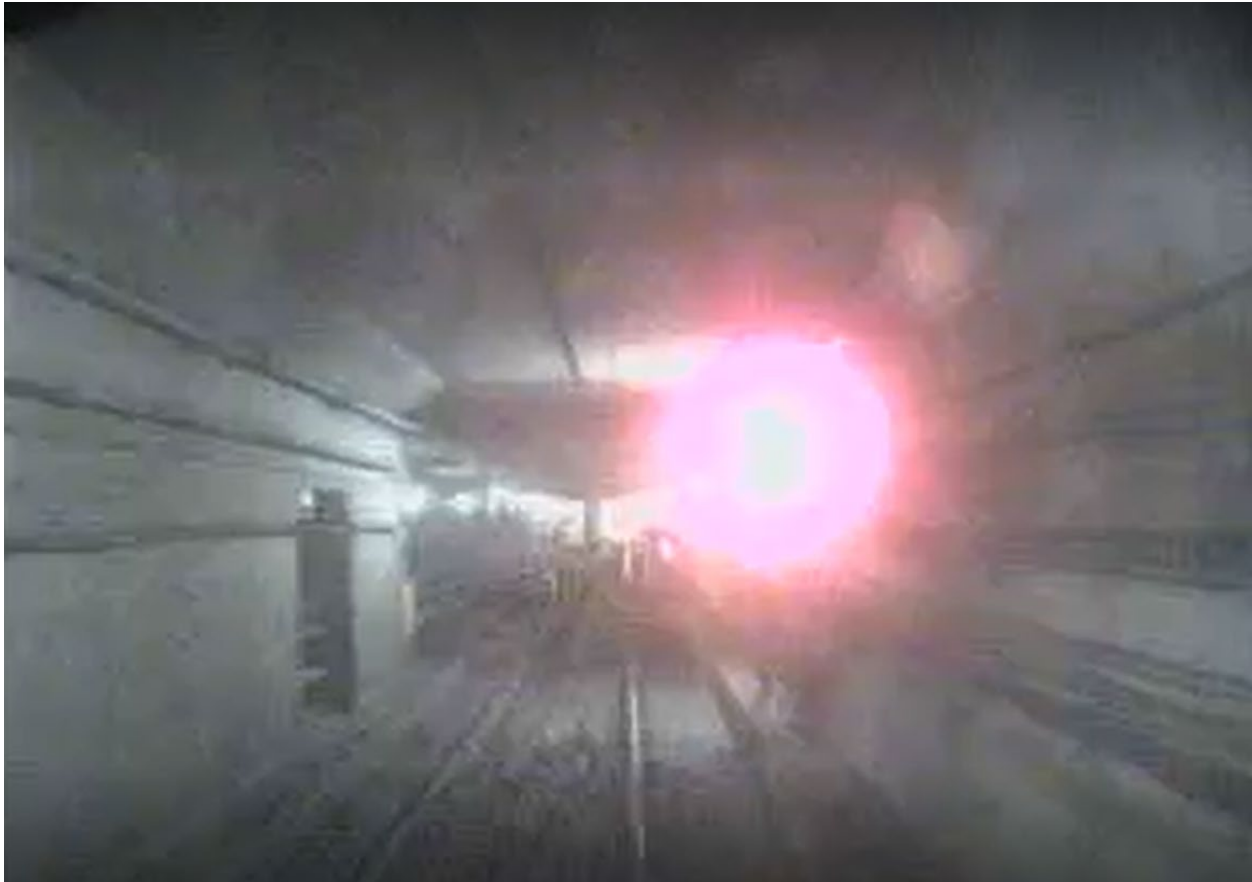
Figure 3 - Footage taken from the forward-facing camera of Train ID 701 determined the train observed Red Signal K04-08 at 16:31 hours, failing to stop.

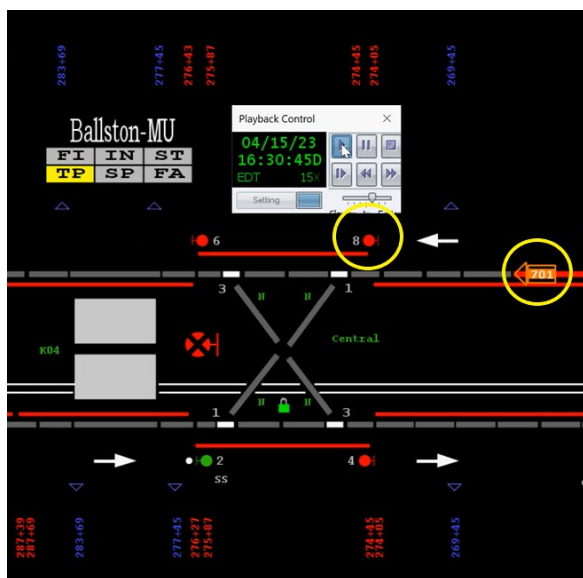
AIMS Playback determined that at approximately 16:30 hours, Train ID 701 approached Red Signal K04-08.

Figure 4 – Train ID 701 moving towards red signal K04-08 with ATP cutout (Train ID White font) at 16:30 hours.

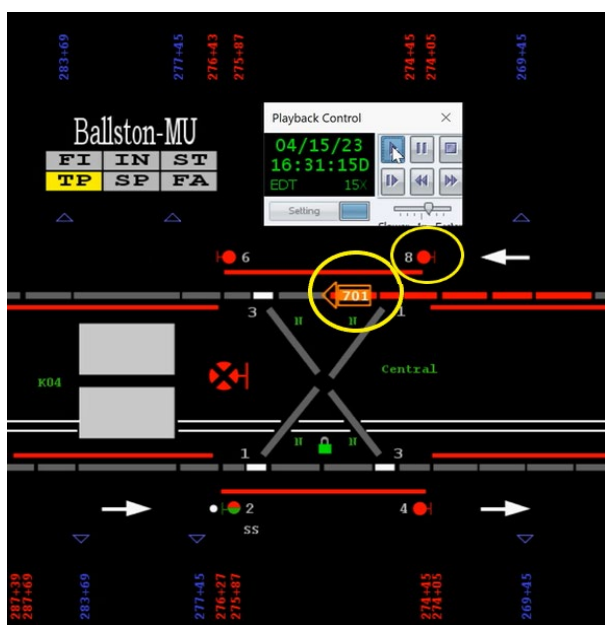
At approximately 16:31 hours, Train ID 701 traveled past Red Signal K04-08 without permission from the ROCC.

Figure 5 - Train ID 701 moved past the red signal K04-08 at 16:31 hours while the signal was still red.

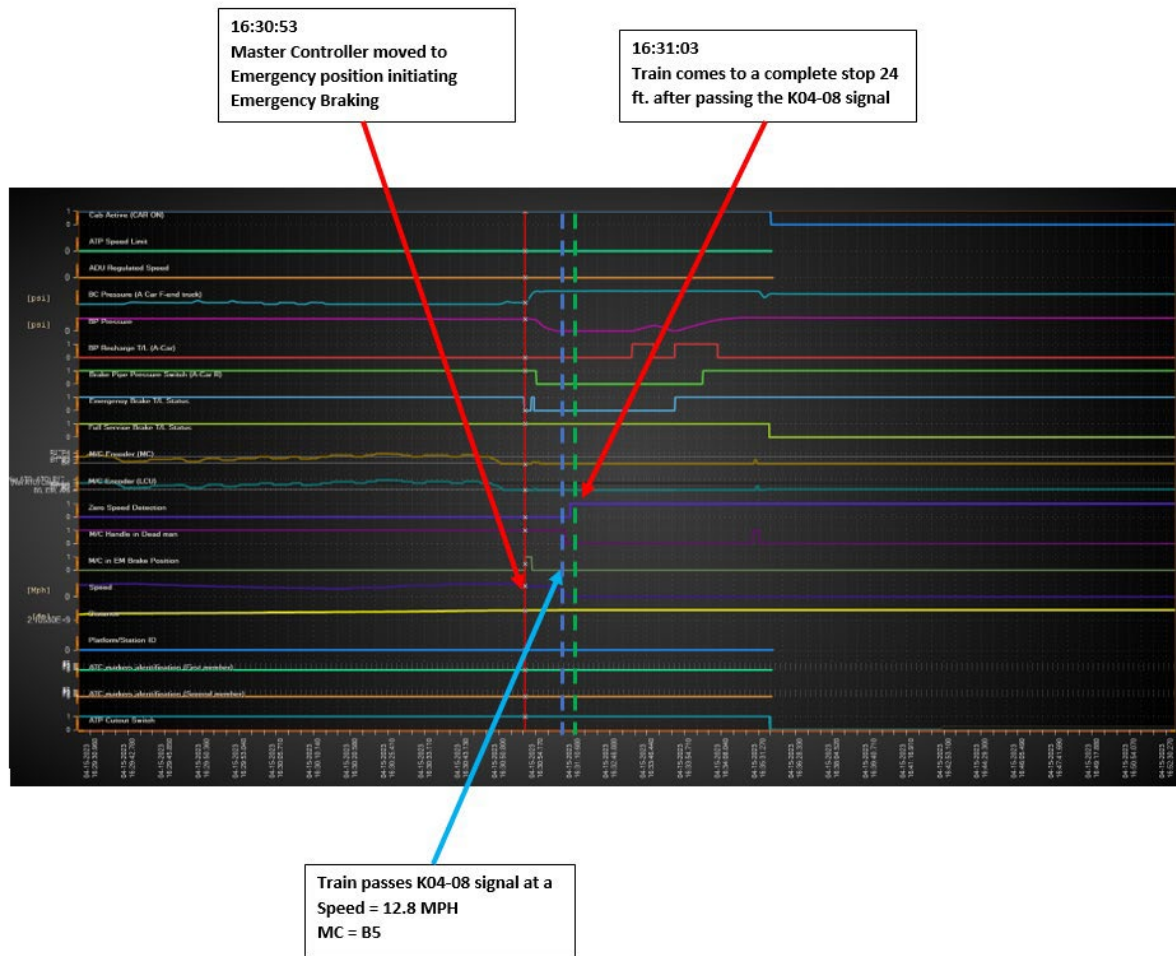
The train travelled up to 38 miles per hour in the 5 minutes of travel from Rosslyn Station toward Ballston Station. The train was traveling at 36.6 miles per hour when the Train Operator applied B5 (maximum normal) braking 314 feet before the red signal. Approximately 3 seconds later, the train operator applied emergency braking 186 feet before the Red Signal when the train was travelling 32 mph. The train passed the red signal at 12.8 mph, and stopped 24 feet beyond the signal.

Graph 2 - depicted when Train 701 passed the K04-08 signal red and the train speed.

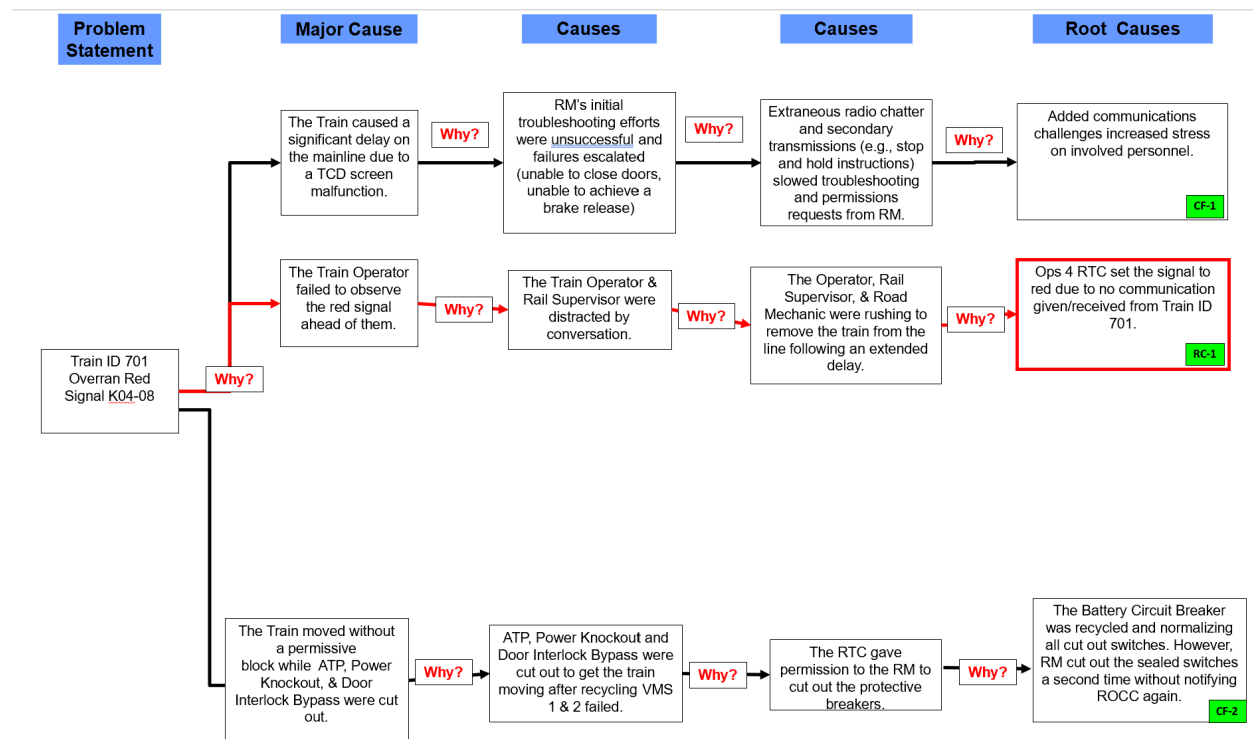
Appendix E – Why-Tree Analysis

The probable cause for this Red Signal Overrun Event was that the Radio RTC and Train Operator failed to follow established troubleshooting and operating procedures. Specifically, the Train Operator moved the train with ATP cut-out and no Permissive Block was given. The Radio RTC did not give the Train Operator a Permissive Block to move the train after ATP was cut out. The RM 3 did not get permission to cut ATP and power knockout a second time. After several unsuccessful attempts to make radio contact with Train ID 701, the Button RTC pulled the lunar signal causing K04-08 signal to be red. The Train Operator was distracted while operating and talking with the Rail Supervisor, whose radio was on Ops 2, when they passed K04-08 signal.
