**WMSC Commissioner Brief: W-0258 Red Signal Overrun – Ballston Station – June 10, 2023**

**FINAL REPORT OF INVESTIGATION A&I E23394**

# Ballston Station – Red Signal Overrun

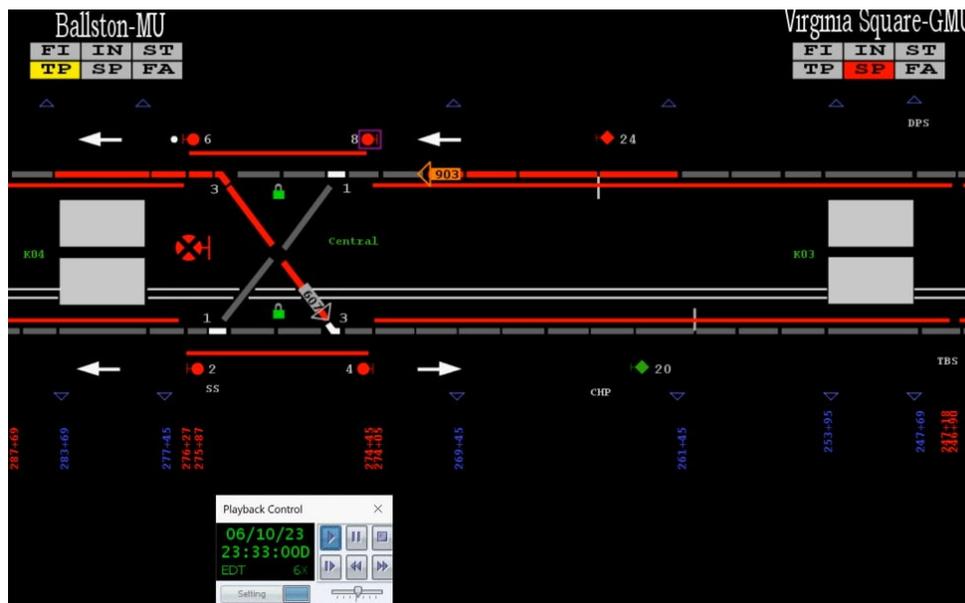
Figure 1 – Train ID 903 located outside of Ballston Station at K04-08 signal red as Train ID 607 traversed the interlocking at 23:33 hours.

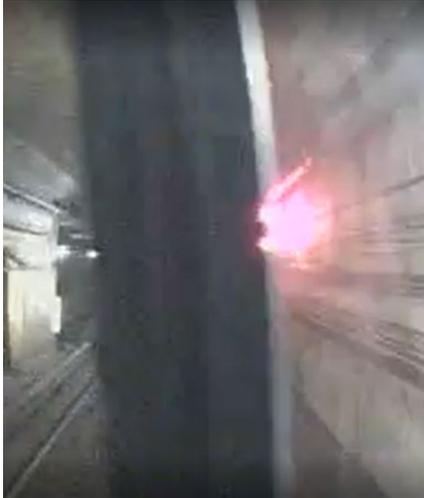
At 23:36 hours, the Train Operator overran signal K04-08 displaying a red aspect, then continued to berth the train at Ballston Station on track 2.

*Image 1 – Camera view from Train ID 903 passing K04-08 signal displaying a red aspect.*

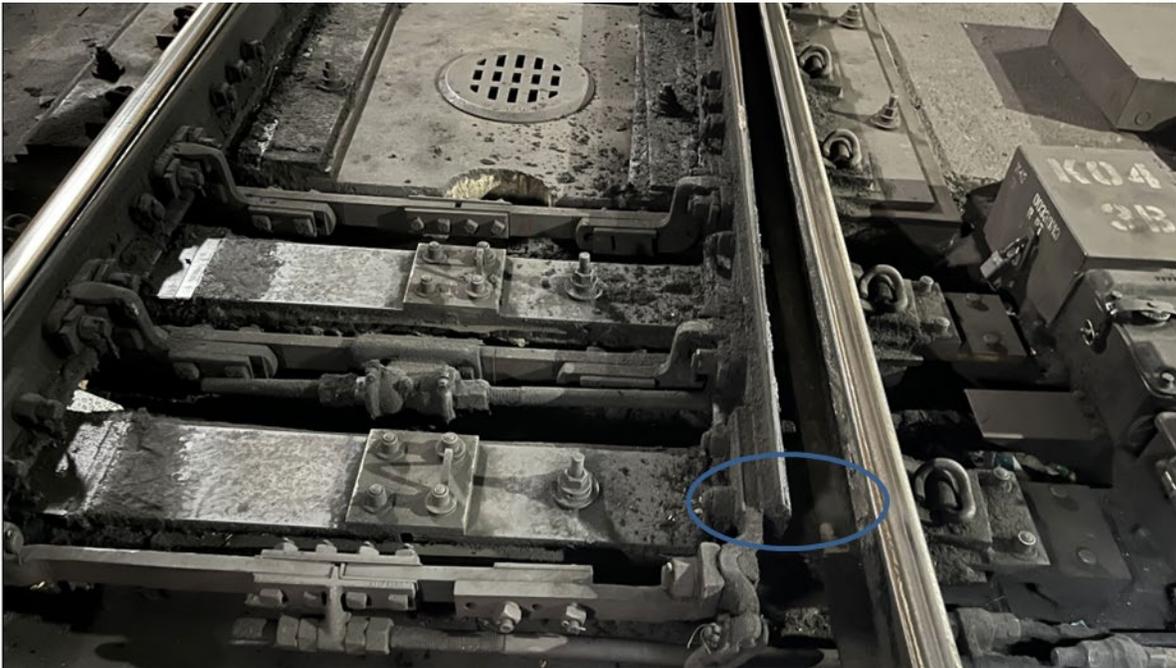
The train movement damaged the switch point of Switch 3B.

Image 2 – Image of damage at switch point 3B.

ATCM inspected the Ballston Station interlocking and reported that switch 3B was trailed and damaged. ATCM performed maintenance and corrections, and then the interlocking was returned to service.

Metrorail repaired the switch damage and later restored service the following day.

At 05:42 hours, ATCM personnel reported that the maintenance to the interlocking was complete, all personnel were clear from the roadway, and normal service could resume to Ballston Station.

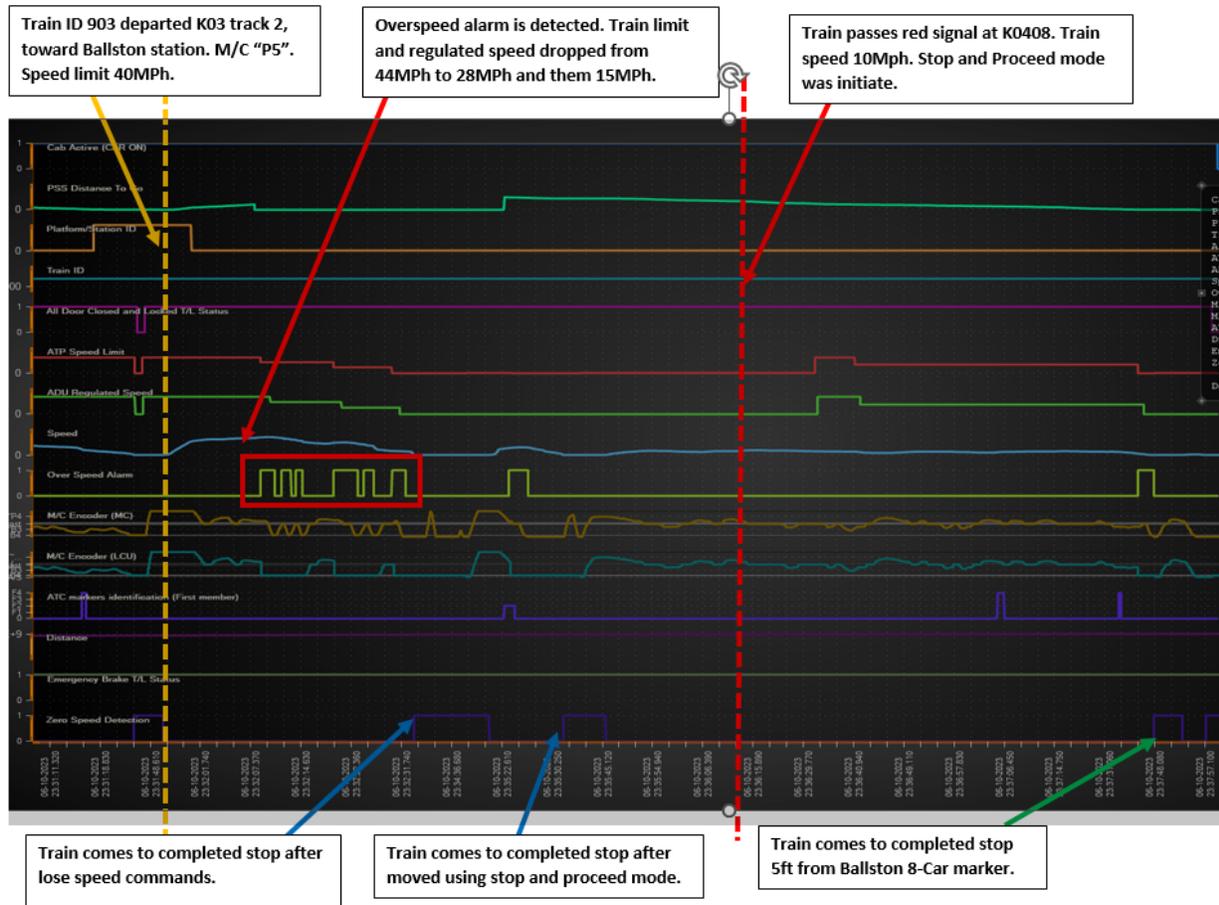
## ER Graph lead car 7566.

Based on VMDS and ER data, there was no fault with the train that contributed to the cause of this incident. The train performed as designed.
