**WMSC Commissioner Brief: W-0259 – Collision – near East Falls Church Station – June 5, 2023**

Prepared for Washington Metrorail Safety Commission meeting on March 5, 2024

Safety event summary:

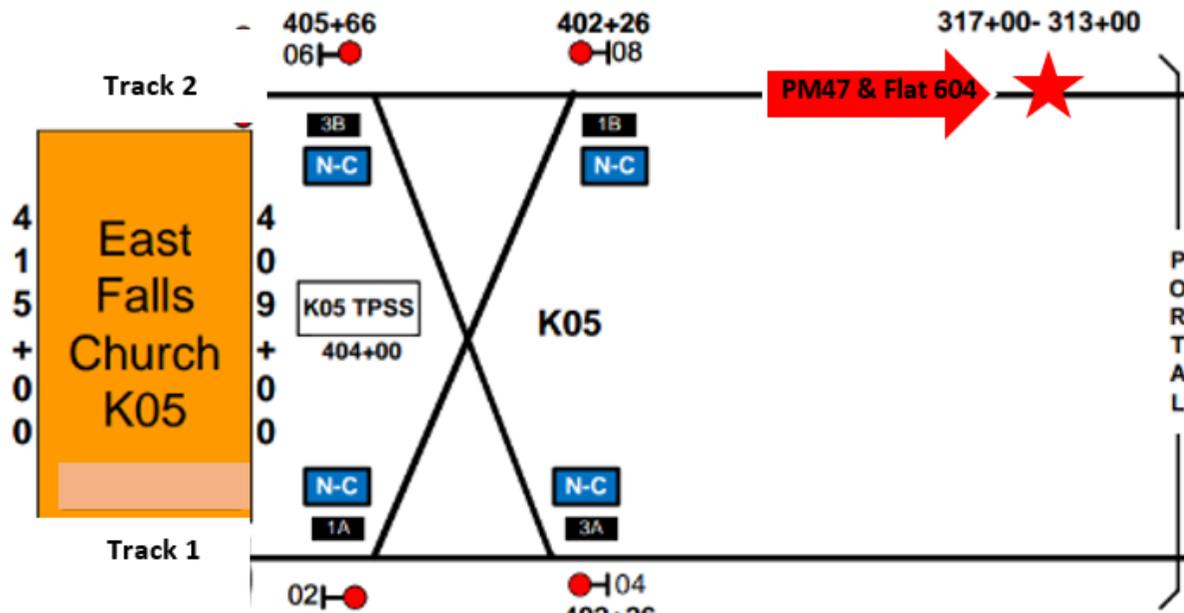
Field Sketch/Schematics

The probable cause of the Collision event on June 5, 2023, between East Falls Church Station and Ballston Station at CM K2 315+00 was the limited visibility of SM-01, which was secured in a blind curve. A contributing factor was the speed at which PM-47 was being operated prior to the collision. While not operating in excess of 15 mph, PM-47 was not being operated at a restricted speed, as the unit was unable to stop within half the range of vision to avoid the collision. An additional Contributing Factor to the event was inadequate communications between shifts, as the outgoing personnel failed to notify Mobile Command or the oncoming Gang Leader of SM-01's position in the work area.

Between East Falls Church Station and Ballston Station – CM K2 315+00

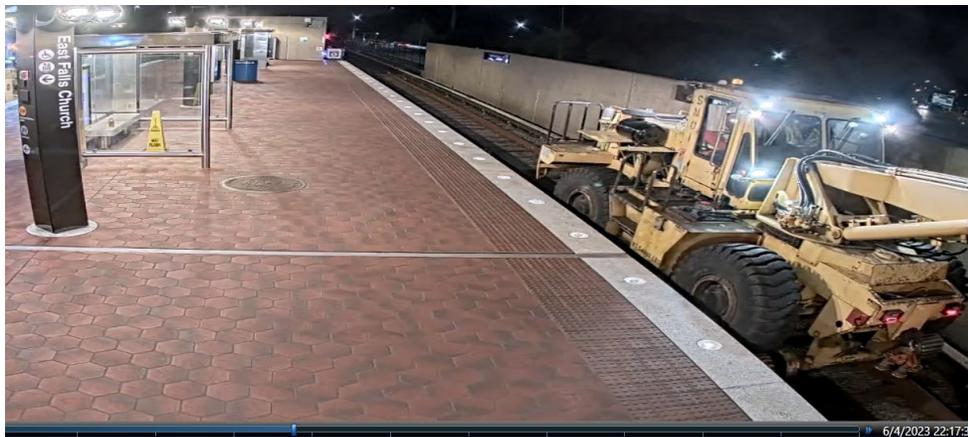
On Sunday, June 4, 2023, at 22:16 hours, Gang Leader #2 instructed the Equipment Operator of SM-01 to depart East Falls Church Station on track 1, cross over to track 2, and continue to CM K2 310+00¹. At 22:17 hours, SM-01 departed East Falls Church Station. SM-01 remained parked at that location within the work area and did not return to the platform for storage.

Image 1 – SM-01 departing East Falls Church Station on Sunday, June 4, 2023, at 22:17 hours.

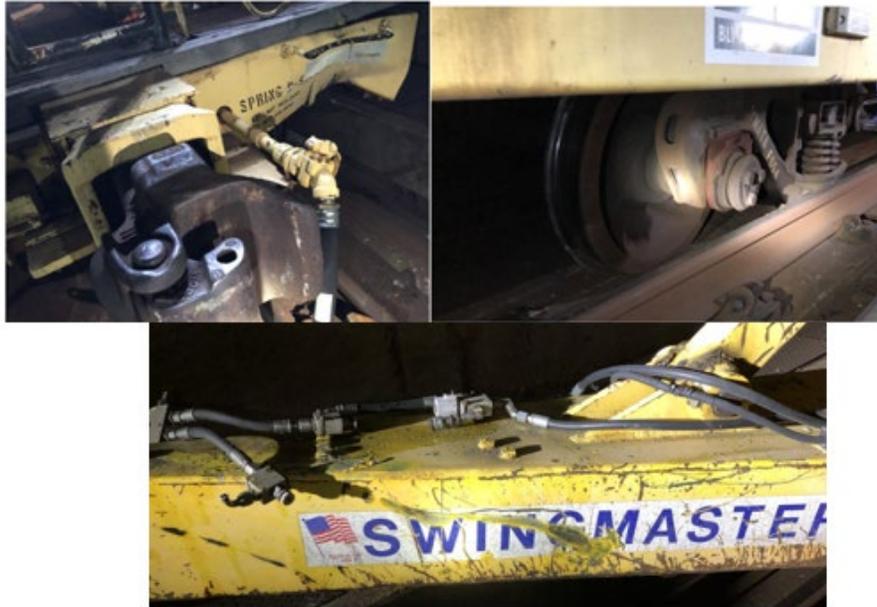
Image 2 – Photos of the damage and derailment on Flat Car 604 and SM-01 after the collision.

- Minor damage to the side frame. The ride control spring had to be reset in the holder. Center pin had fallen out due to bolster retaining plate breaking. All damage was on B-End Truck. Recommend truck replacement.
- Damaged brake dead lever weldment damaged, End bulkhead suffered severe damage, Job box had shifted beyond the deck, deck damage near flagman's booth.
- The brake beam was broken where the hand brake is attached, noted old damage/weld to brake piping, hand brake inoperative, see note in chassis. No indication of any defective parts. Last PM completed December 12, 2022.

- Mechanics performed functionality test on SM01 and confirmed that the vehicle functioned and operated normally.
- The major damage observed on SM01 was the auxiliary hydraulic components on the boom, which is not utilized by TRST for regular duty.
- Other minor damages include paint scratches and scrapes on the boom which won't affect the function of the machine.

- SM-01 was secured within a blind curve, a Hot Spot in the Track Access Guide.
- The boom attached to SM-01 was propped against the wall and one wheel chock was utilized to prevent SM-01 from moving.
- SM-01 sustained damage to the boom.
- Flat 604 sustained damage to the front body and step rung.

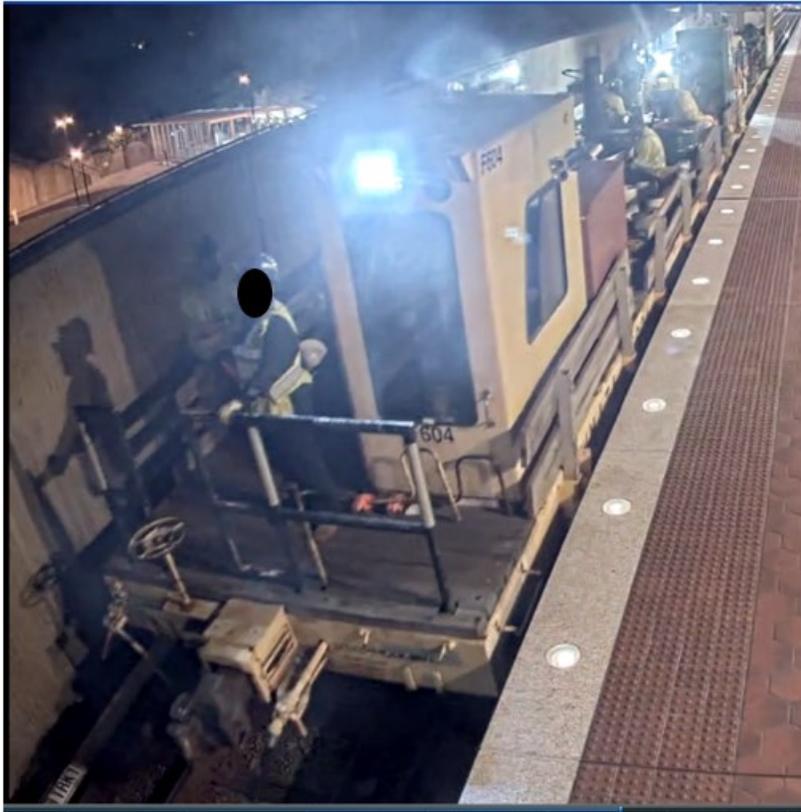
Image 3 – PM-47 with Flat Car 604 departing East Falls Church Station at 21:42 hours.

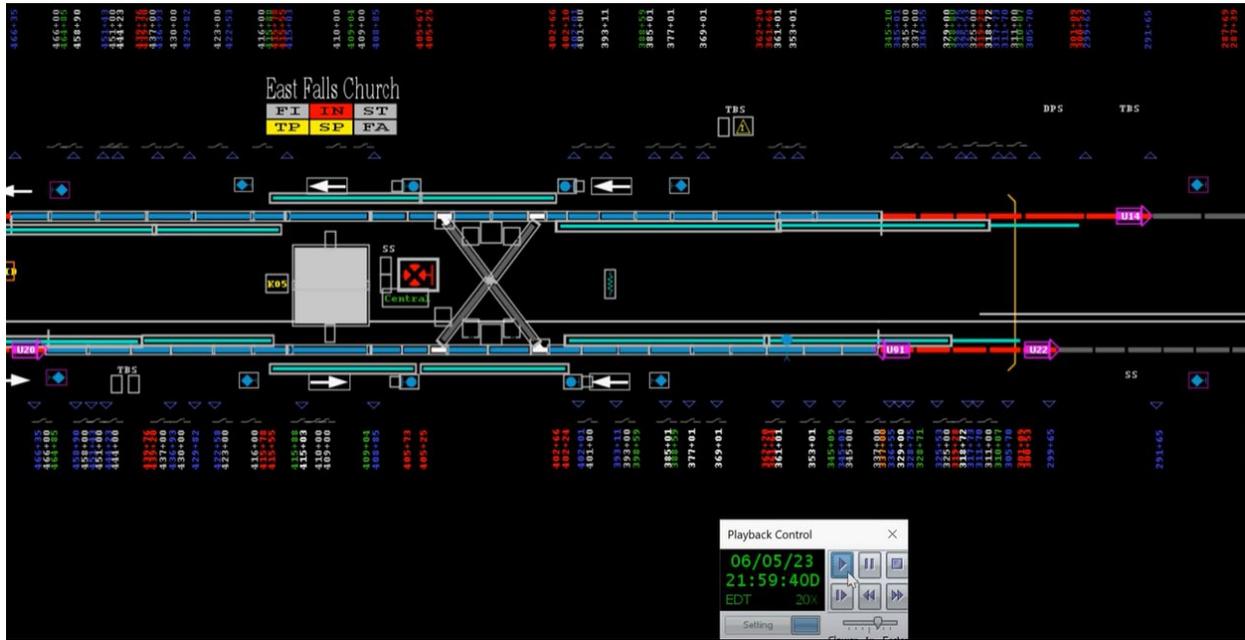
Figure 1 - AIMS depiction of the work area at East Falls Church Station at the time of the event at 21:59 hours.
