WMSM Commissioner Brief: W-0260 Derailment – Near Potomac Yard Station – April 11, 2023

Washington Metropolitan Area Transit Authority
Department of Safety (SAFE)
Office of Safety Investigations (OSI)
FINAL REPORT OF INVESTIGATION A&I E23242

Outside Potomac Yard Station – CM C2 408+00 – Derailment

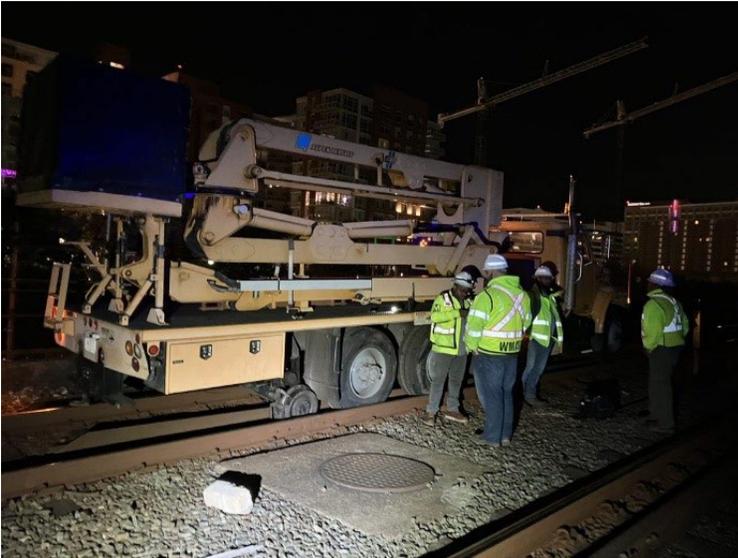
Figure 1: Hi-rail unit 14800 derailed on 04/11/23 at 01:38, travelling in reverse to Alexandria Yard along the Blue Line, between National Airport and Potomac Yard Stations.

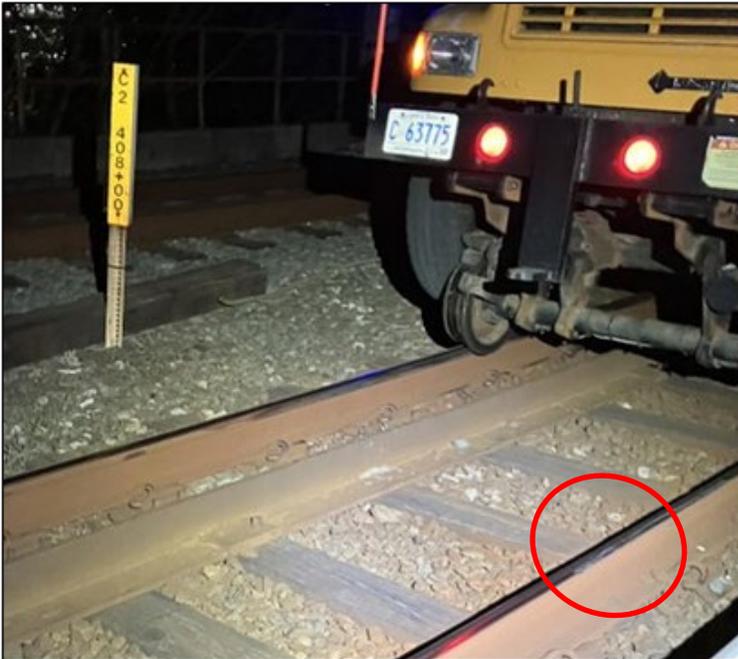
Figure 2: Point of derailment (in red), approximately two feet before Chain Marker C2 408+00.

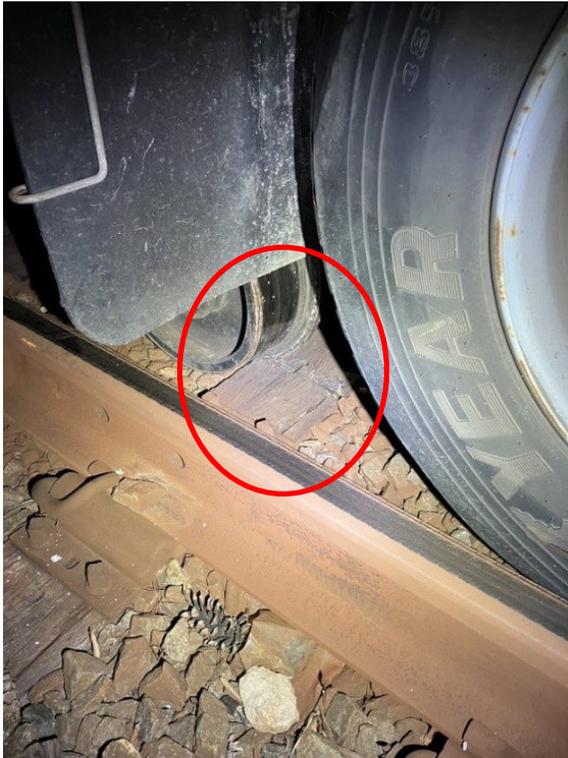
Figure 3: The shows the point of rest. Note the tie damage due to the wheel flange travel. Point of rest is approximately 26 feet from POD.

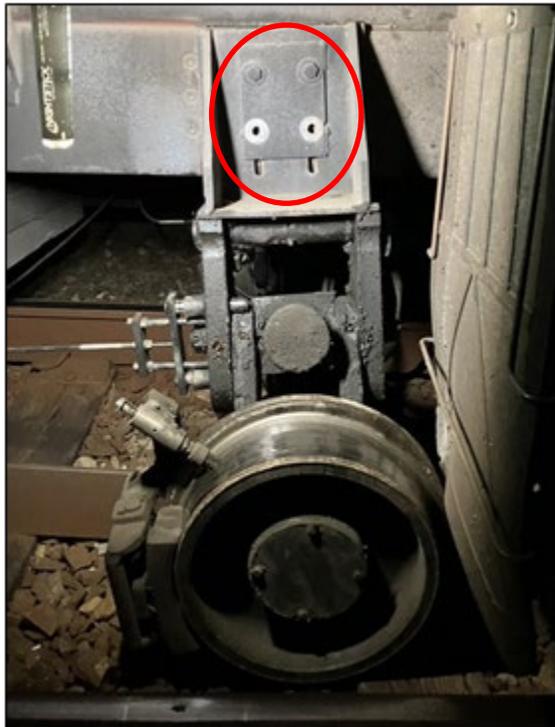
Field investigation by responding Operations and SAFE personnel identified two bolts missing from the rear right wheel chassis. These bolts can be adjusted, but they were designed to stay in place once tightened. The chassis is essential for both rail and over the road operations. Field inspection of the area also identified a change in the wheel-rail interface approximately twenty feet from the point of derailment. This was evidenced by noticeable swirl marks on the top of the running rail leading to the point of derailment. There was no damage to the tracks, ATC equipment, or third rail.

Figure 4: The hi-rail derailed chassis, within the track gauge. Note on the right side two bolts (in red) are always in placed but sheared off.

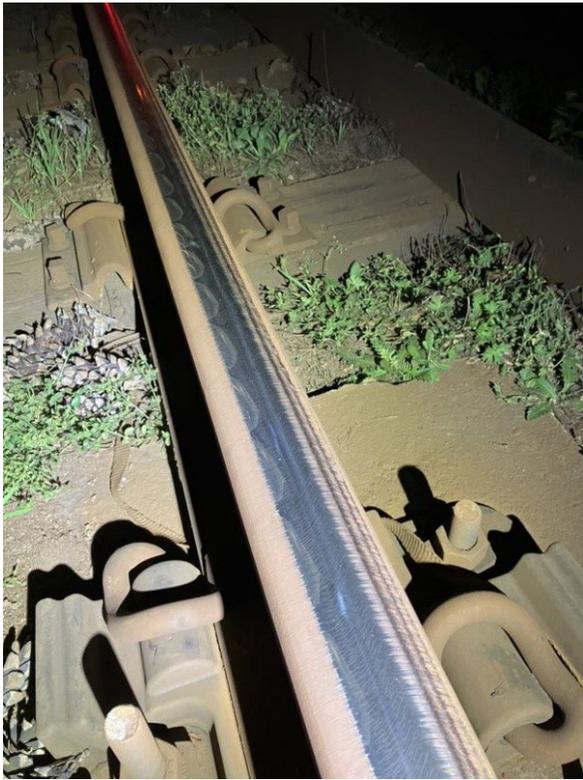
Figure 5: The rail markings switched to a swirling mark at approximately 20 feet prior to the point of derailment.

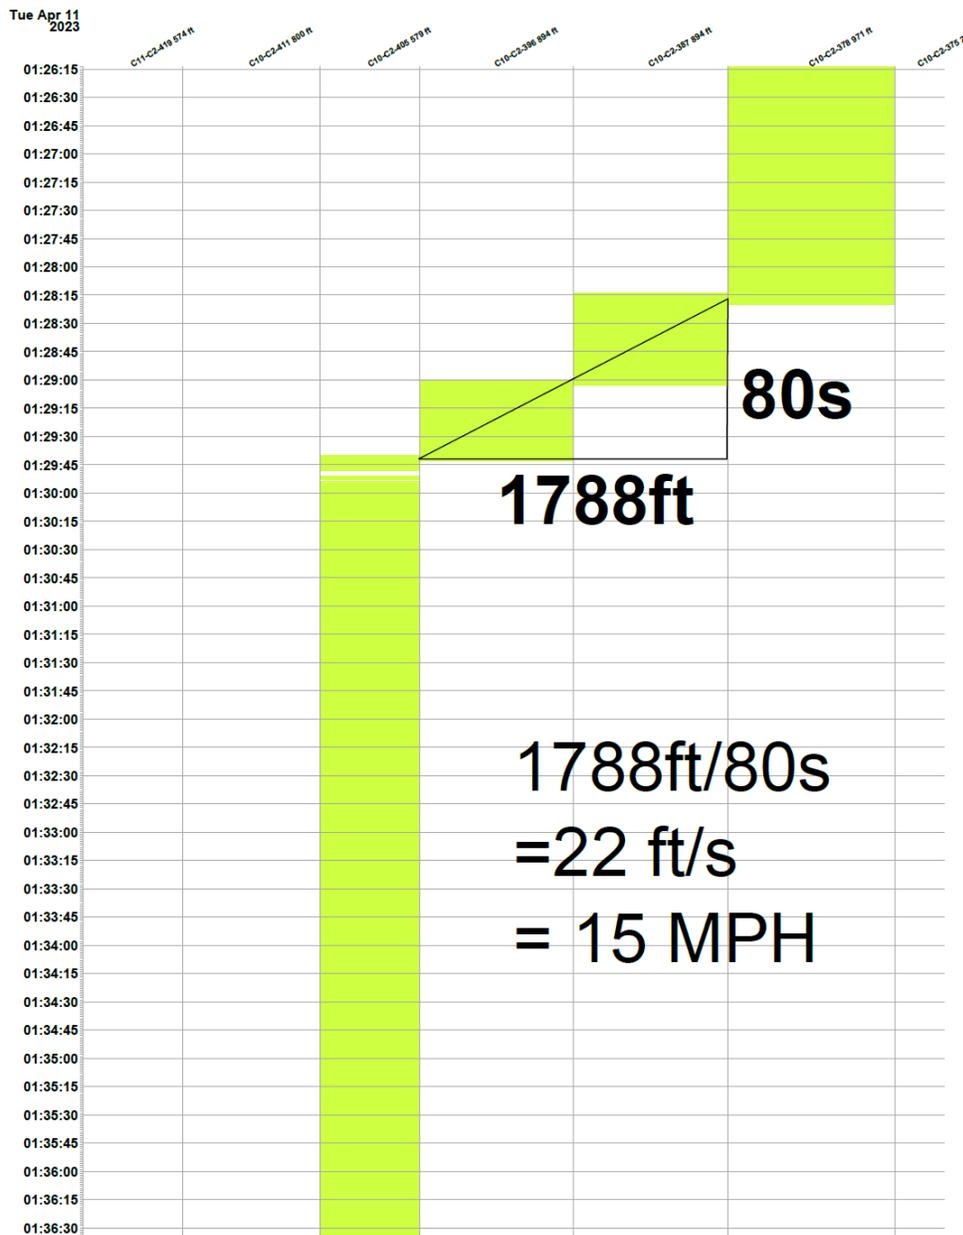
Prior to reaching block C2-405, the vehicle shown shunting in this chart traveled 1,788 feet in 80 seconds, which works out to 15MPH.

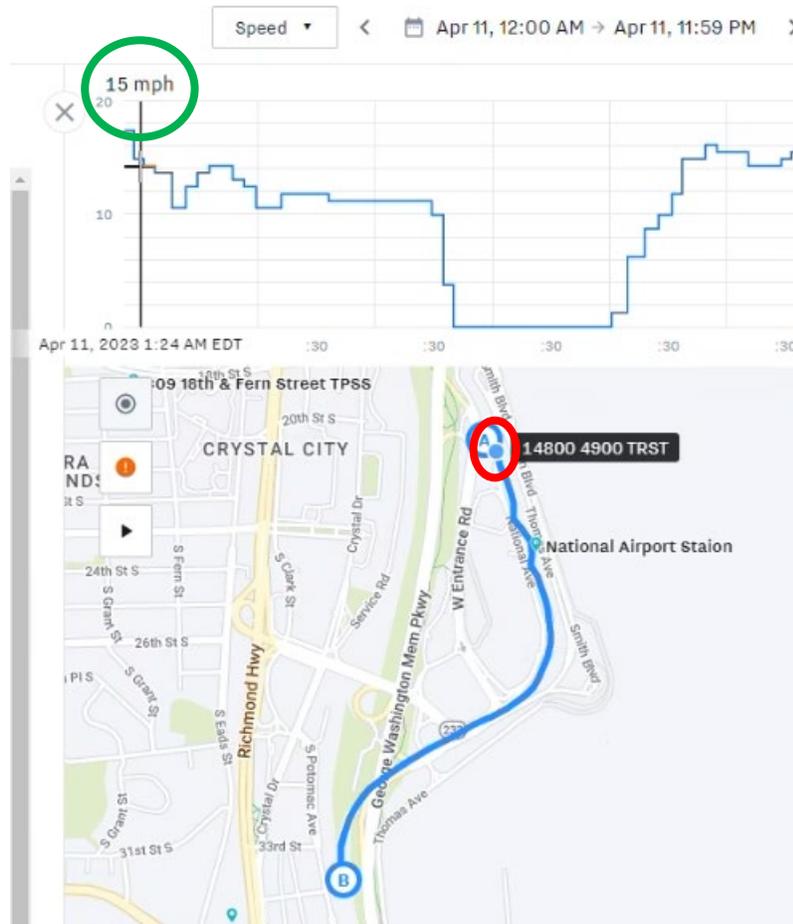
Figure 6: This image shows the event recorder data of the hi-rail vehicle speed as it traversed from Crystal City Station to Braddock Road Station.

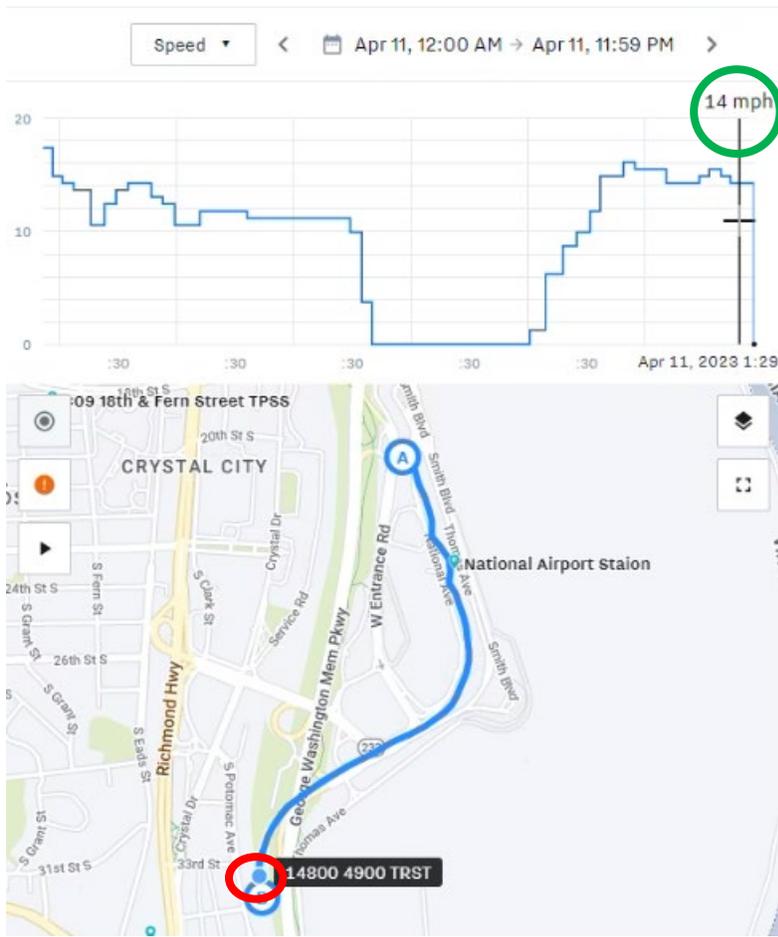
Figure 7: This image shows the event recorder data of the hi-rail vehicle speed right before it derailed.

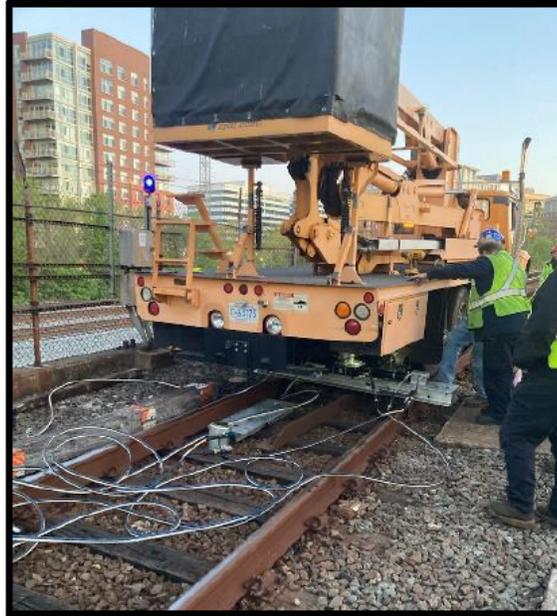
Figure 1. 14800 derailment

At the time of initial response, the left-side of the rear hi-rail gear was found to be not fully deployed and locked. In this condition, the rail wheel would have been severely unloaded and offer no lateral resistance in the direction of derailment and is the likely cause of the incident.

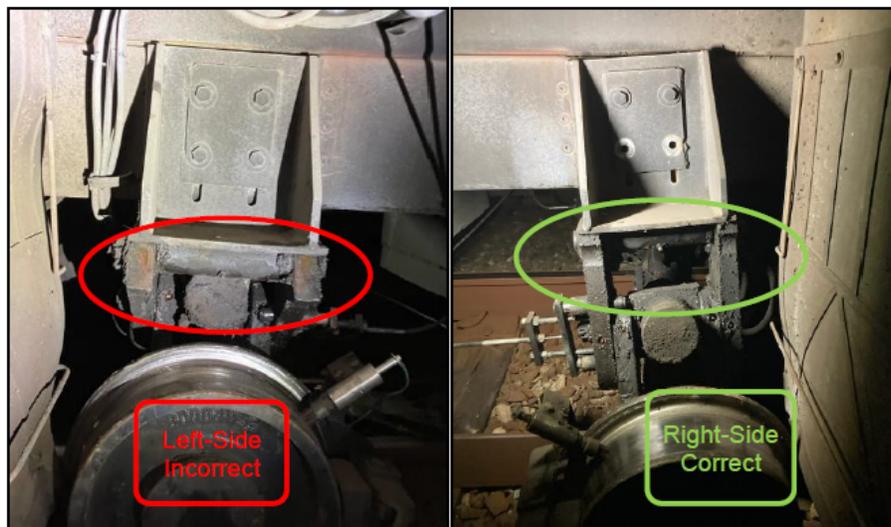
Figure 2. Left-side and right-side hi-rail comparison

During CENV/CTEM review of photographs taken at the incident location, the left-side of the rear hi-rail gear can be seen not fully deployed (see Figure 2). The two rectangular pads circled should be rotated an additional 90° to be coincident with the mounting plate as shown on the right-side.

In this configuration, the down force normally shared with the rail wheel and tires is borne solely by the tires. Without any downforce, the wheel flange will not offer resistance to lateral forces and the vehicle would not be able to counteract centrifugal forces in a radius. Additionally, the vehicle has less ability to conform to changing cross-level in a spiral.

Significant damage was found to the left side of hi-rail gear and its associated mounting. Although not located at the incident, two of four bolts were missing from the right side hi-rail mounting location (see Figure 2). The right hi-rail was pushed forward consistent with derailling in the reverse travel direction and being the only side supporting vehicle weight. The left side mounting had all four mounting bolts and had only mild misalignment.

- Review WMATA hi-rail operation and usage training.
- Evaluate the need to return 14800 to service. If the unit is not decommissioned, the following recommendations should be performed:
 - Have the rear hi-rail gear inspected and repaired/replaced by qualified personnel.
 - Repair rear tow eye and install with new mounting hardware.

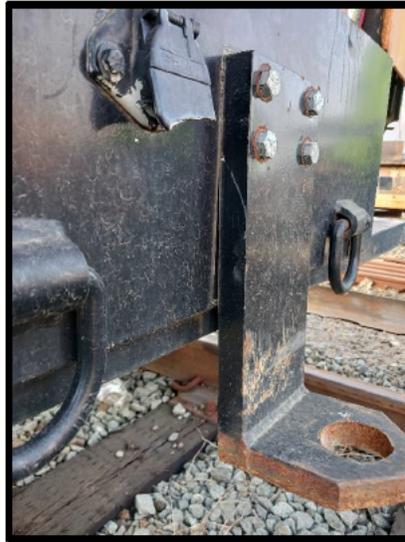
Figure 3. Toweye damage

During the rerailment procedure, the rear toweye experienced damage from jacking (see Figure 3). The bracket is bent and needs to be repaired. When reinstalling, the mounting bolts should be replaced.

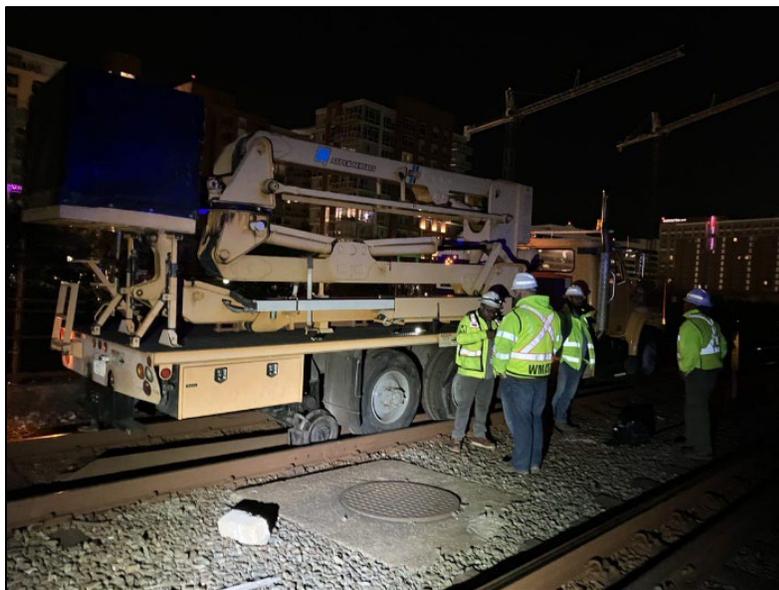
Figure 9: Hi-rail unit 14800 derailed on 04/11/23 at 01:38, traveling in reverse to Alexandria Yard along the Blue Line, between National Airport and Potomac Yard Stations.

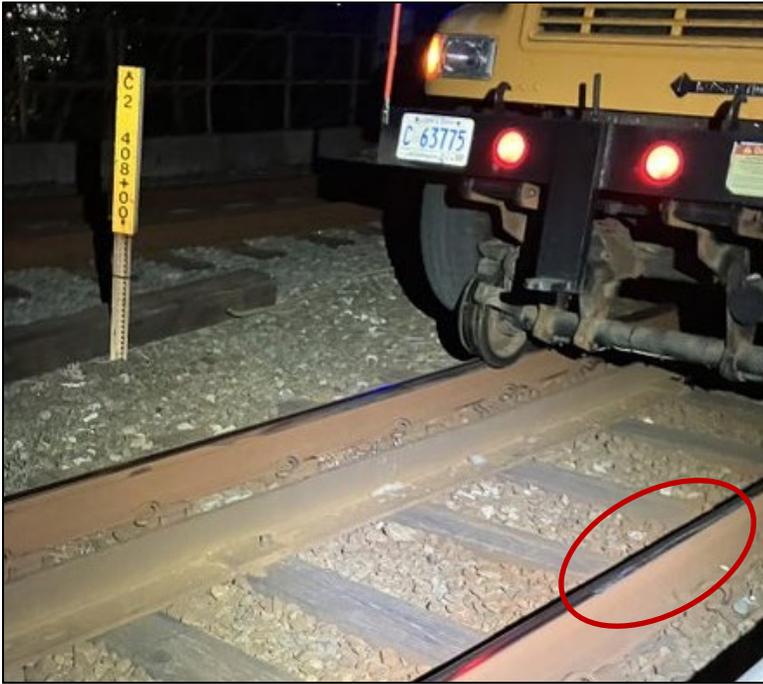
Figure 10: Point of derailment (in red), approximately two feet before Chain Marker C2 408+00. The front of the unit was the trailing end in the direction of travel.

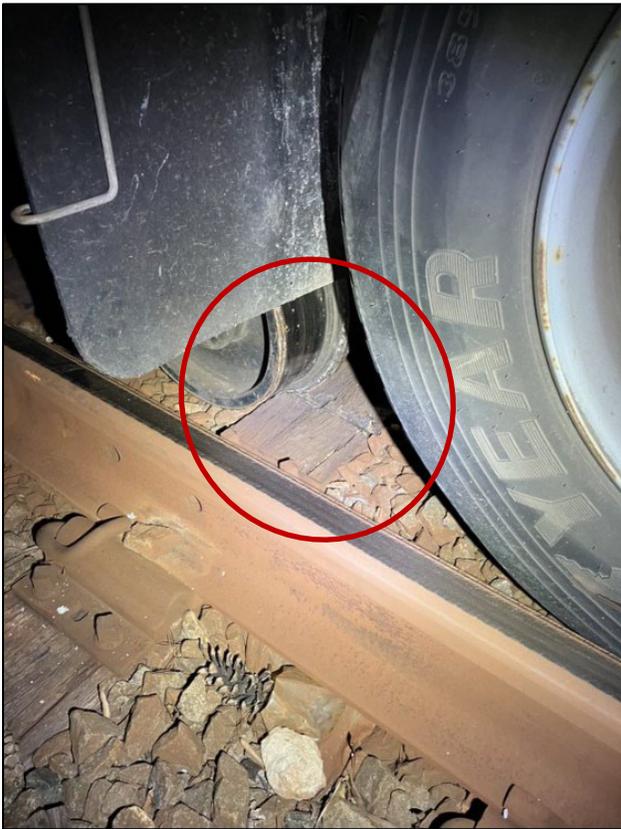
Figure 11: Shows the point of rest. Note the rail tie damage due to the wheel flange travel. Point of rest is approximately 26 feet from POD.

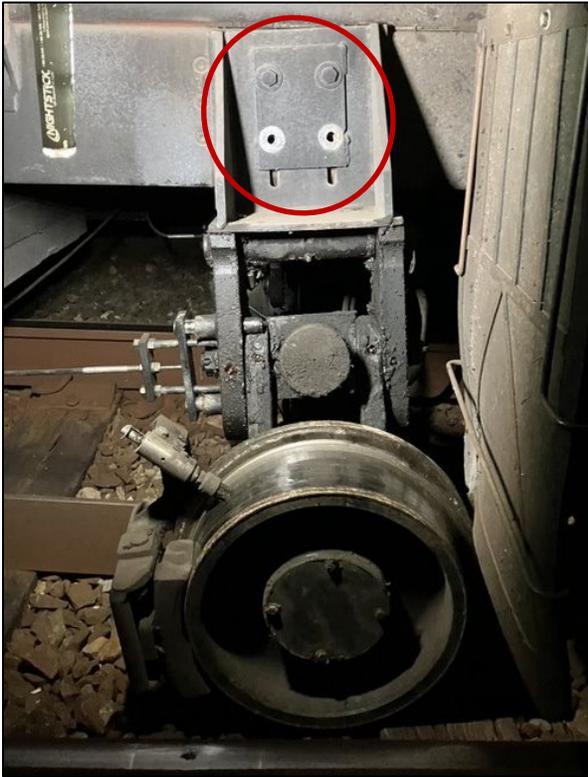
Figure 12: The hi-rail derailed chassis, within the track gauge. Note the two bolts sheared.

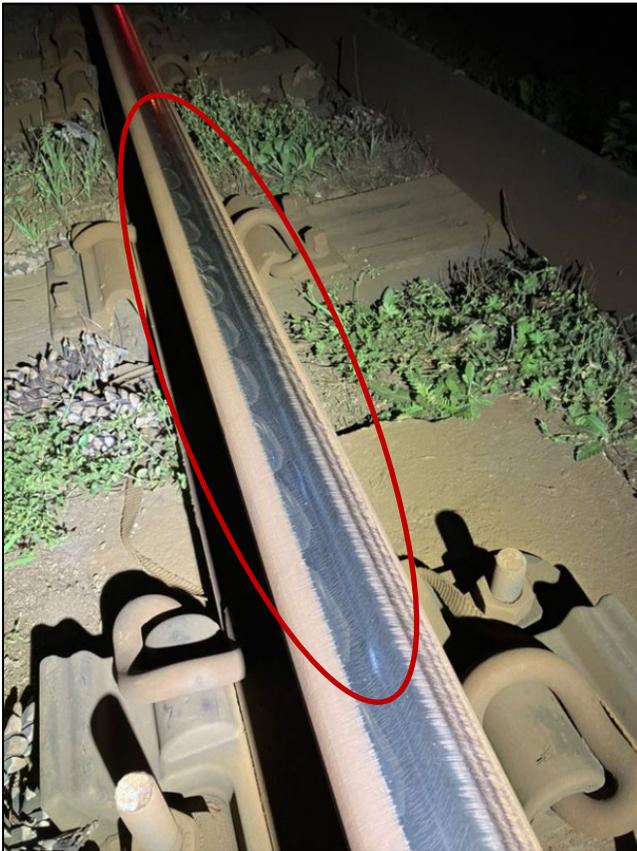
Figure 13: The rail markings switched to a swirling mark at approximately 20 feet to the point of derailment.
