WMSC Commissioner Brief: W-0261 Collision – Greenbelt Rail Yard – June 29, 2023

Washington Metropolitan Area Transit Authority
Department of Safety (SAFE)
Office of Safety Investigations (OSI)
FINAL REPORT OF INVESTIGATION A&I E23443

Greenbelt Yard – Collision

June 29, 2023

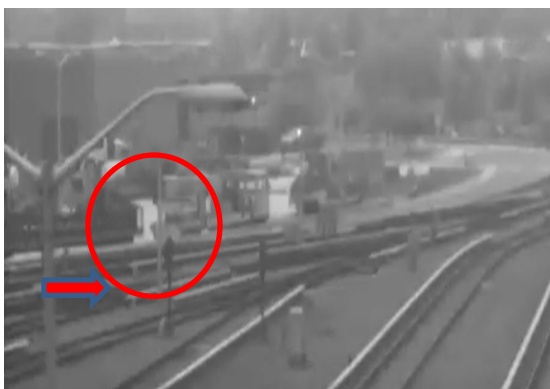
Image 2 - Pre-collision PM-55 and AV01

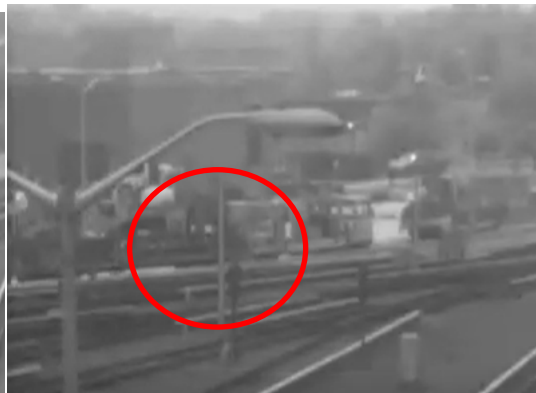
None of the required safety stops were completed. At the time of the collision, AV-01 was secured on the storage track when F-544 collided with the rear of AV-01, causing damage to the housing structure of the rear-mounted camera. The collision did not move AV-01.

Image 3 – Post-collision PM55 and AV01

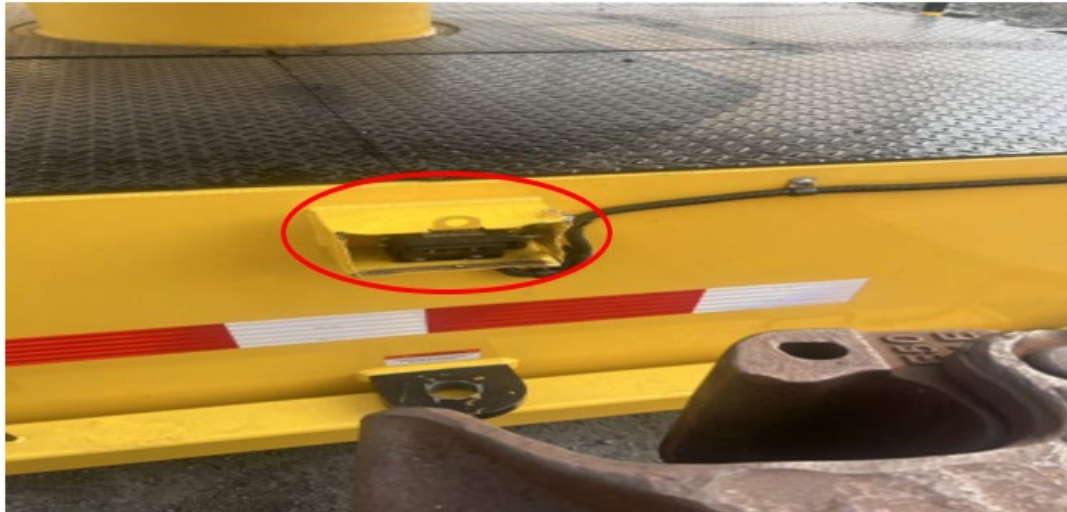
CTEM inspected PM-55, F-539, F544, and AV-01. The inspection revealed damage observed to the housing structure of AV-01's rear-mounted camera; the camera was not damaged. Additionally, F-544 sustained scratches to the back-end bumper.

Image 1 – Damage to the housing structure of the rear-mounted camera of AV-01.

The Office of Car Track Equipment Maintenance (CTEM) performed an inspection on PM-55, F-539, F544, and AV-01. The inspection revealed that damage was observed to the housing structure of AV-01's rear-mounted camera; the camera was not damaged. Scratches to the back-end bumper of F-544 were also observed.

Camera Box was bent from the B-end knuckle of F544, No other damage

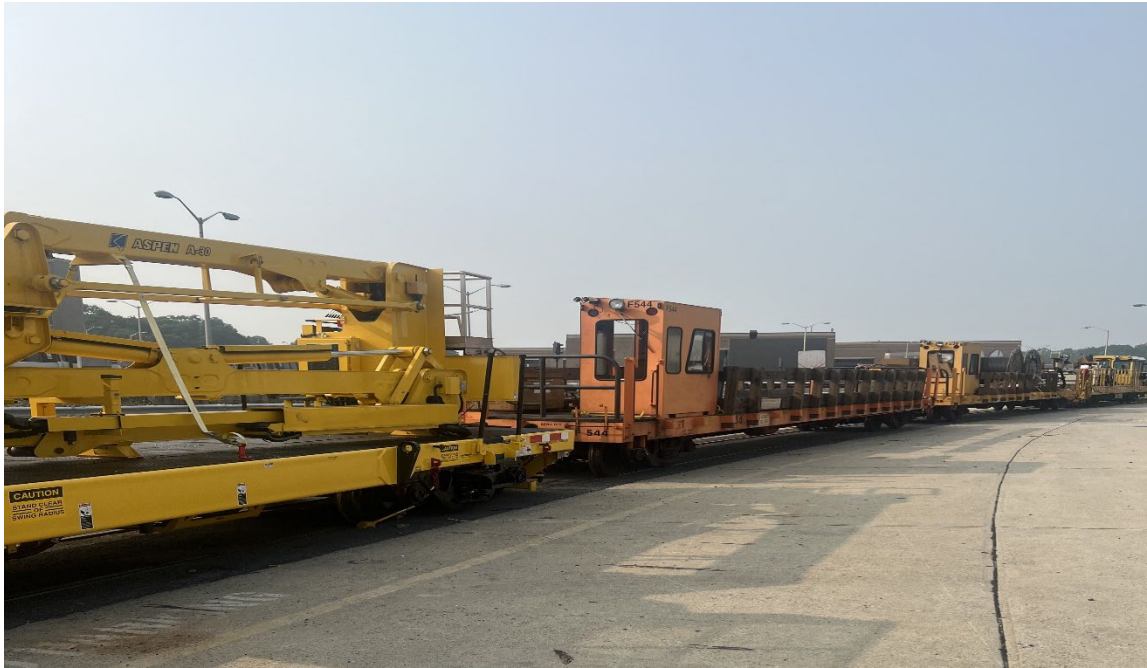
Image 1 - Post-Incident AV-01 - F544 - F539 - PM55 (left to right).

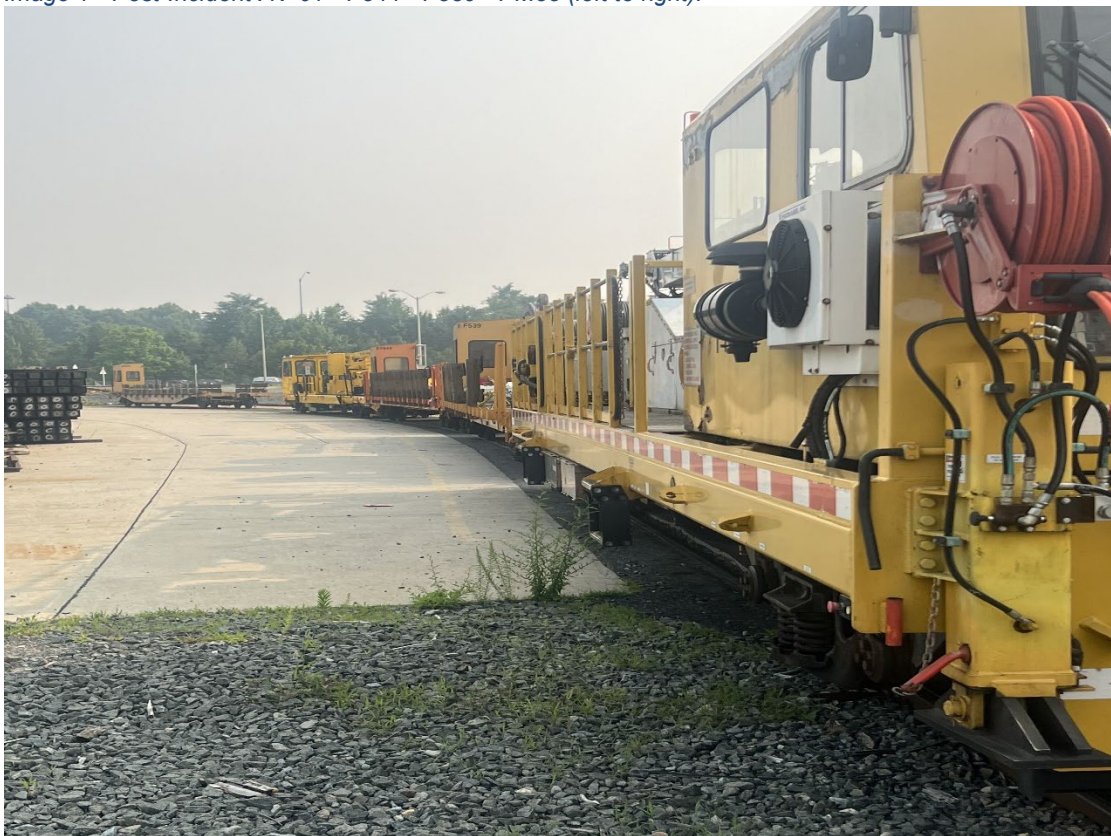
Image 2 - Post-Incident AV01 - F544 - F539 - F544 - AV01 - PM55 (left to right).

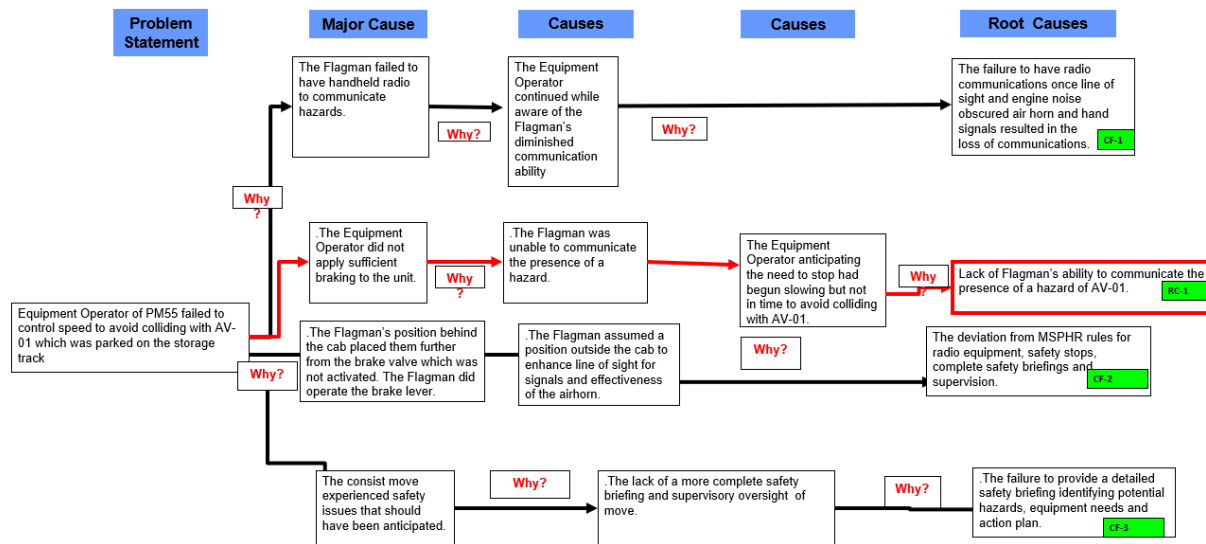
Appendix E – Why-Tree Analysis

The probable cause of the Collision event on June 29, 2023, at Greenbelt Yard was the Equipment Operator's failure to stop before colliding with a secured vehicle. Contributing factors to the event included the Flagman failing to activate the emergency brake or notify the Equipment Operator to stop. The Flagman did not have a required handheld radio, which prevented them from directly communicating with the Equipment Operator.

Corrective Action Code	Description	Responsible Party	Estimated Completion Date
109567_SAFE CAPS_CTEM _001	Conduct refresher or reinstruction of CTEM Flagman for RWP to include required safe operating speed reductions in areas of limited visibility, required equipment, PPE, and RSJB to include knowledge of work site conditions.	CTEM SRC	Completed
